Notes from E&S Inspection on 6/11/2025

Site inspection photos taken during inspection on 6/11/2025

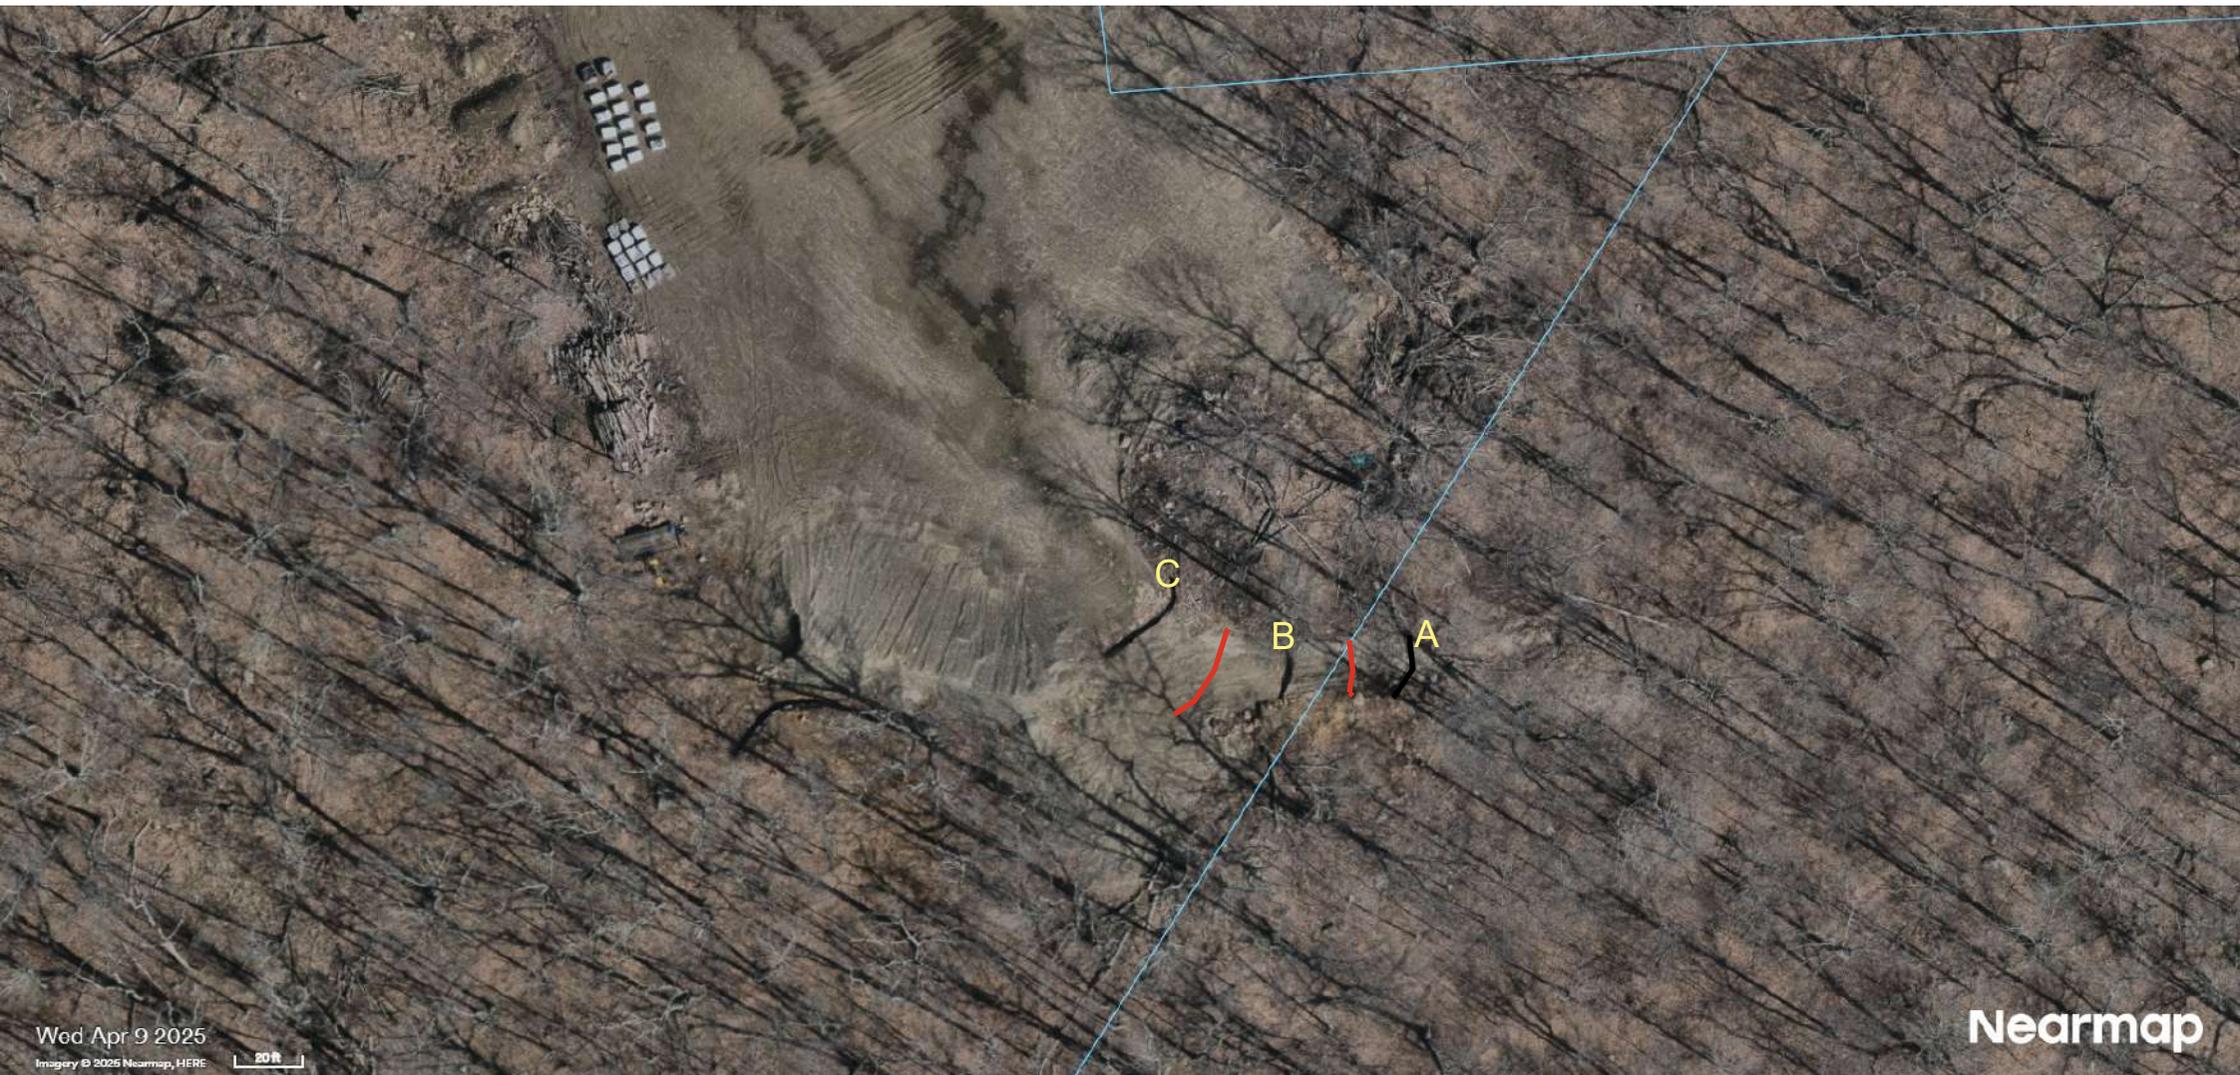
This is an aerial image to depict areas that need additional erosion and sediment controls.

The red lines are situated between existing rows of silt fencing and represent the approx location you need to install rows of staked-in hay bales.

The row of silt fence labeled A, needs to be maintained and repaired. There is too much sediment build up and it is bypassing the silt fence.

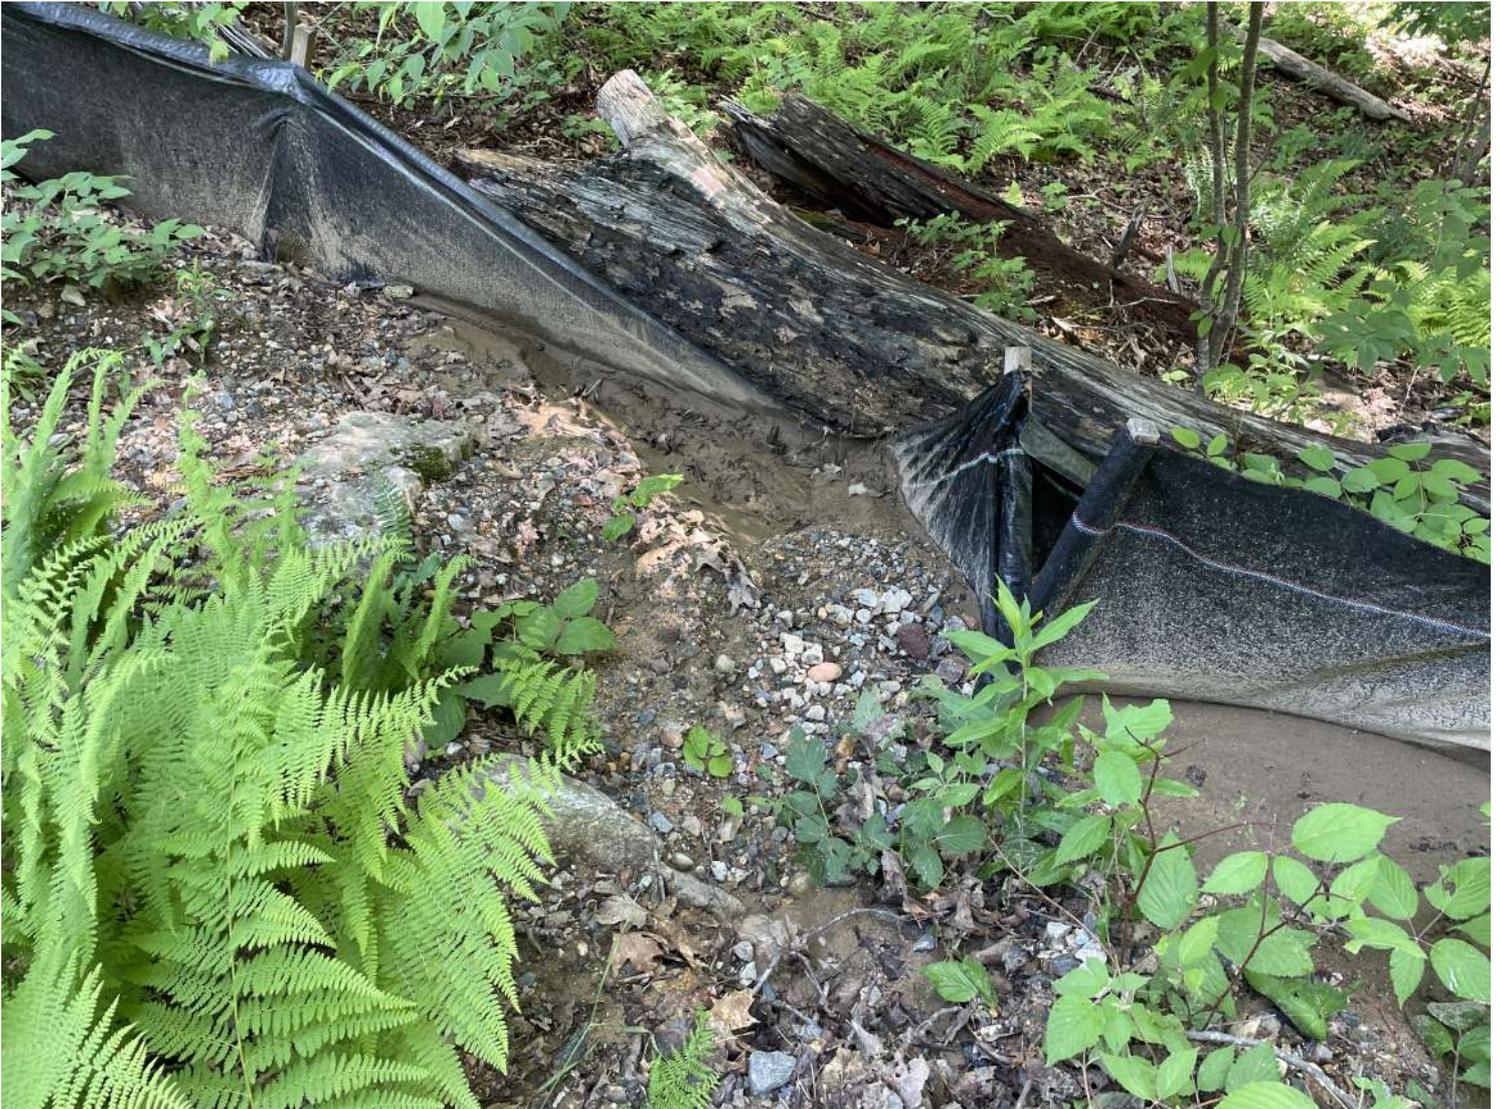
Silt Fence A: over-topping and bypass of sediment

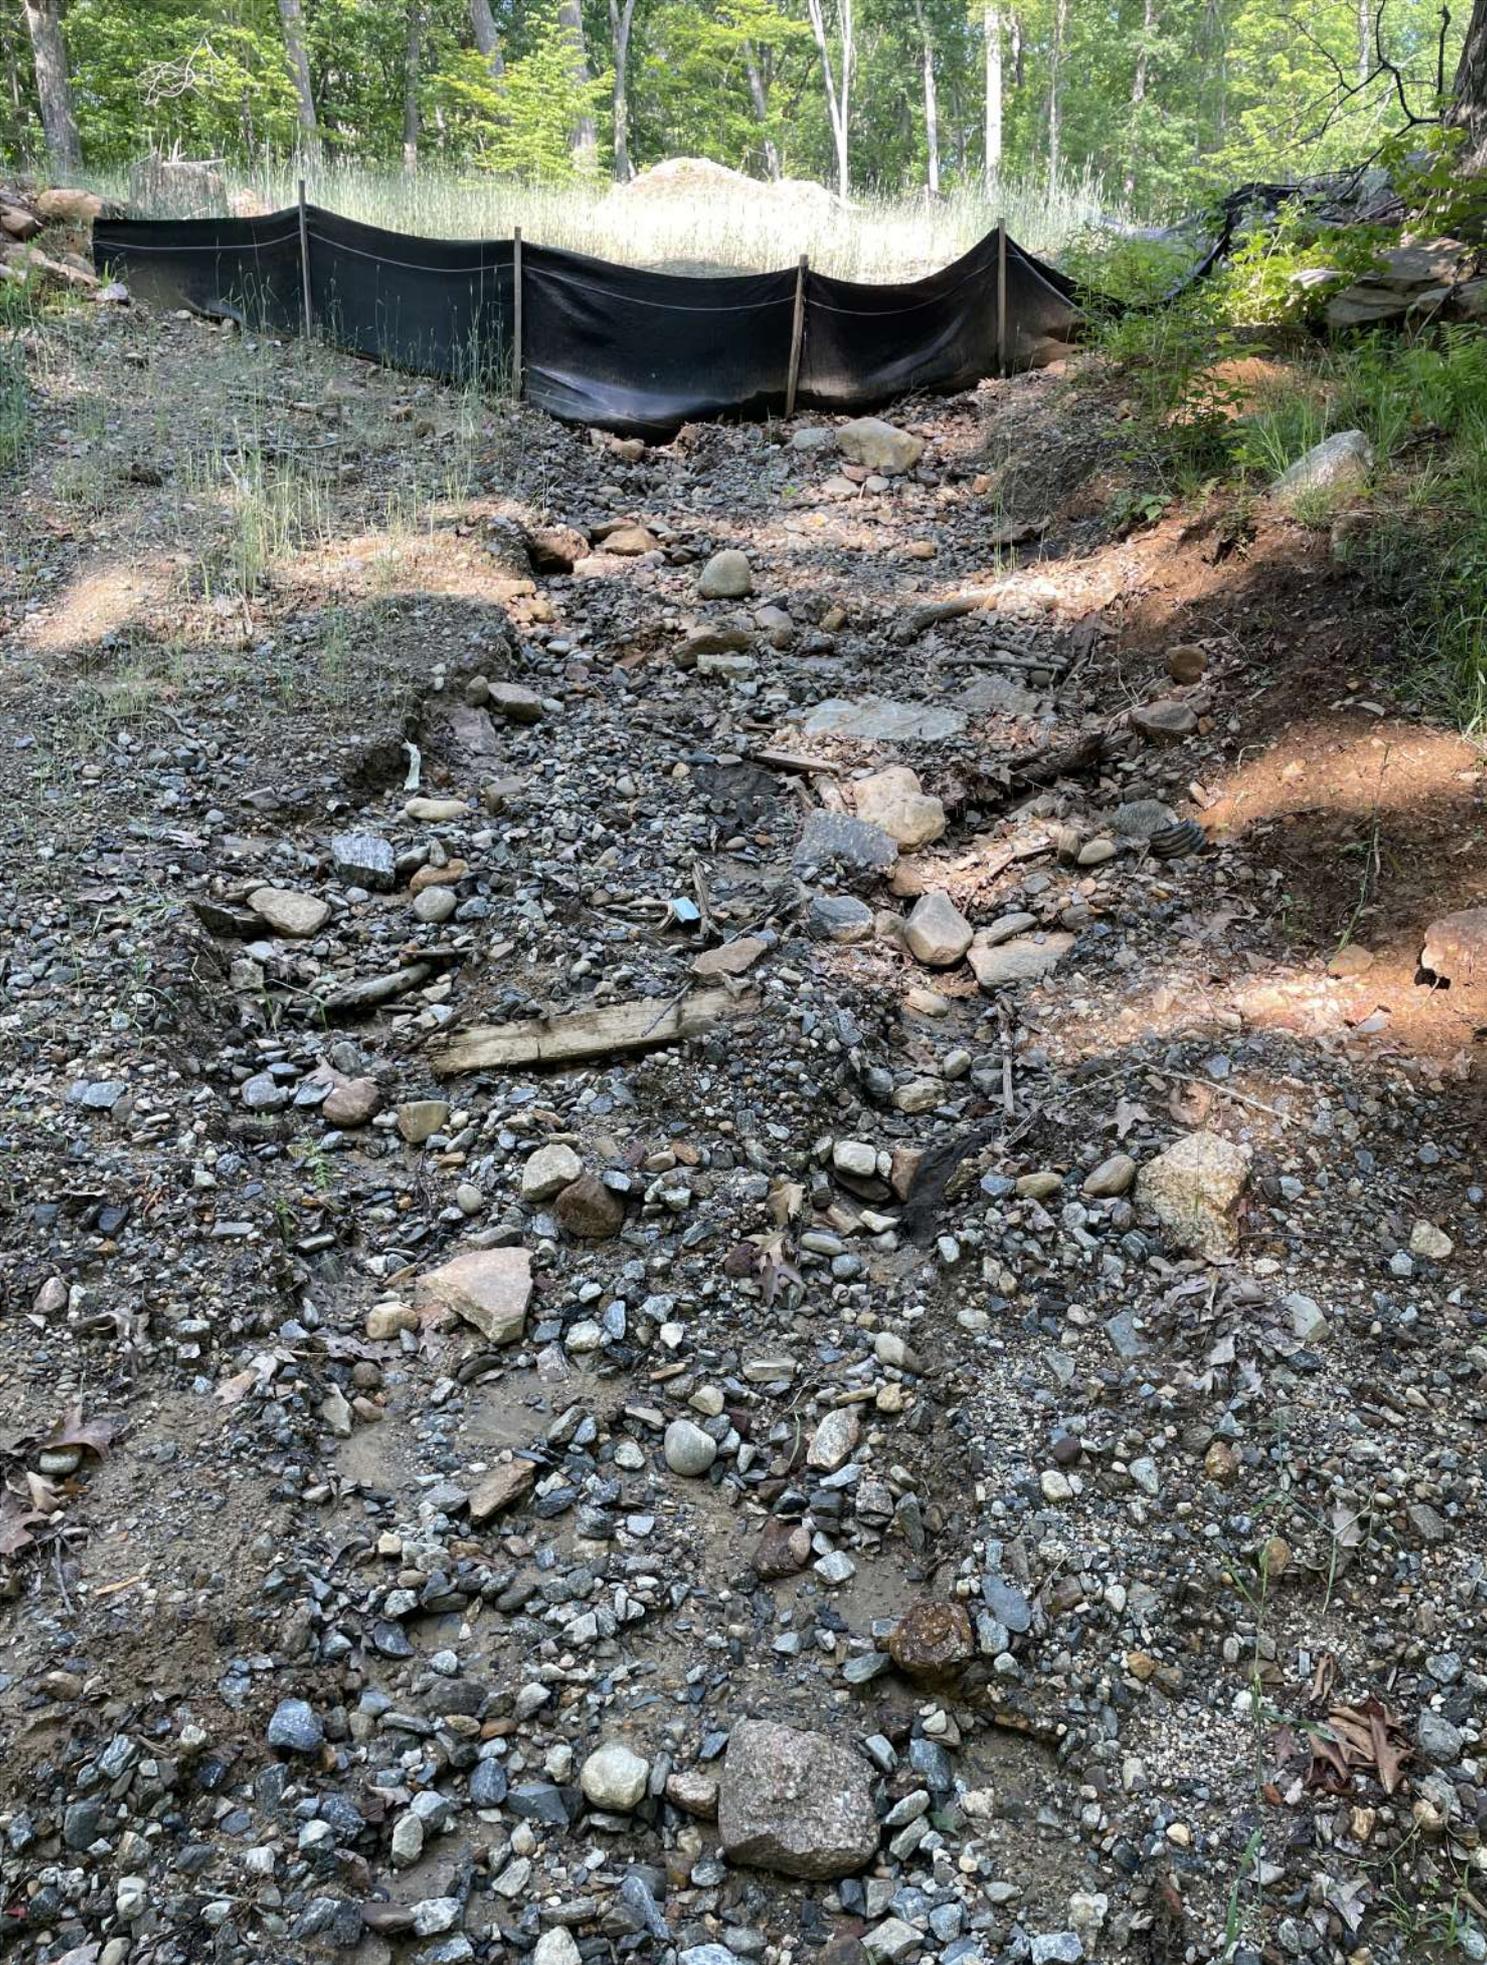
Silt fence B: significant erosion down gradient of silt fence B. Staked in hay bales needed.

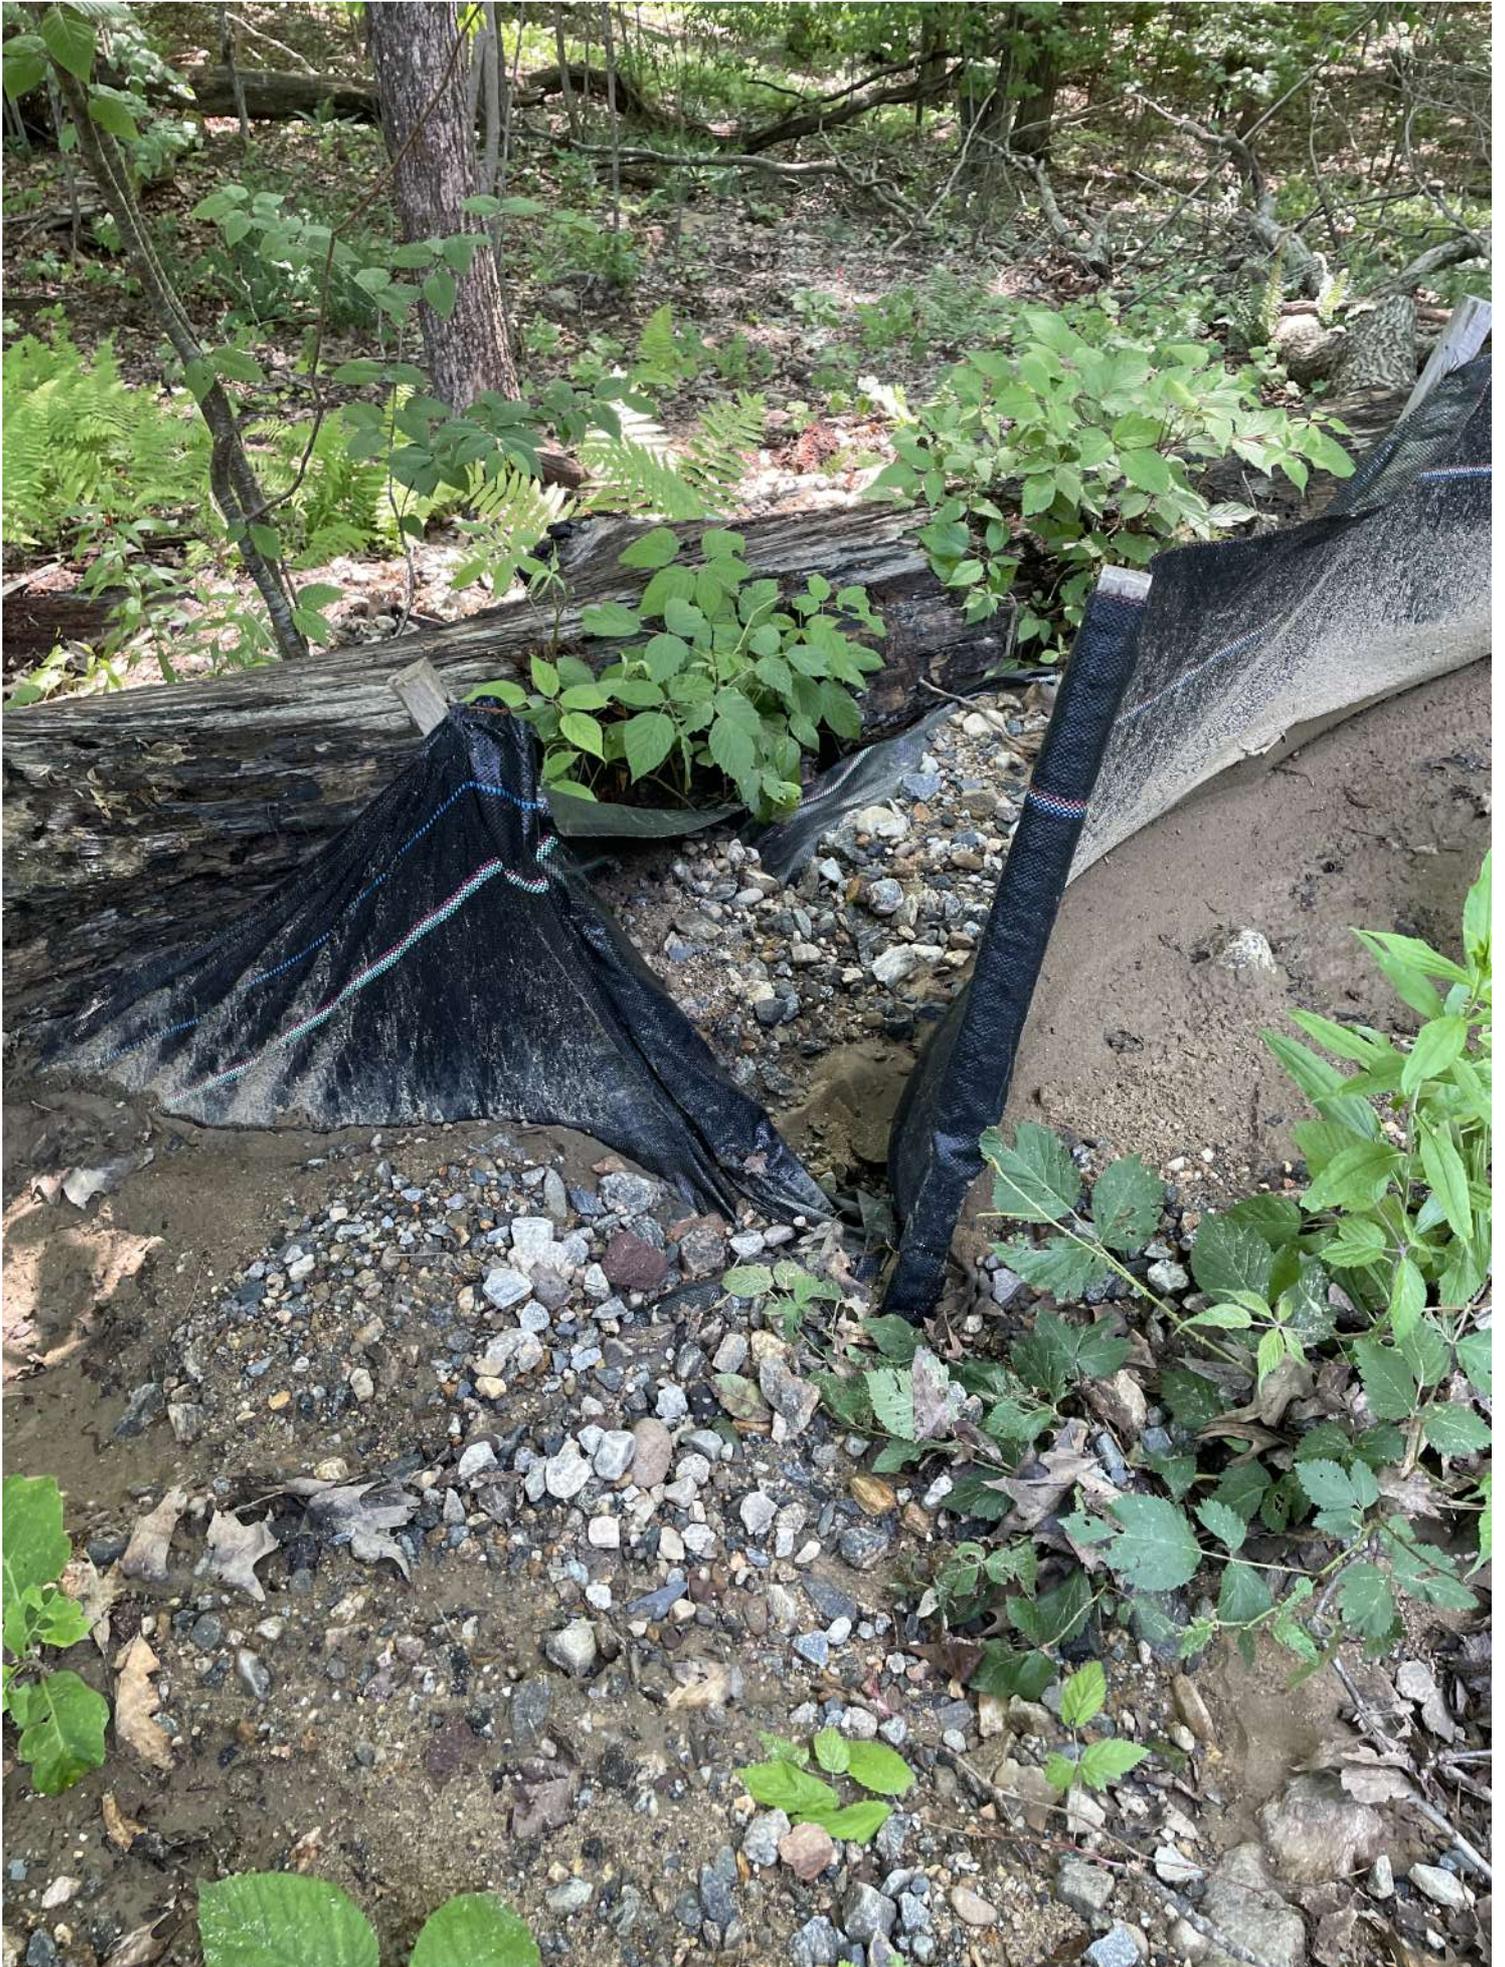
Silt fence A: area of by-pass that needs repair

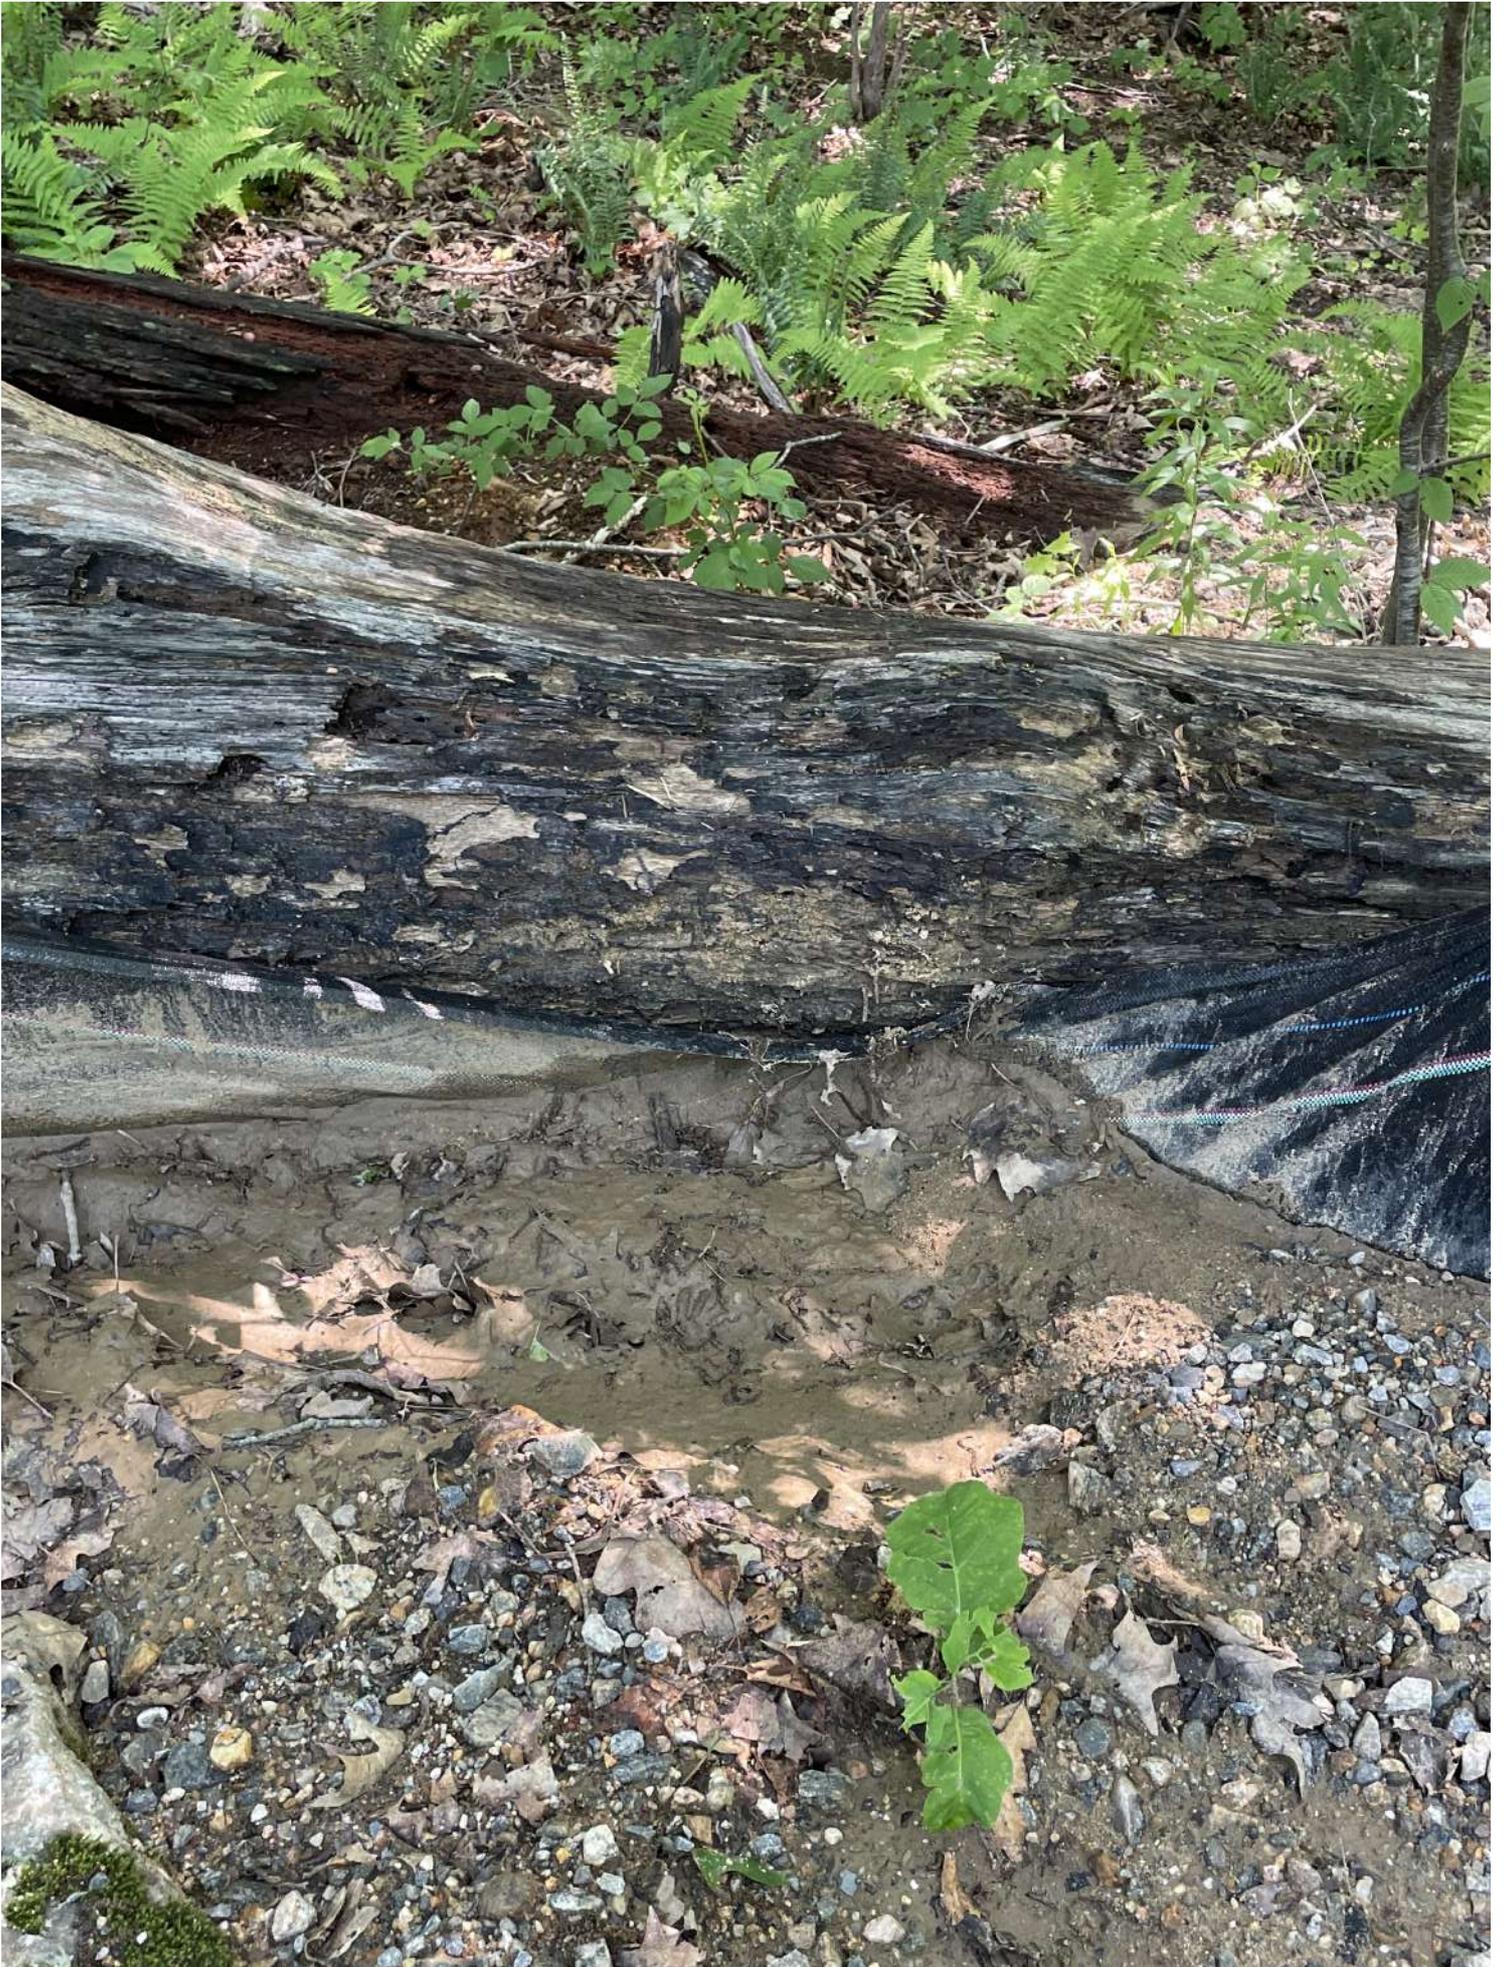
Silt Fence A: area of over-topping. Needs repair.

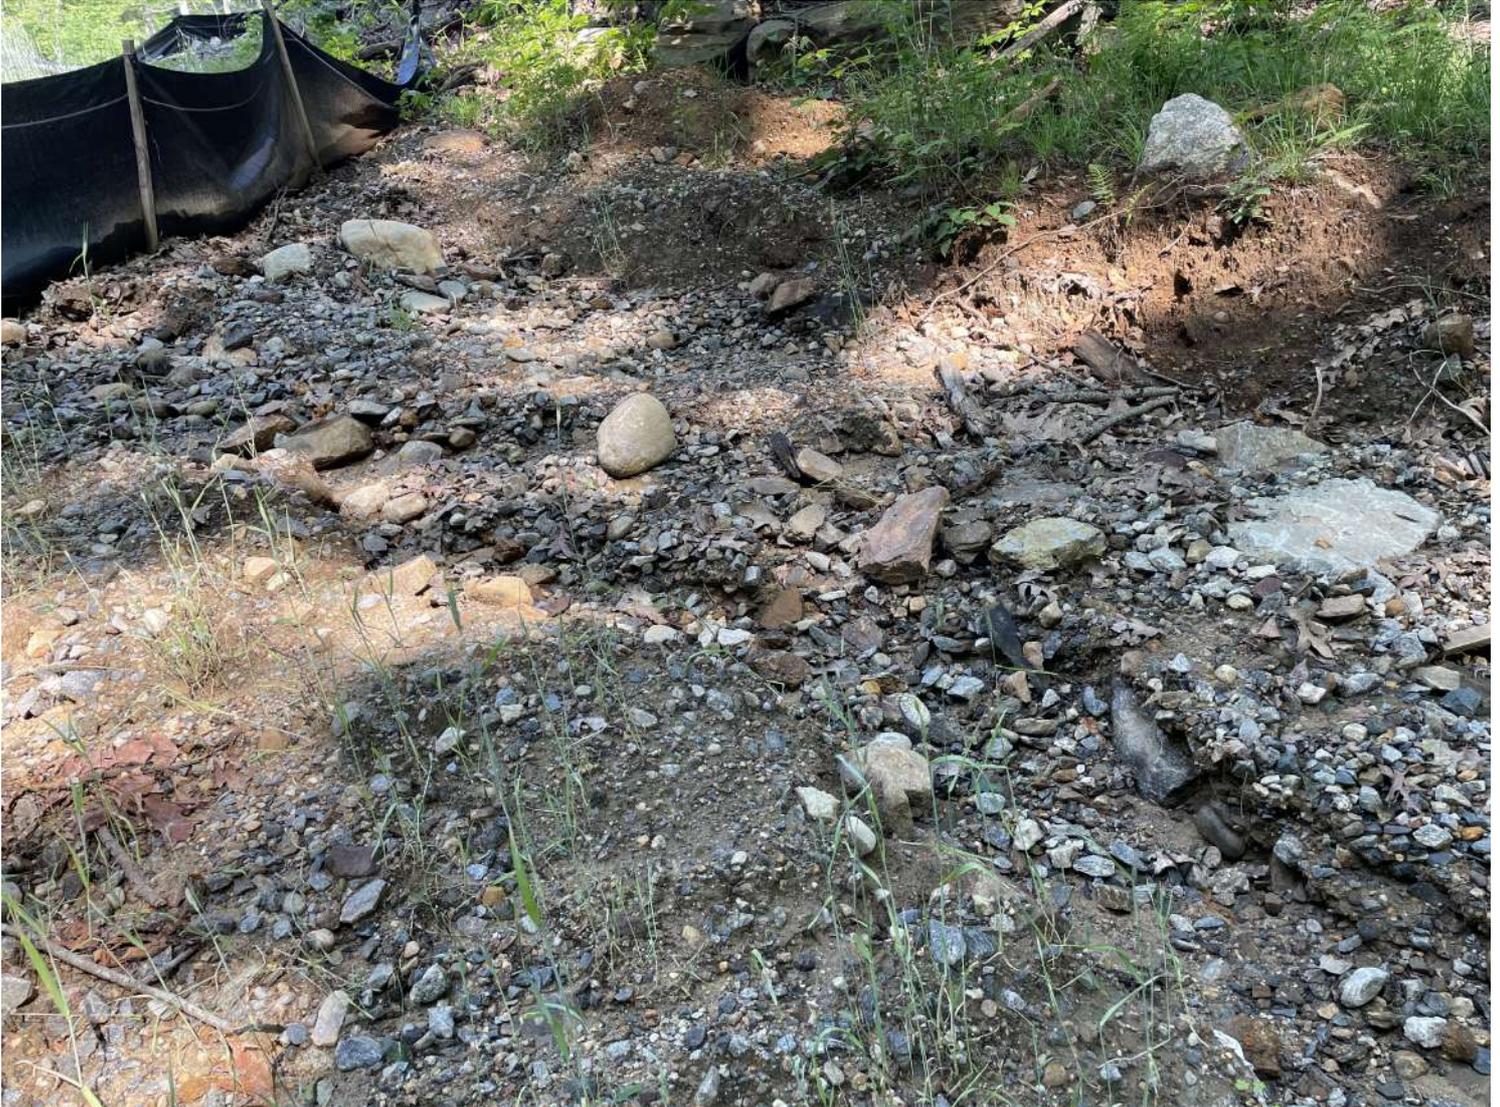
Between Silt fence A and B: Erosion has worsened since inspection on June 4th.
