Notes from E&S Inspection on 7/2/2025

Erosion and Sediment Control Inspection Photos from inspection on 7/2/2025.
This is a post-storm inspection.

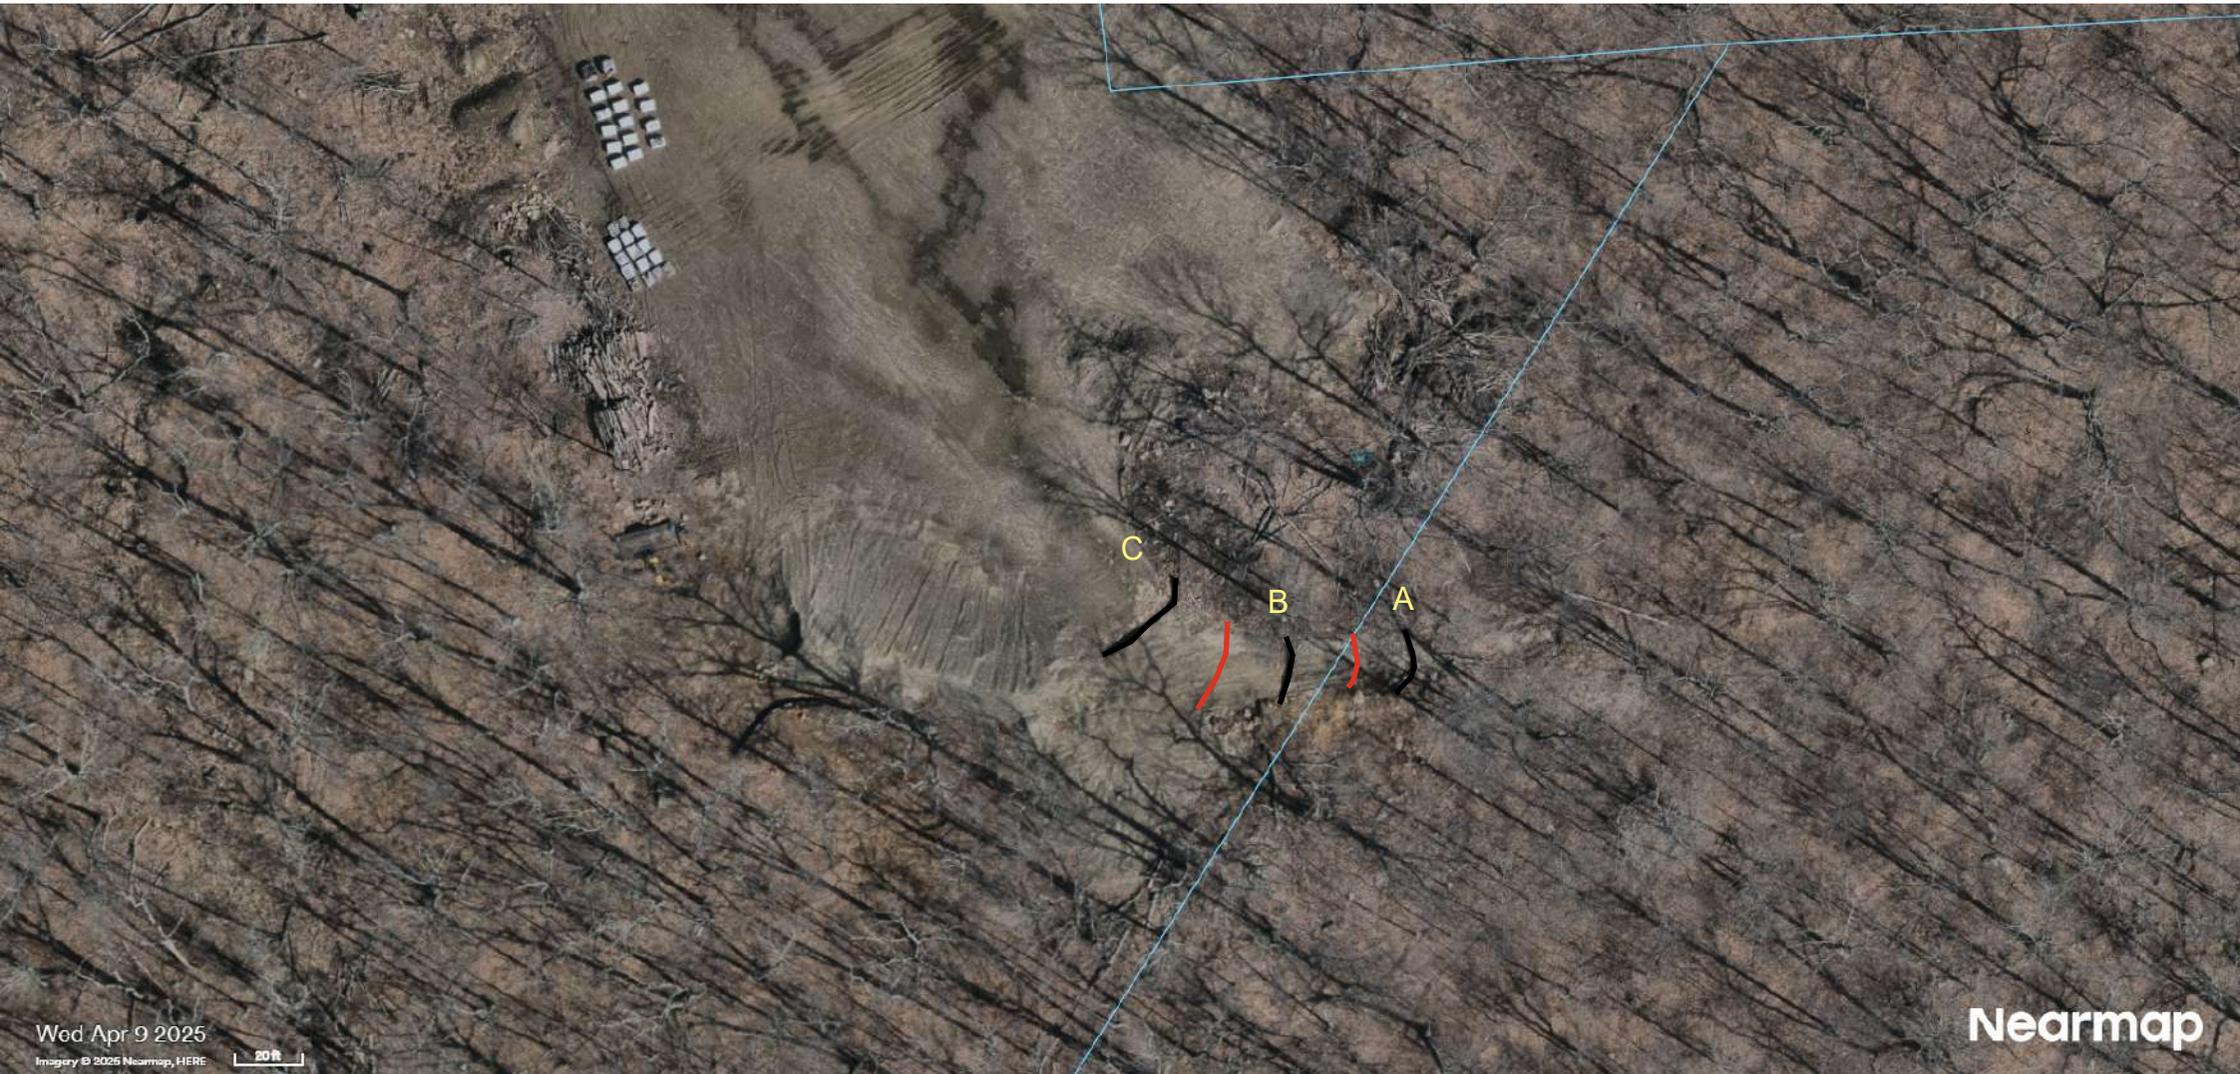
This is an aerial image to depict location of existing silt fences and haybales

The red lines represent the newly installed rows of staked in haybales

The rows of silt fences have been labeled A, B, and C. Consistent with inspection notes from 6/11/2025 inspection.

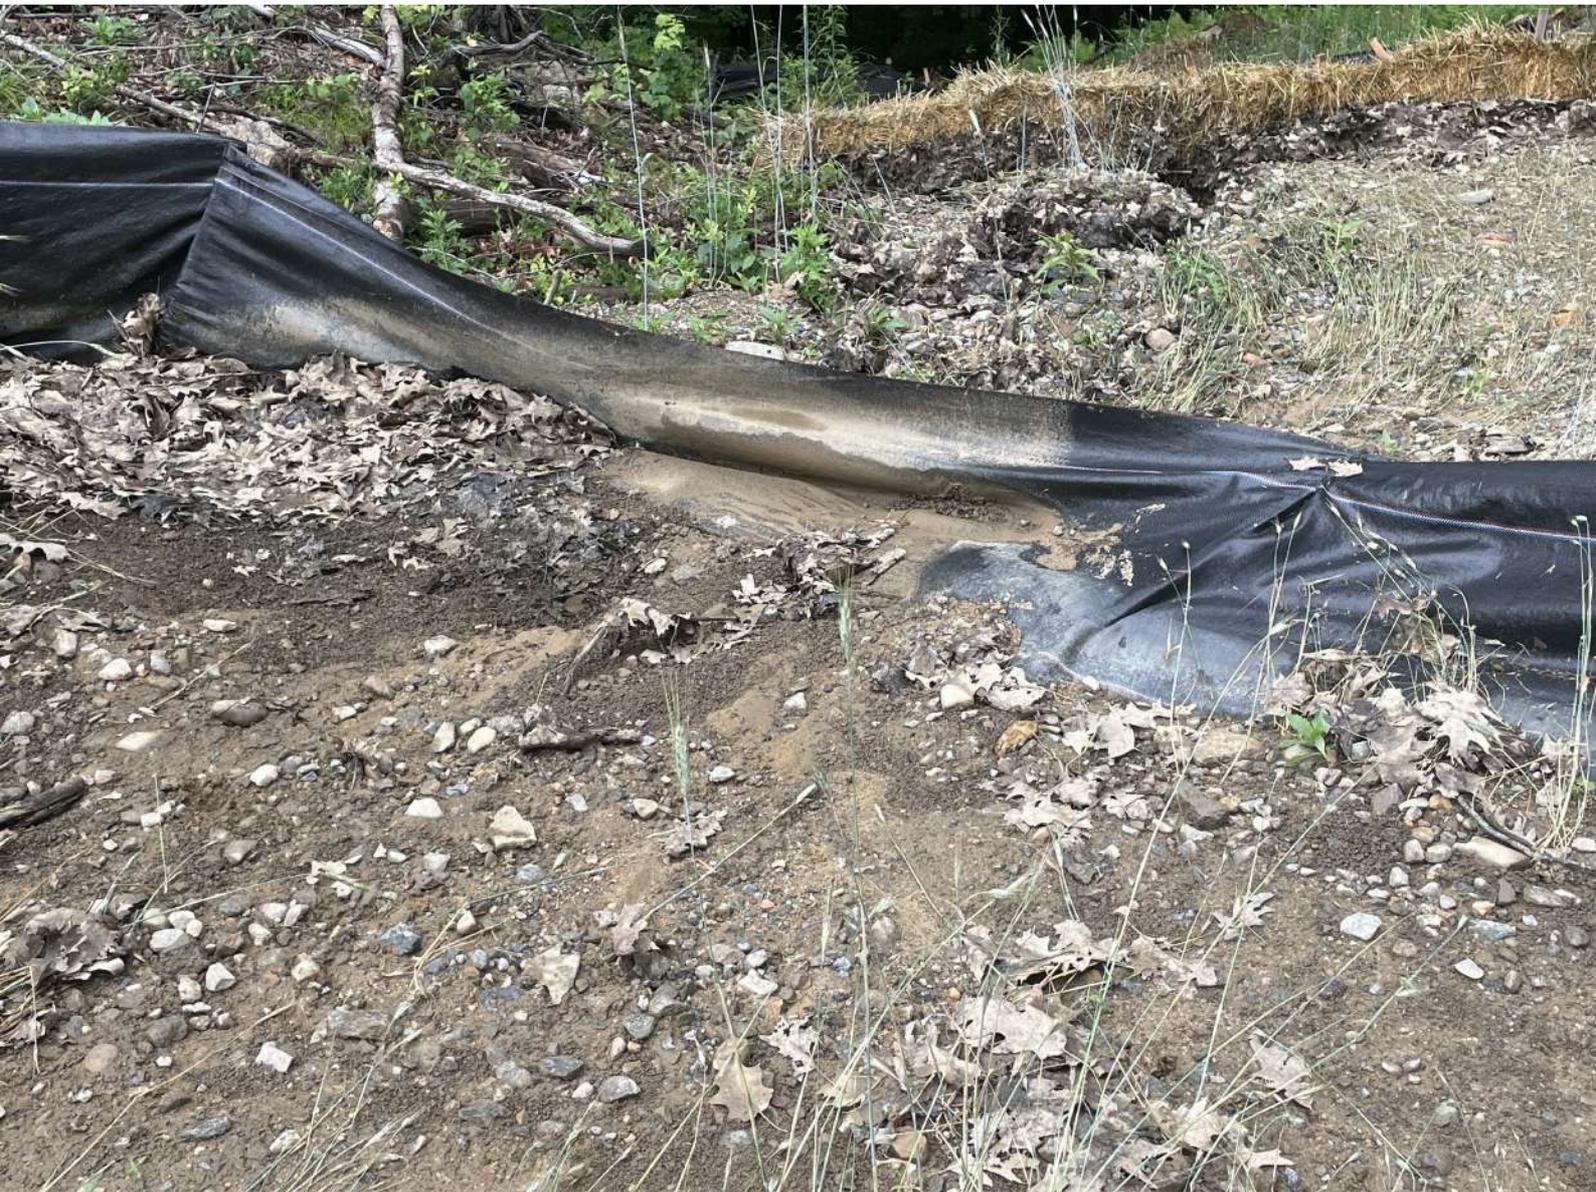
Silt fence "C" overtopped

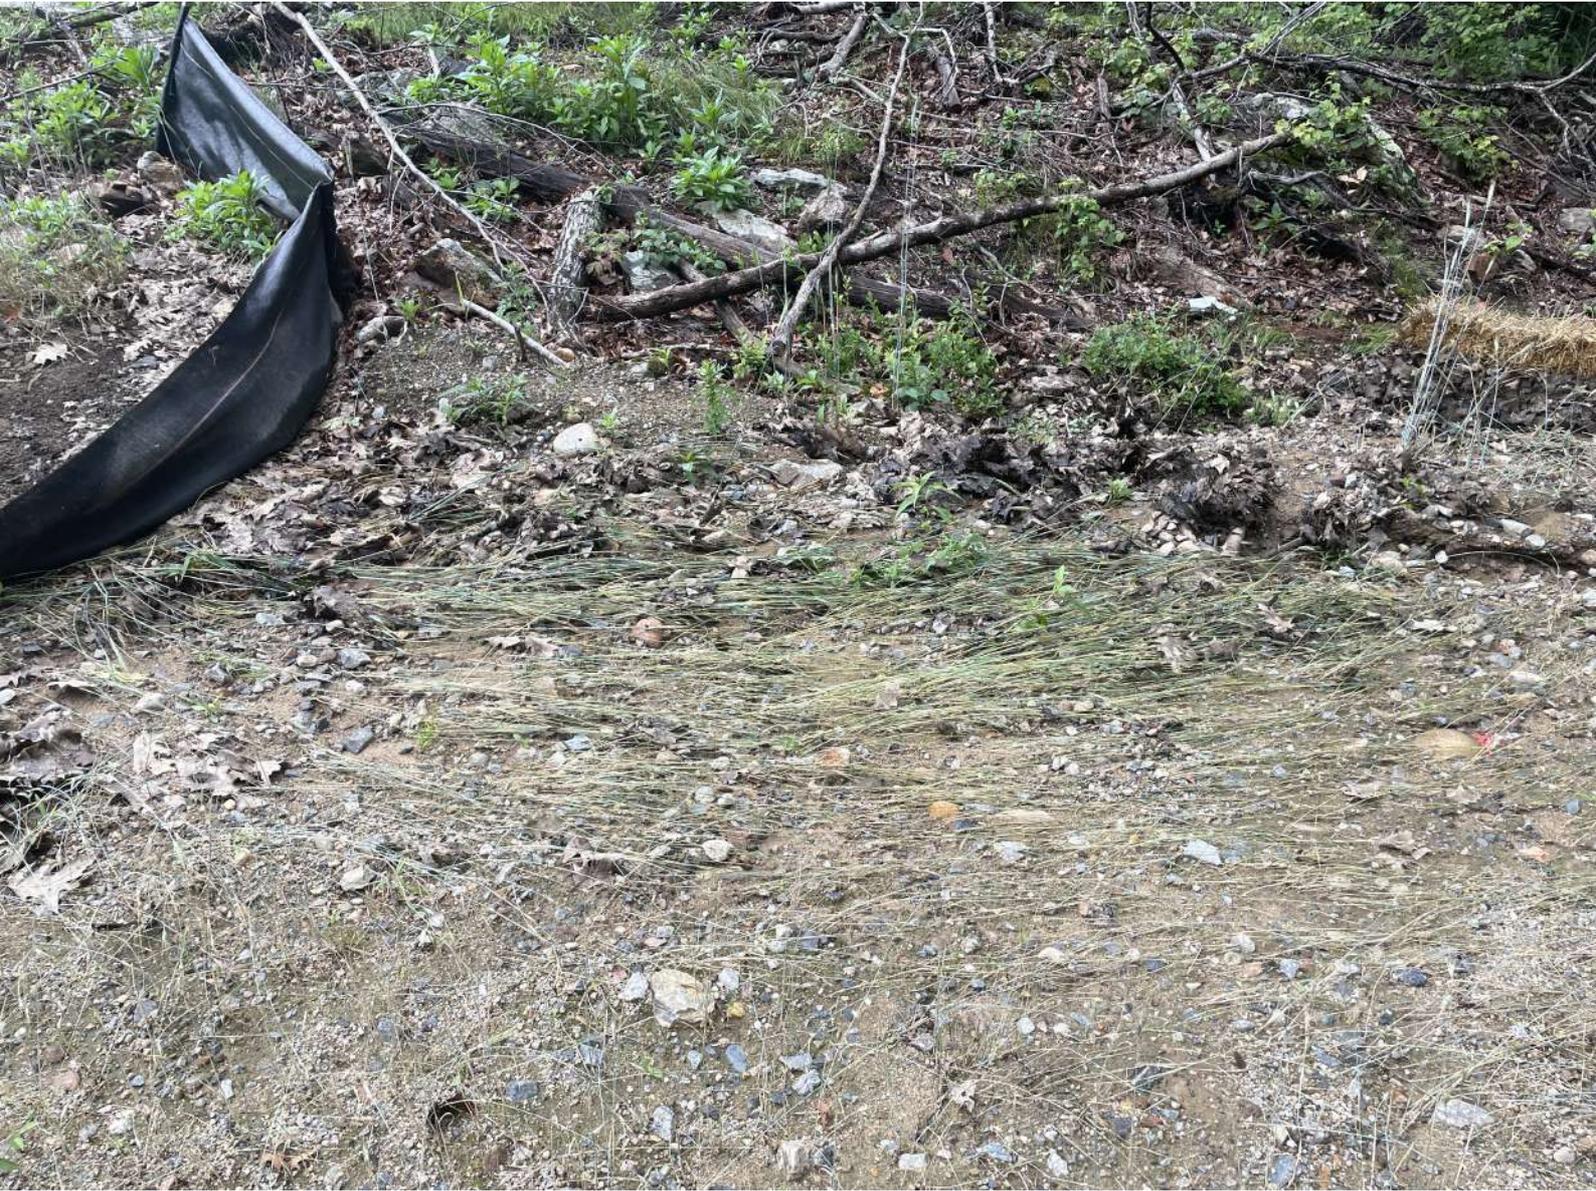
Down gradient of silt fence C. Vegetation laying flat from high velocity flow.

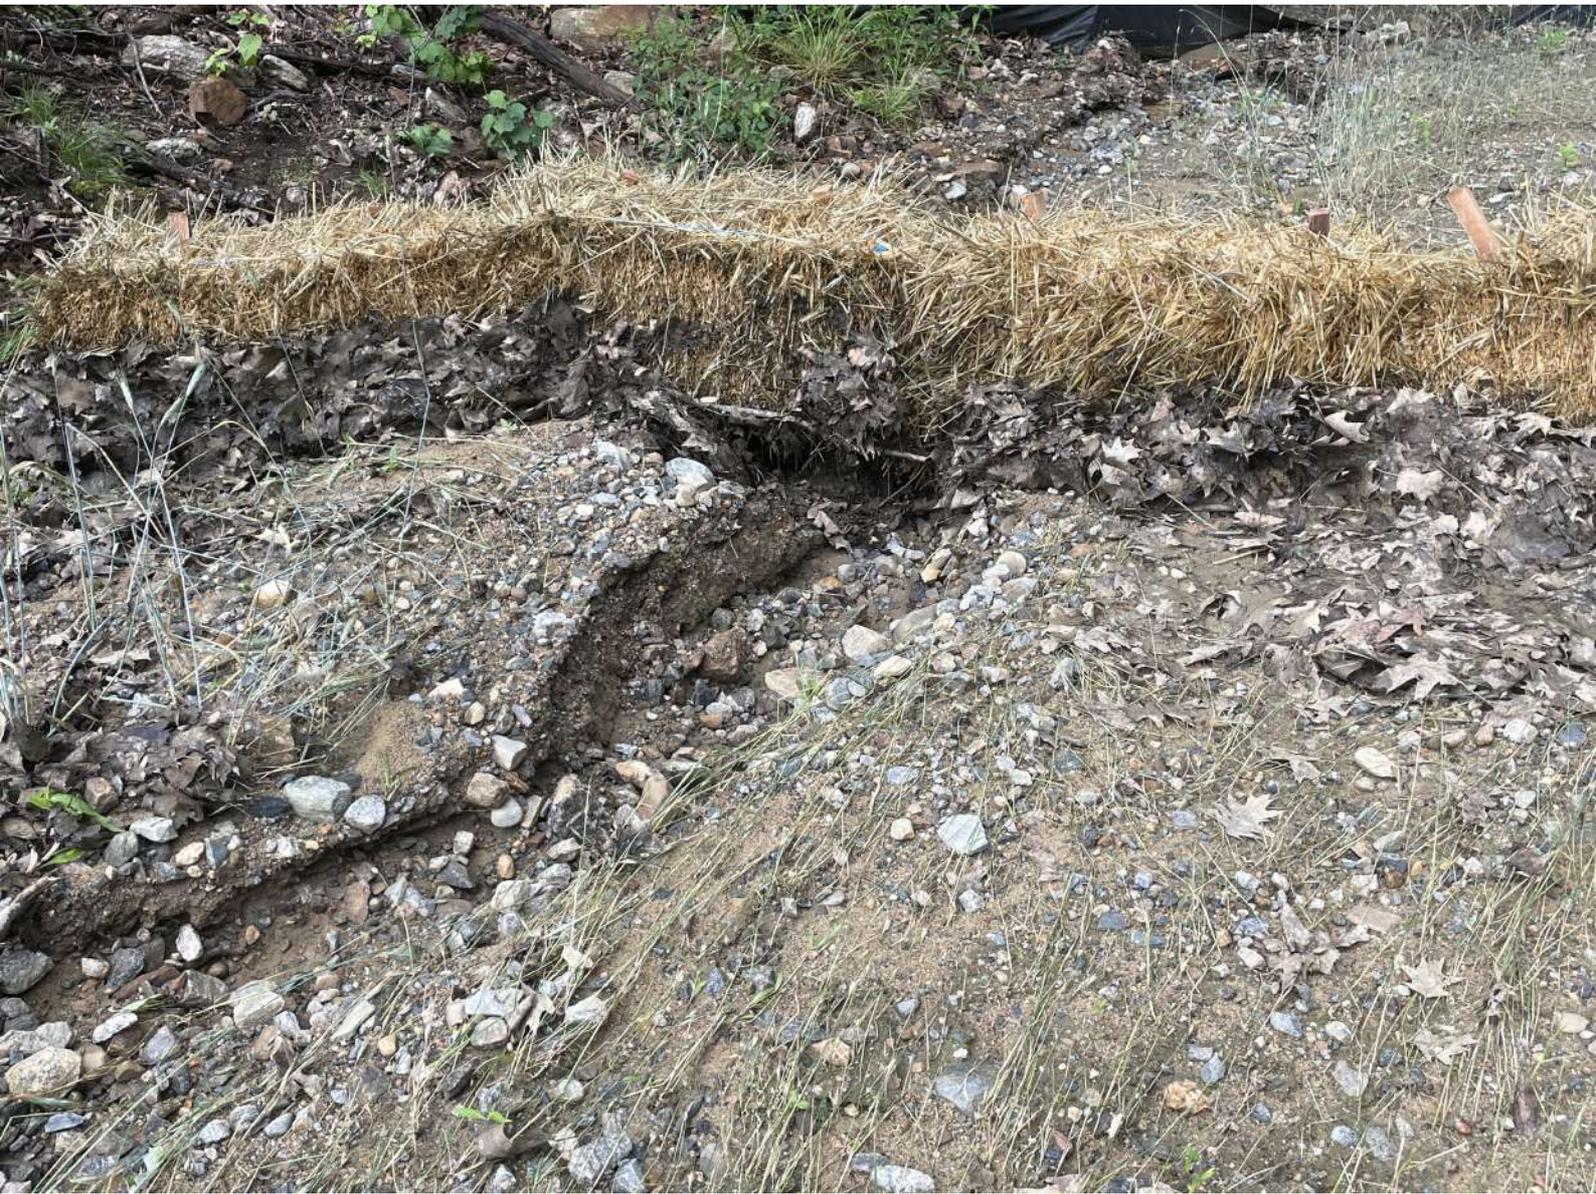
Undermined hay bales between Silt fences B and C

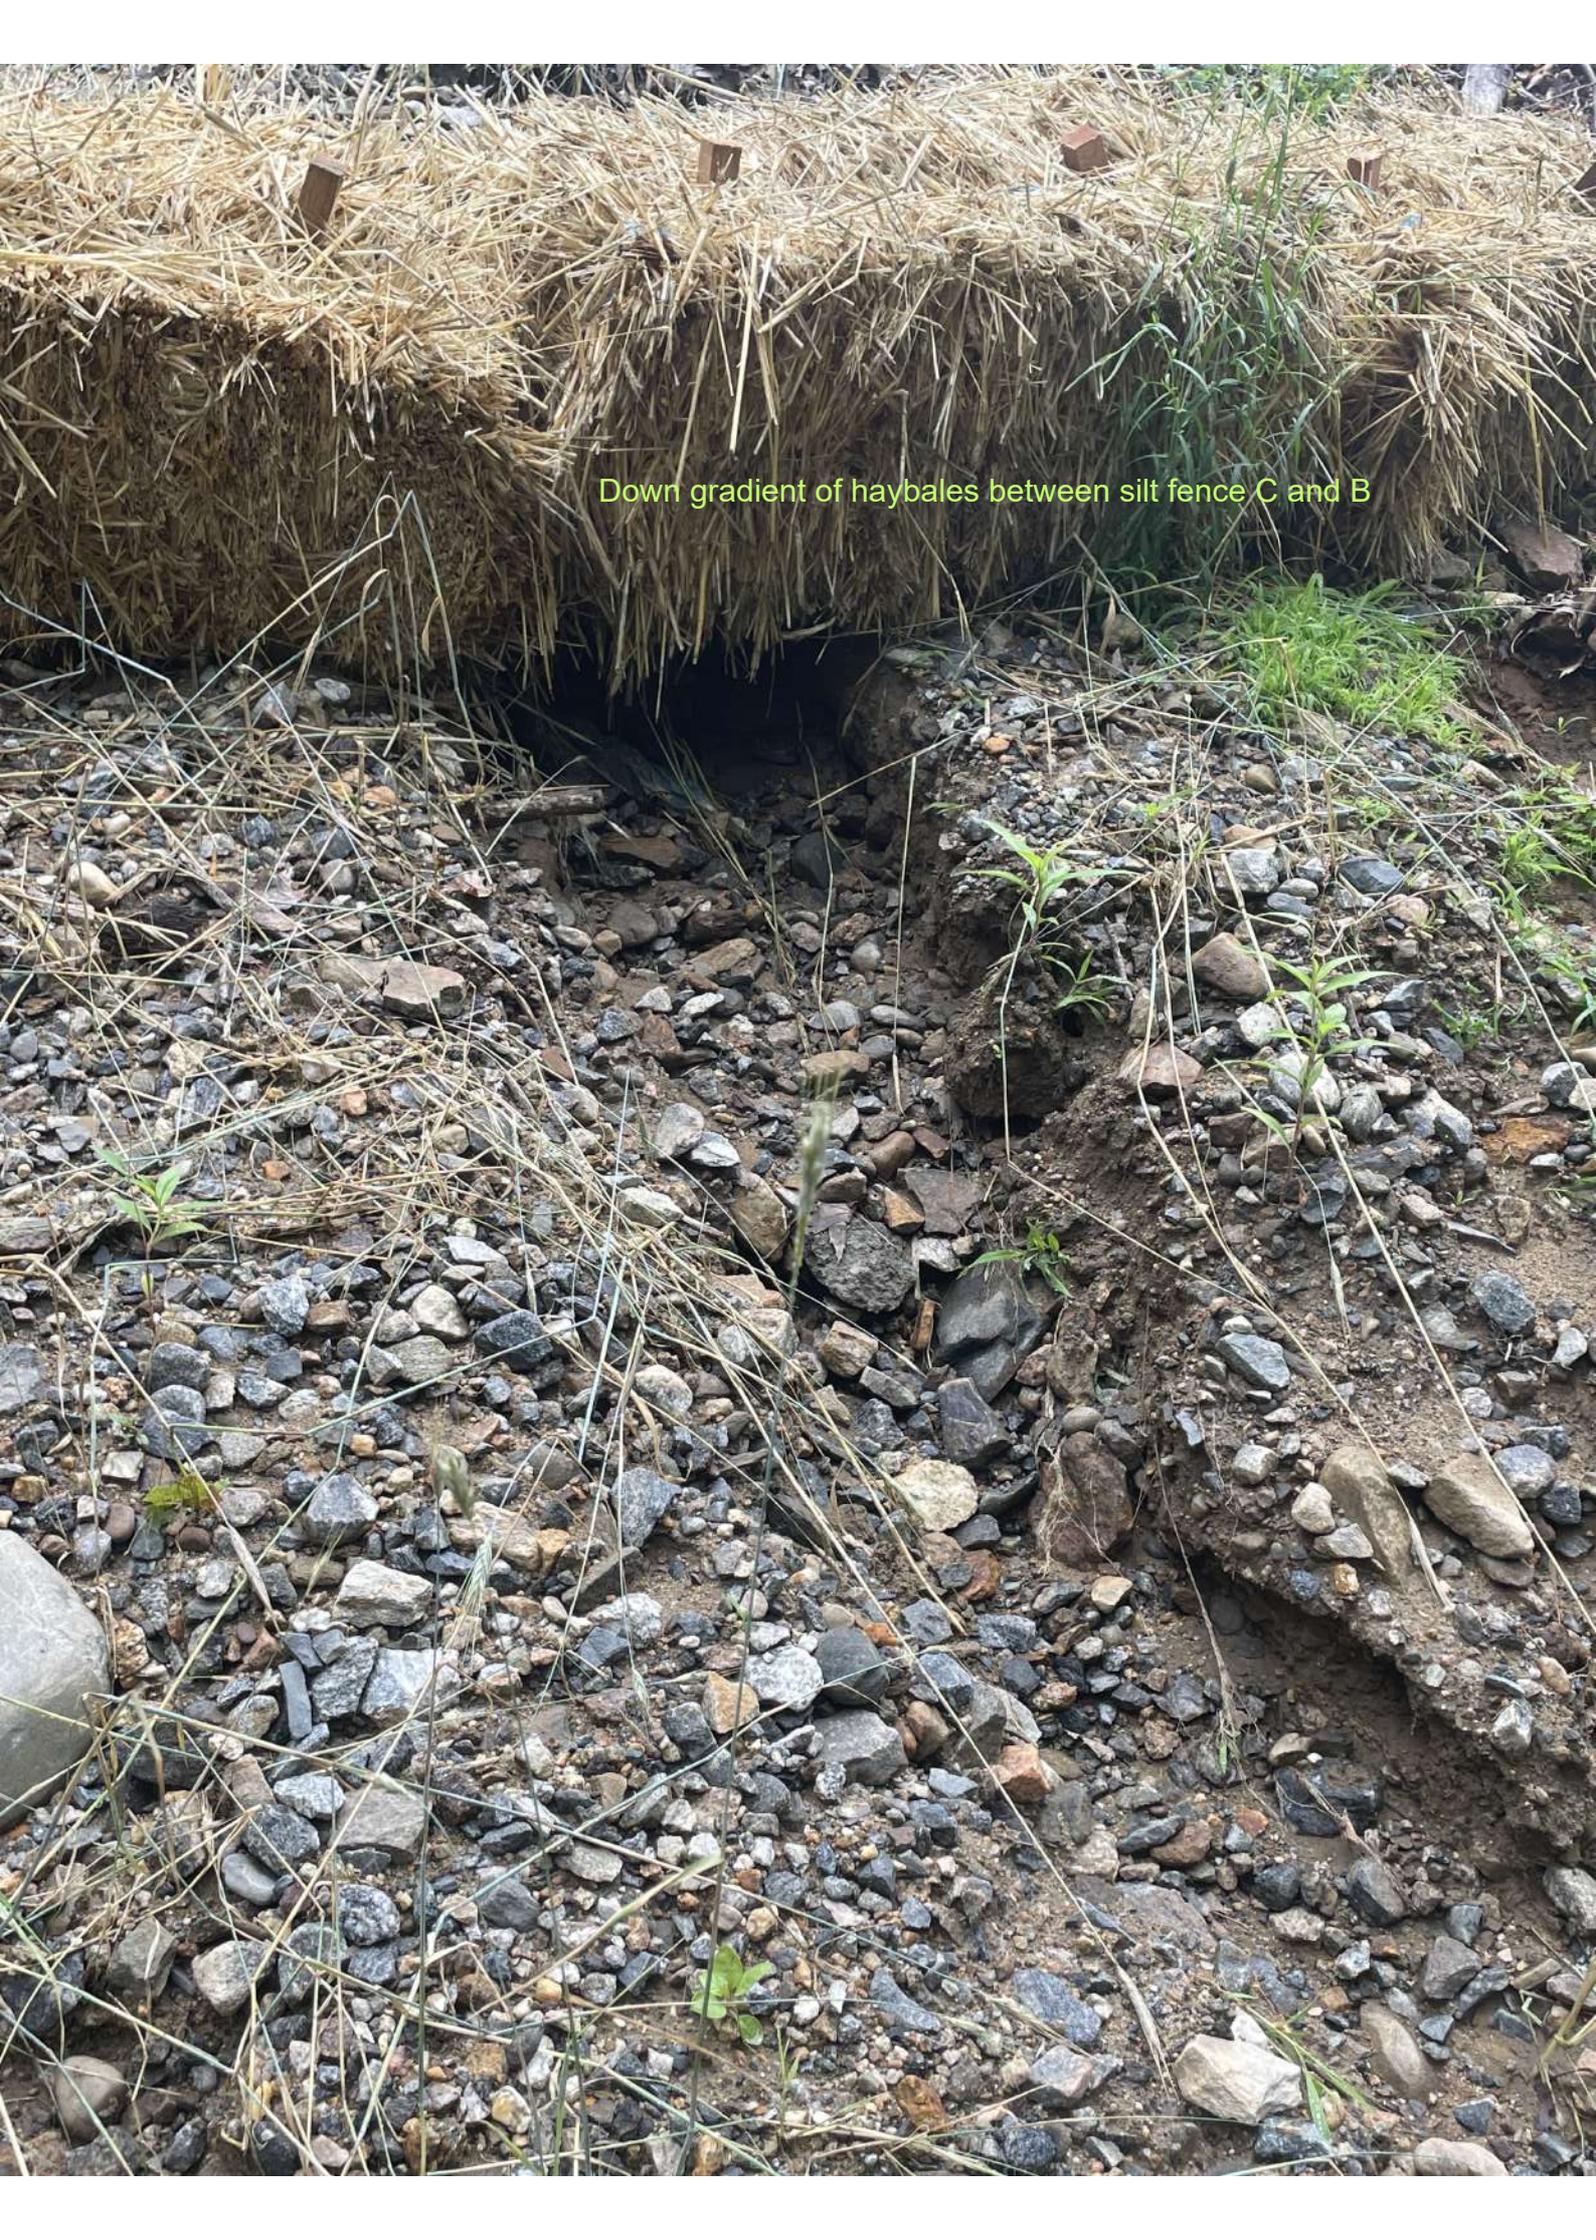
Down gradient of haybales between silt fence C and B

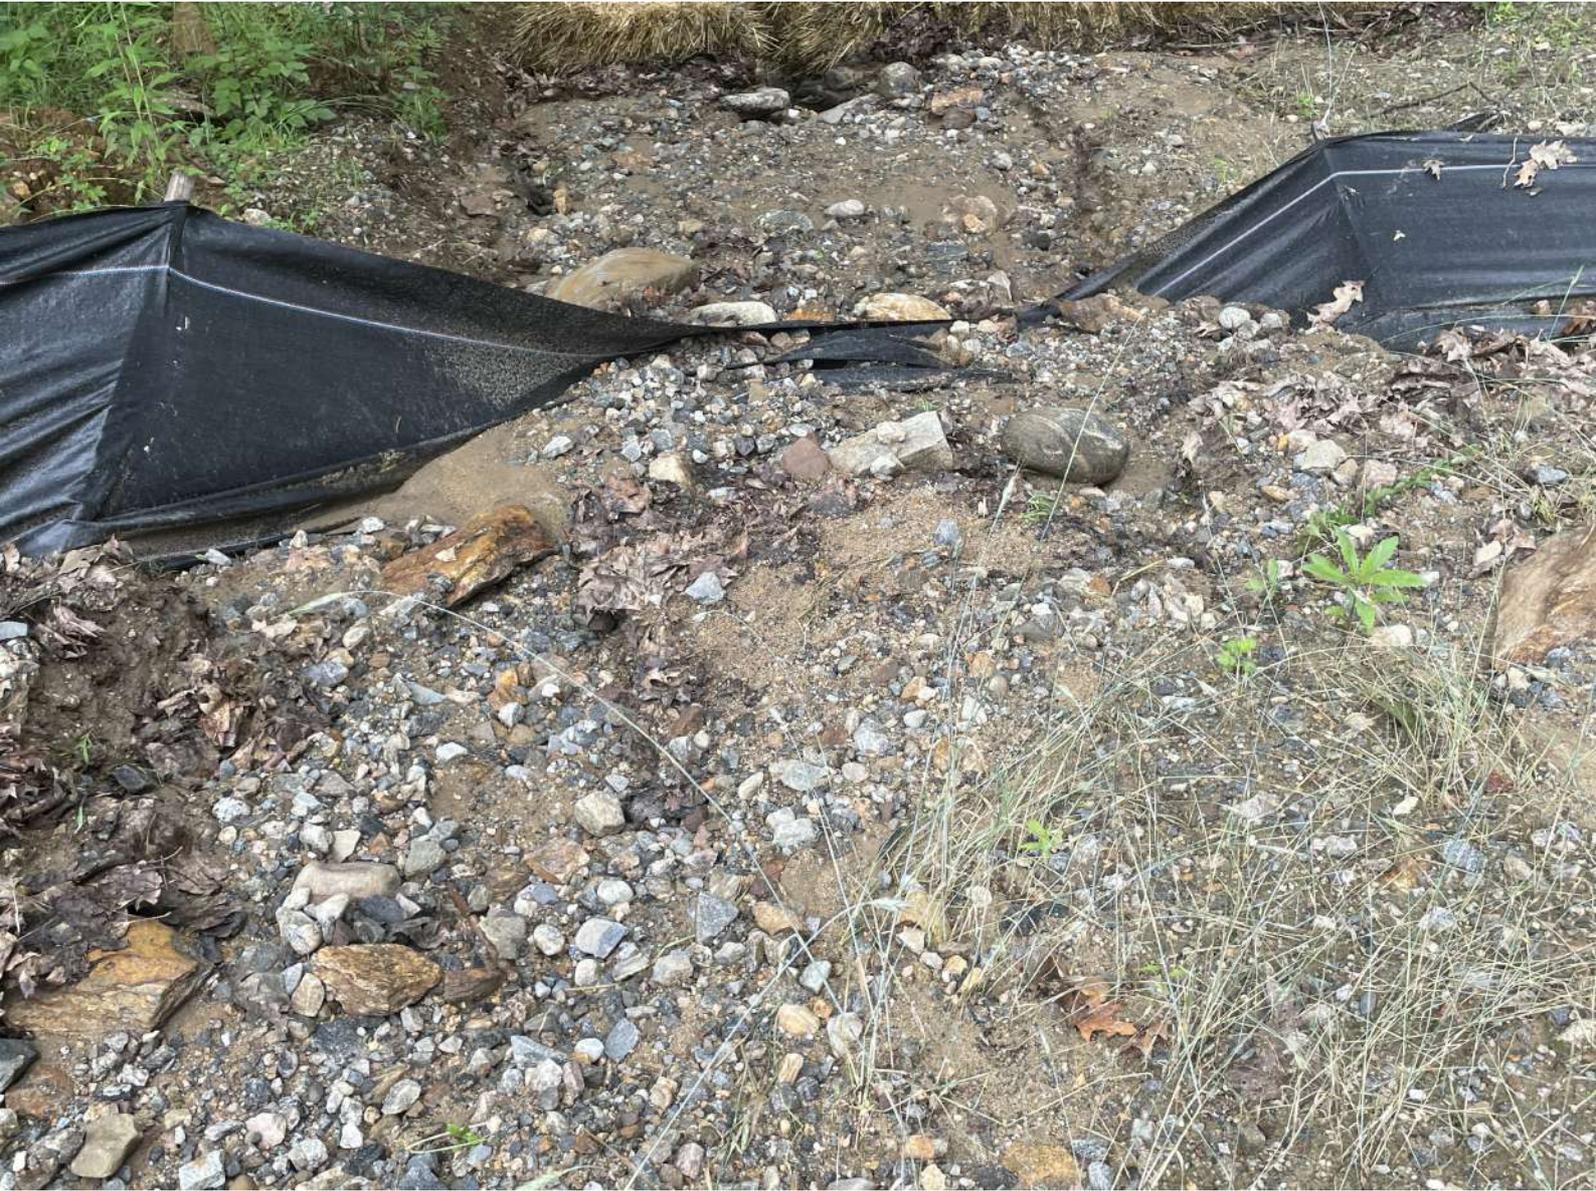
Failure of silt fence B

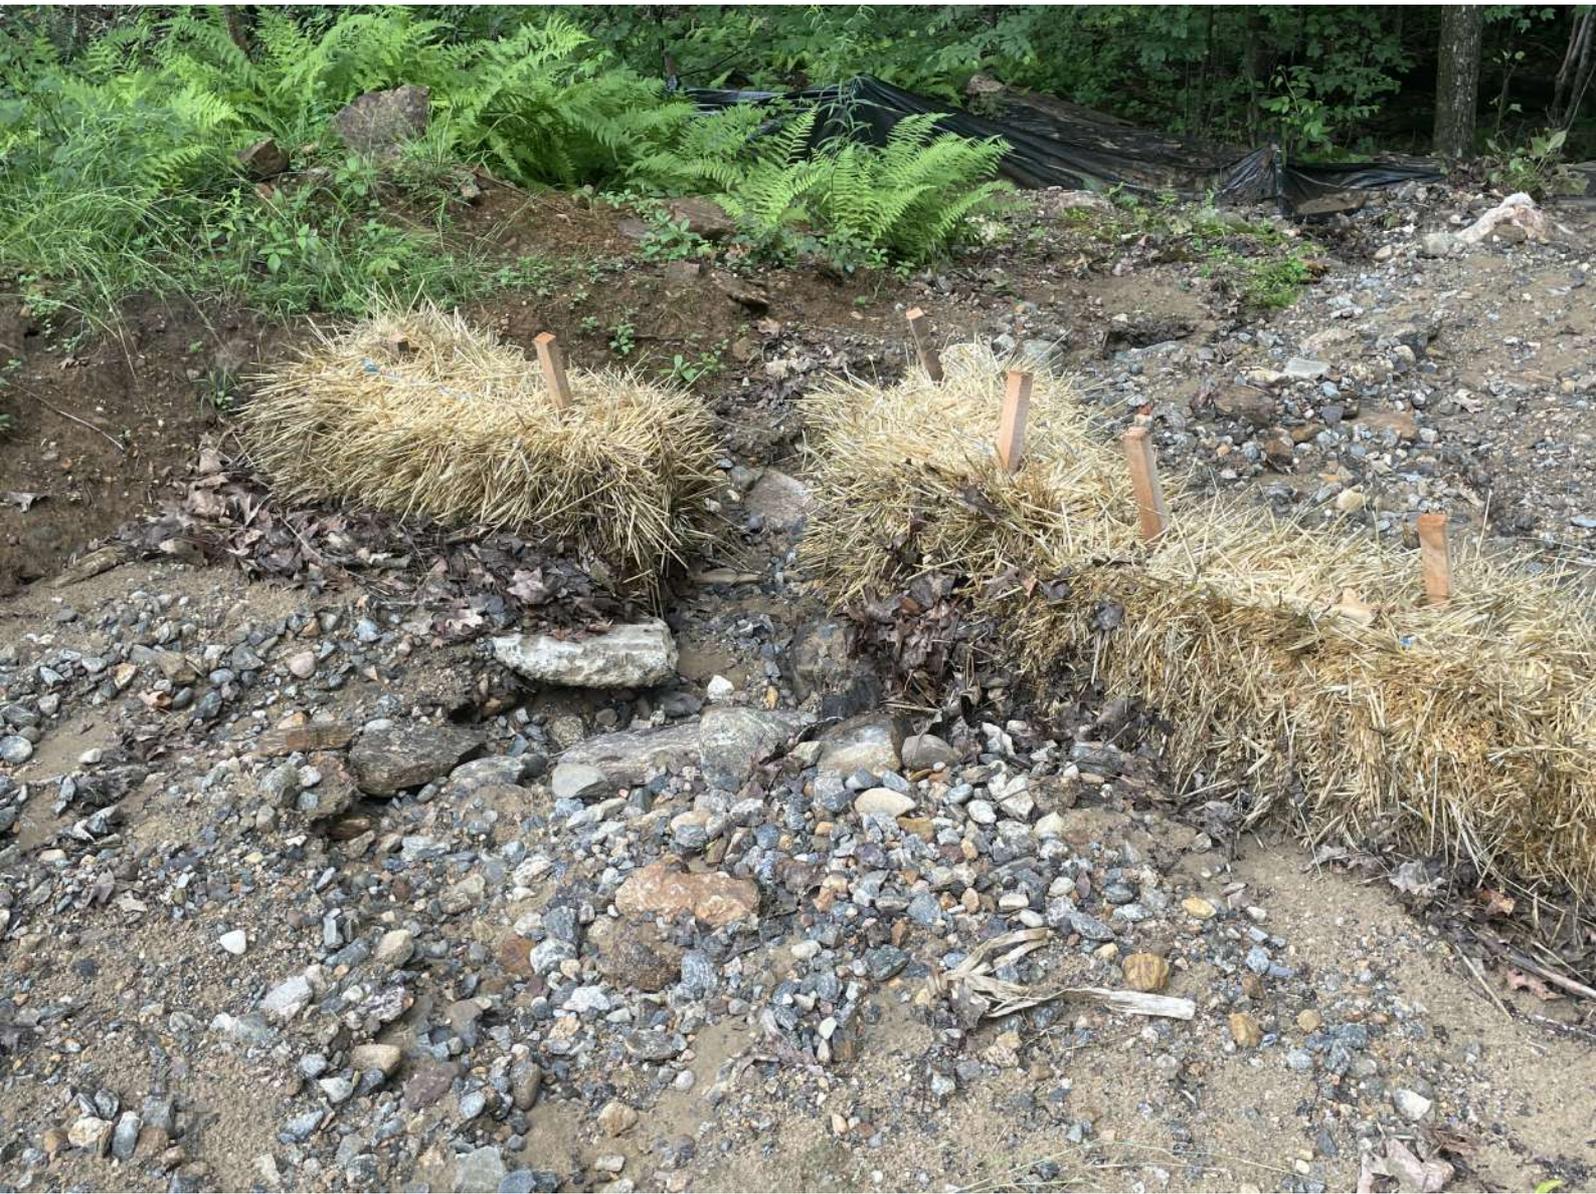
failed haybale between silt fence A and B

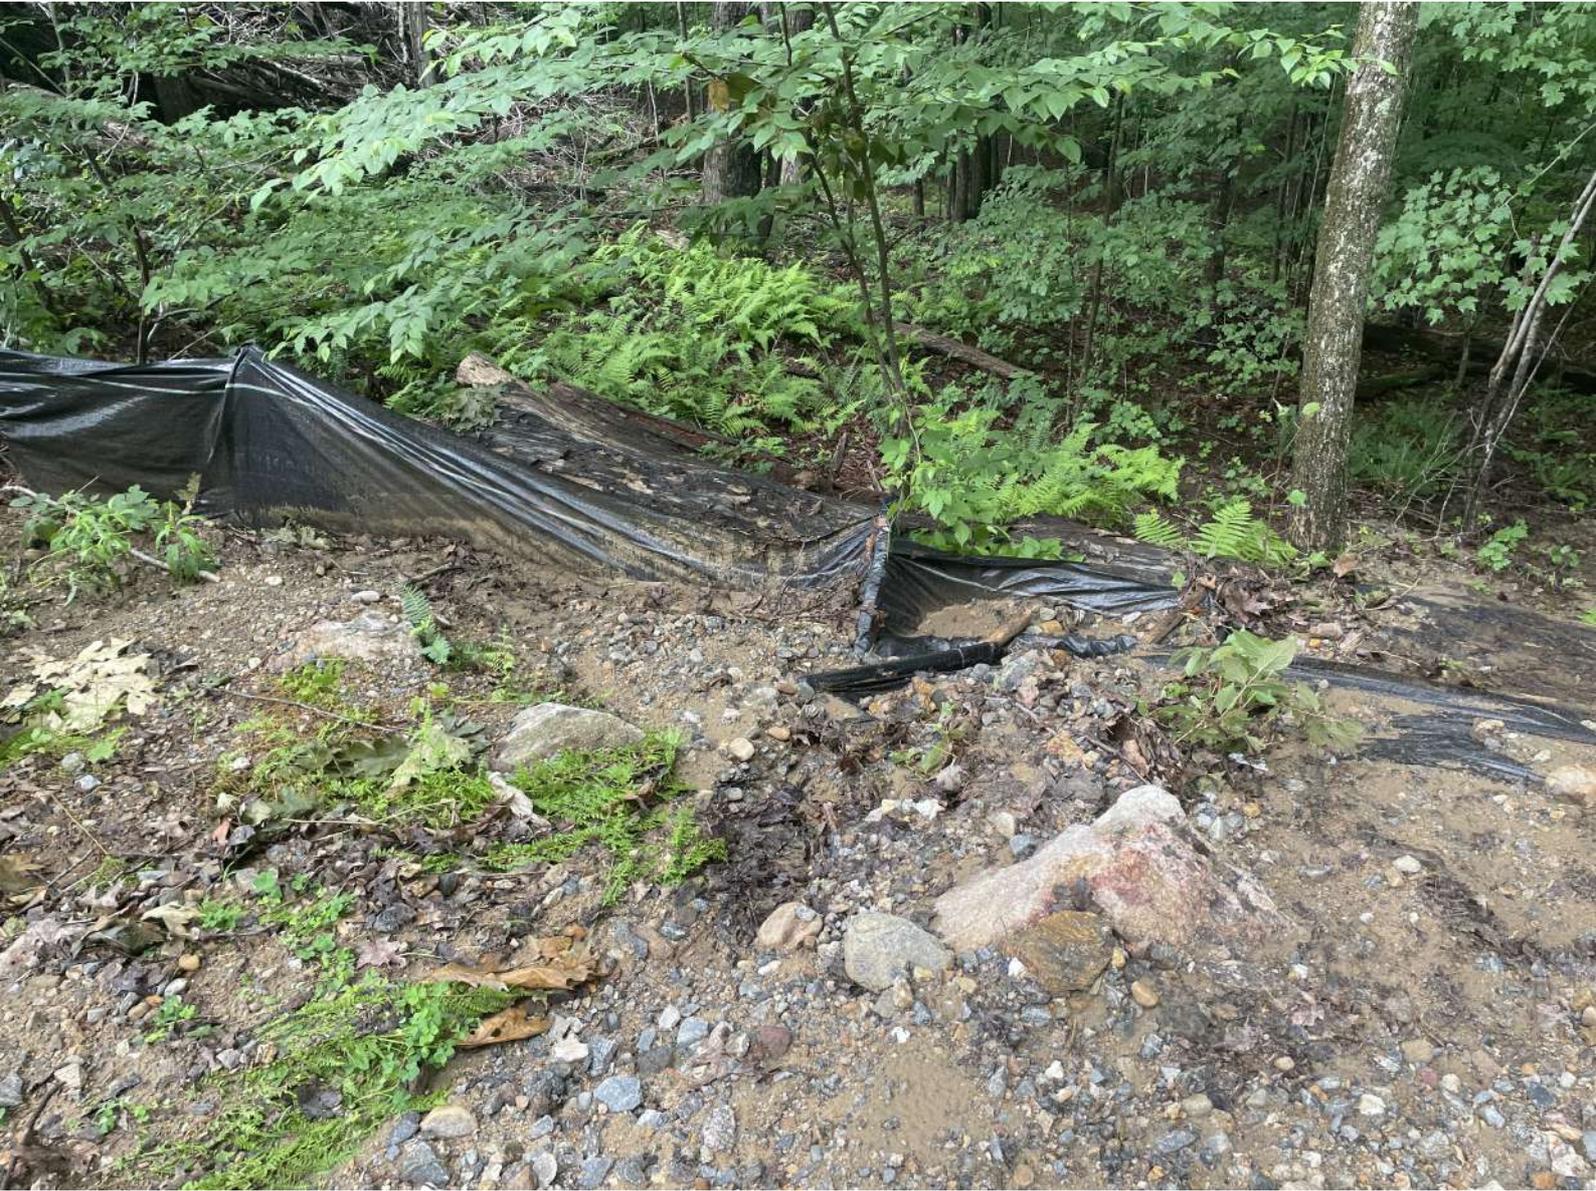
Failure of Silt fence A

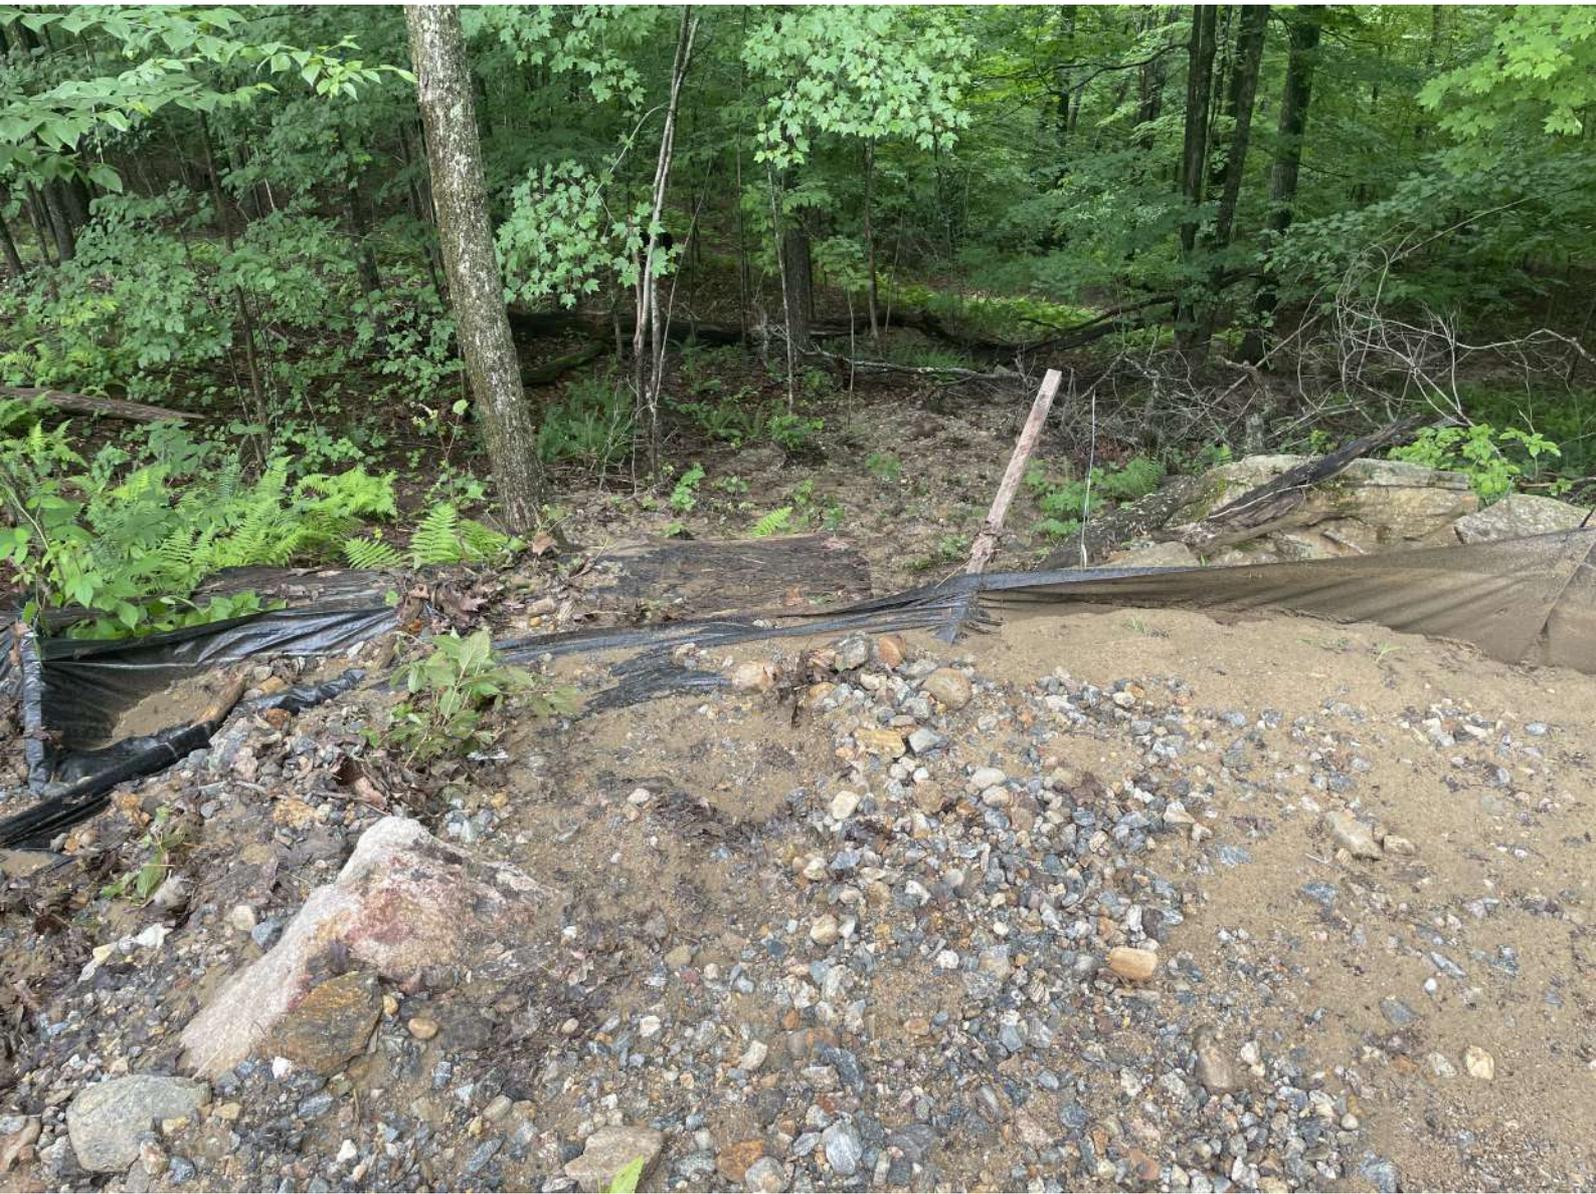
Failure of Silt fence A (photo 2)

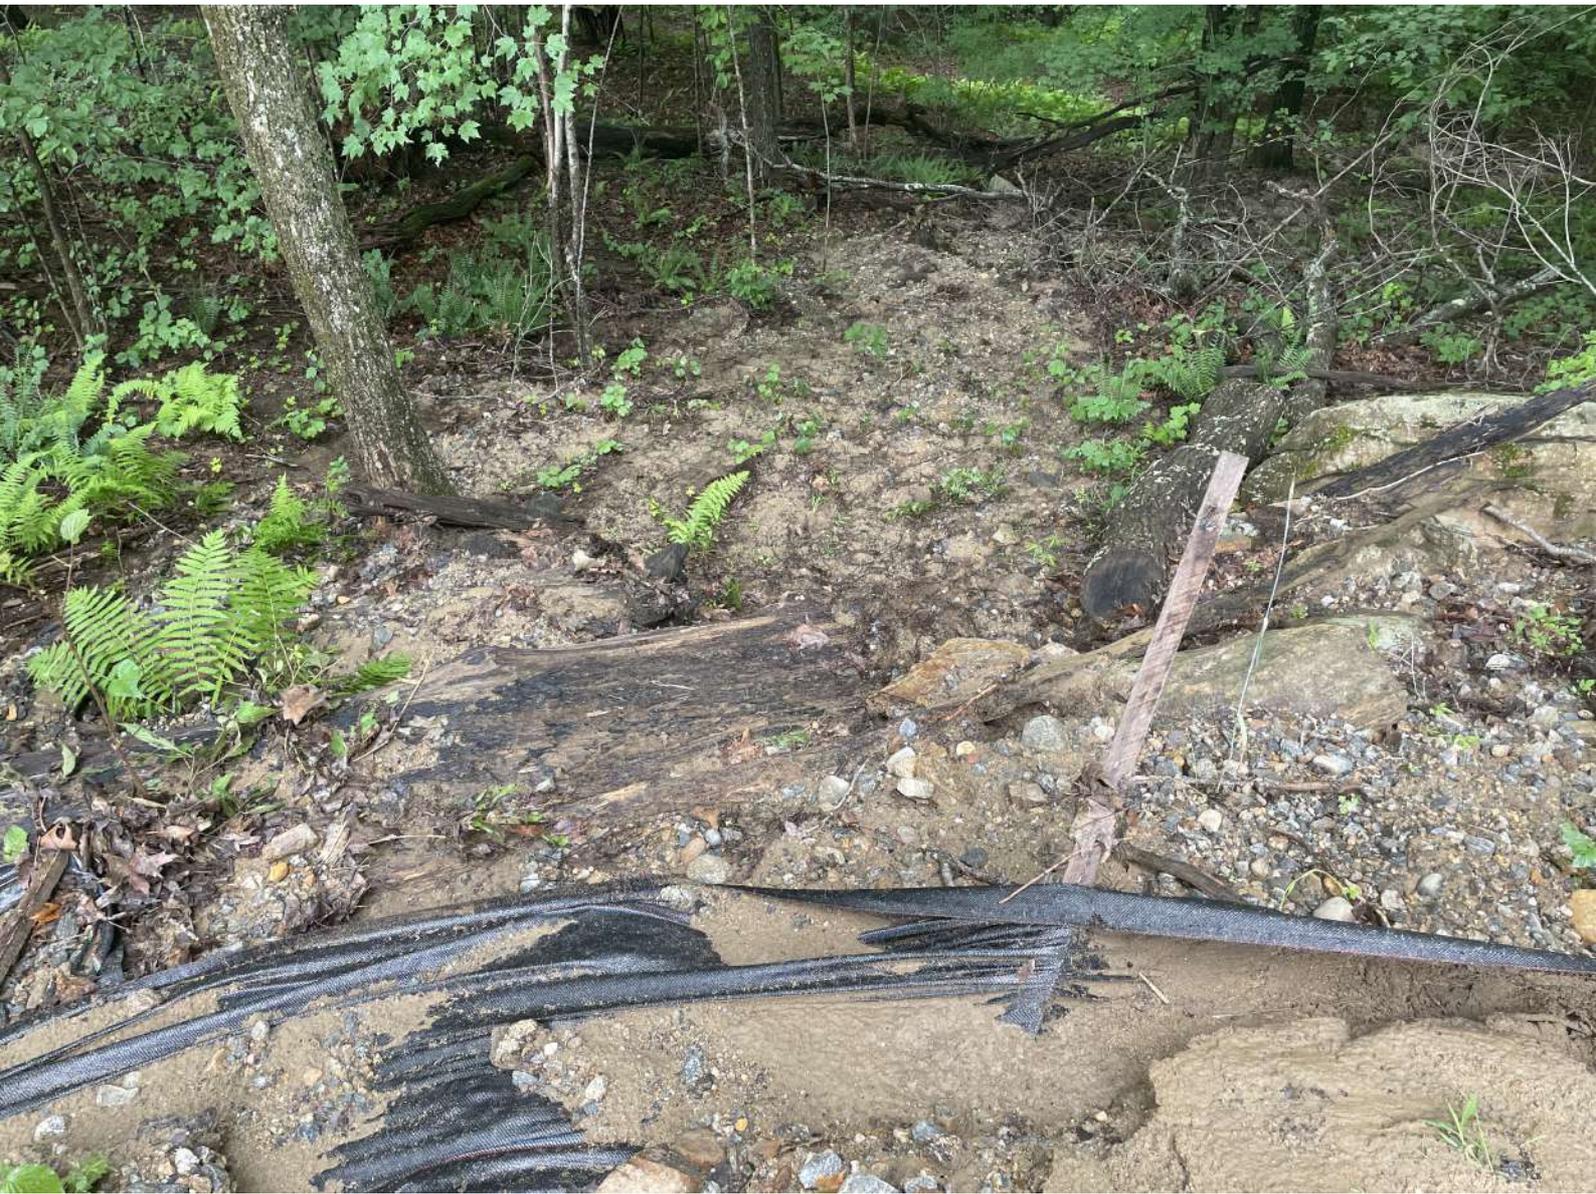
Sediment transport down gradient of silt fence A
