WP-25-28

Wetlands Permitting

Proposed activity in the upland review area for tree cutting, site grading, driveway, shed, footing drain discharge, erosion controls, etc. Modification of Wetlands Permit #20-47.

RE: *MONITORING OF VERNAL POOL CREATION & WETLAND SWALE*
60 Zeya Drive, Coventry, CT
REMA Job #: 20-2311-COV20

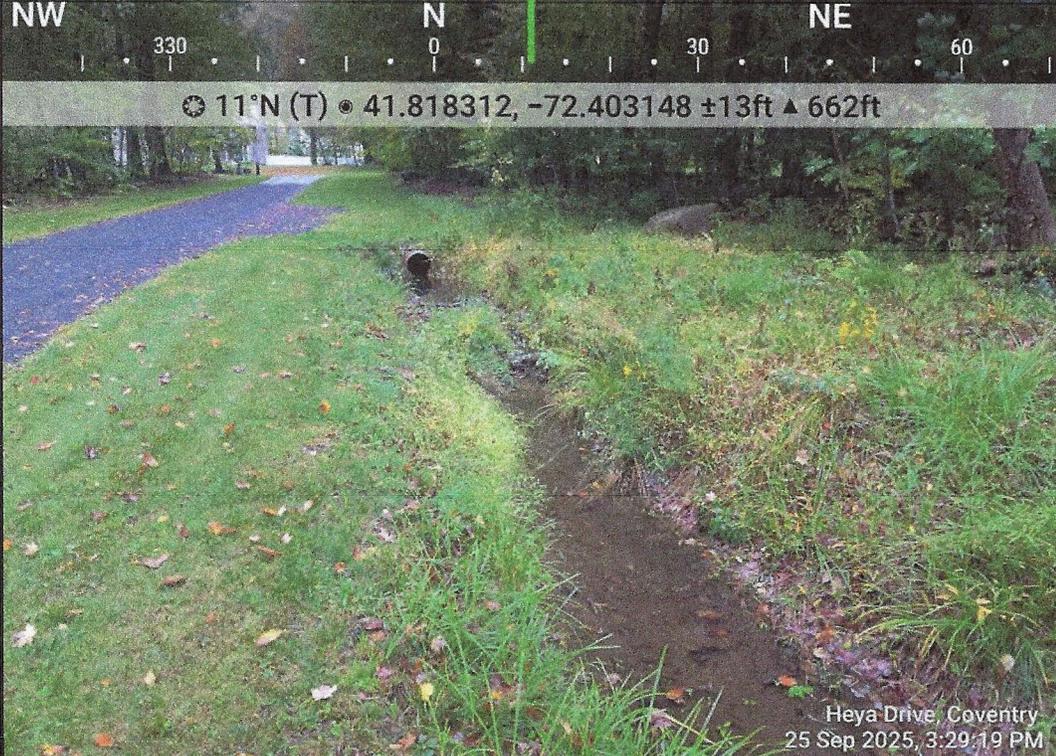
DATE: September 25, 2025	FACING: (see photo)	1
---------------------------------	----------------------------	----------

Comments: Drainage swale
---	---------------------------------

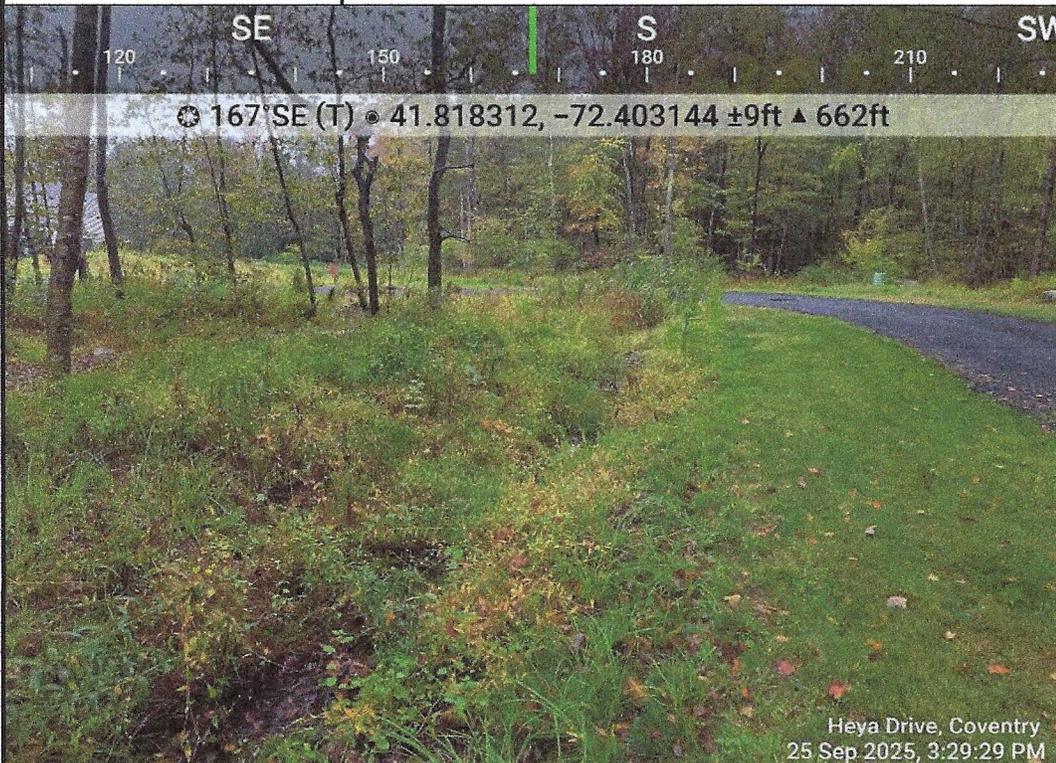
DATE: September 25, 2025	FACING: (see photo)	PHOTO NO.: 2
---------------------------------	----------------------------	---------------------

1. The wetland swale is fully vegetated and conveying stormwater towards the cross-culvert under the driveway. There is no evidence of erosion within or at the discharge location. The shrub plantings that were installed a few years ago are still present, but they are somewhat stunted due to deer browse. We expect that over time they will reach full stature.
2. The area immediately around the created vernal pool is densely vegetated. Again, all of the shrubs that were planted are present but most are of low stature due to deer browse. We expect that over time they will reach full stature.
3. At the time of the inspection the seasonally flooded portion of the pool had approximately 6-8 inches of water, likely as the result of recent rainfall. Inspection

Comments: Drainage Swale
--	---------------------------------

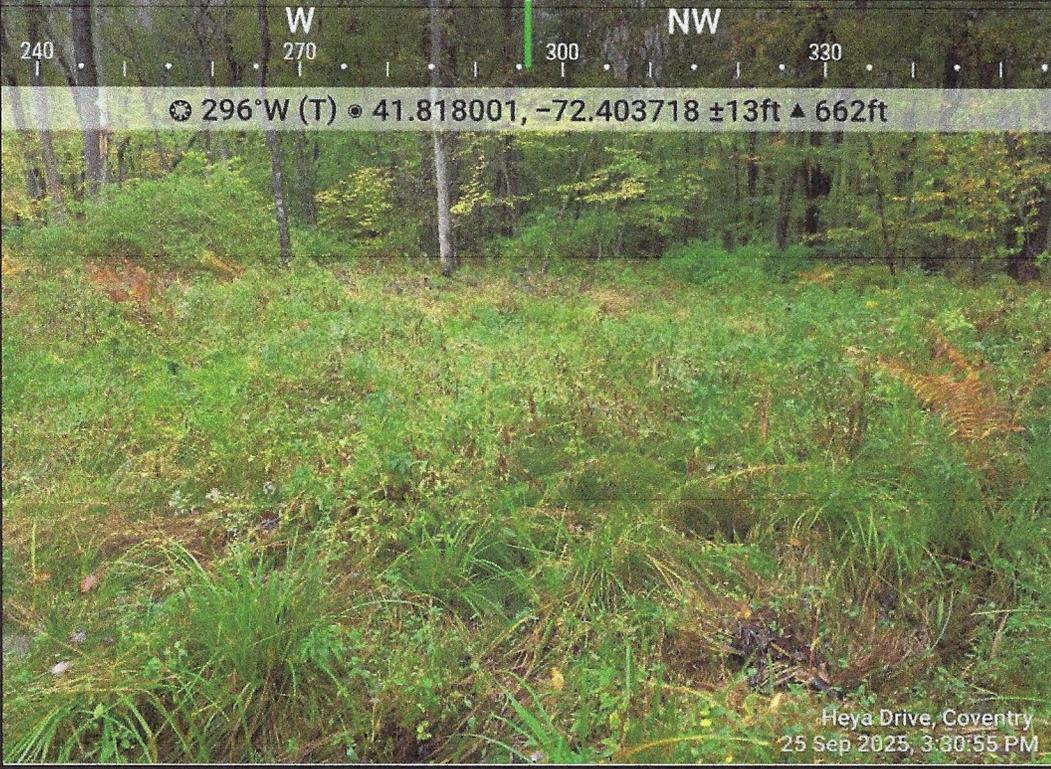
SITE/LOCATION: 60 Zeya Drive Conventry, CT	REMA JOB NO.: 20-2311-COV20	ANNOTATED PHOTO LOG
	INVESTIGATOR(S): G.T. Logan, MS, PWS, CSE		
DATE: September 25, 2025	FACING: (see photo)	3

Comments: Area of created vernal pool; bypass swale in foreground

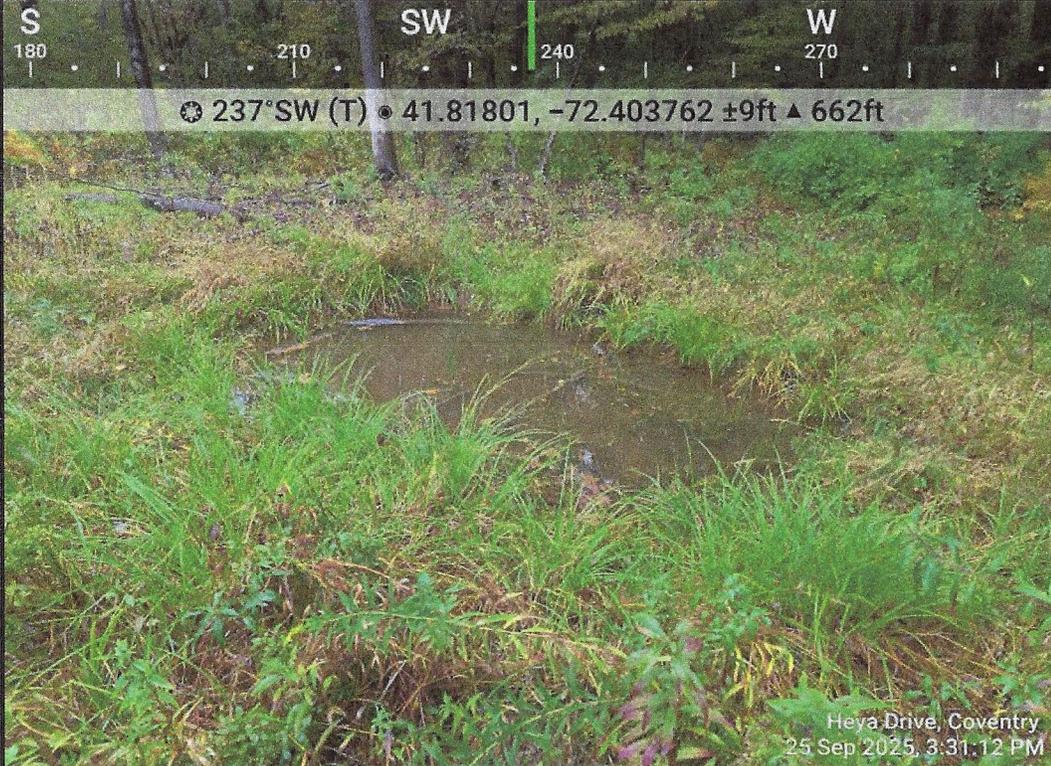
DATE: September 25, 2025	FACING: (see photo)	PHOTO NO.: 4

Comments: Created Vernal pool; 6-8 inches of inundation after heavy rainfall

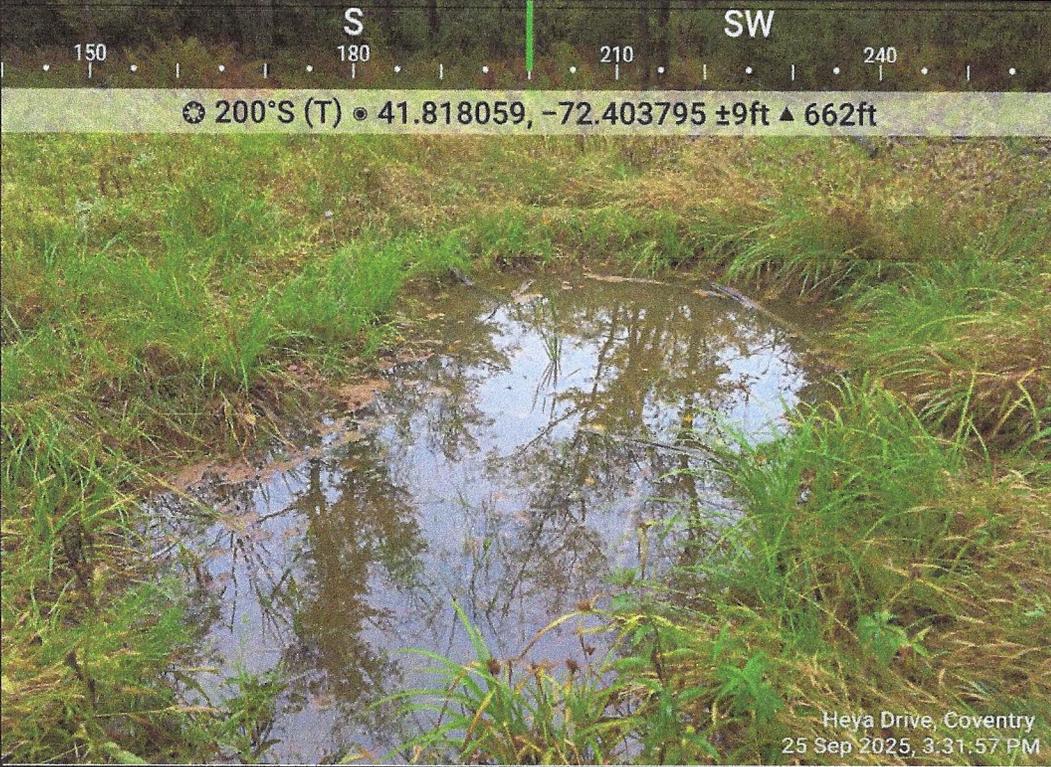
SITE/LOCATION: 60 Zeya Drive Coventry, CT	REMA JOB NO.: 20-2311-COV20	ANNOTATED PHOTO LOG
	INVESTIGATOR(S): G.T. Logan, MS, PWS, CSE		
DATE: September 25, 2025	FACING: (see photo)	5

Comments: Vernal pool after summer/fall rainfalls	
		<small>Heya Drive, Coventry 25 Sep 2025, 3:31:57 PM</small>

It appears that the targeted hydrology for the created vernal pool has been achieved. Next Spring (2026), REMA will begin our monitoring for breeding by obligate vernal pool species, such as wood frogs, which is the target species, and provide a monitoring report for the Agency.

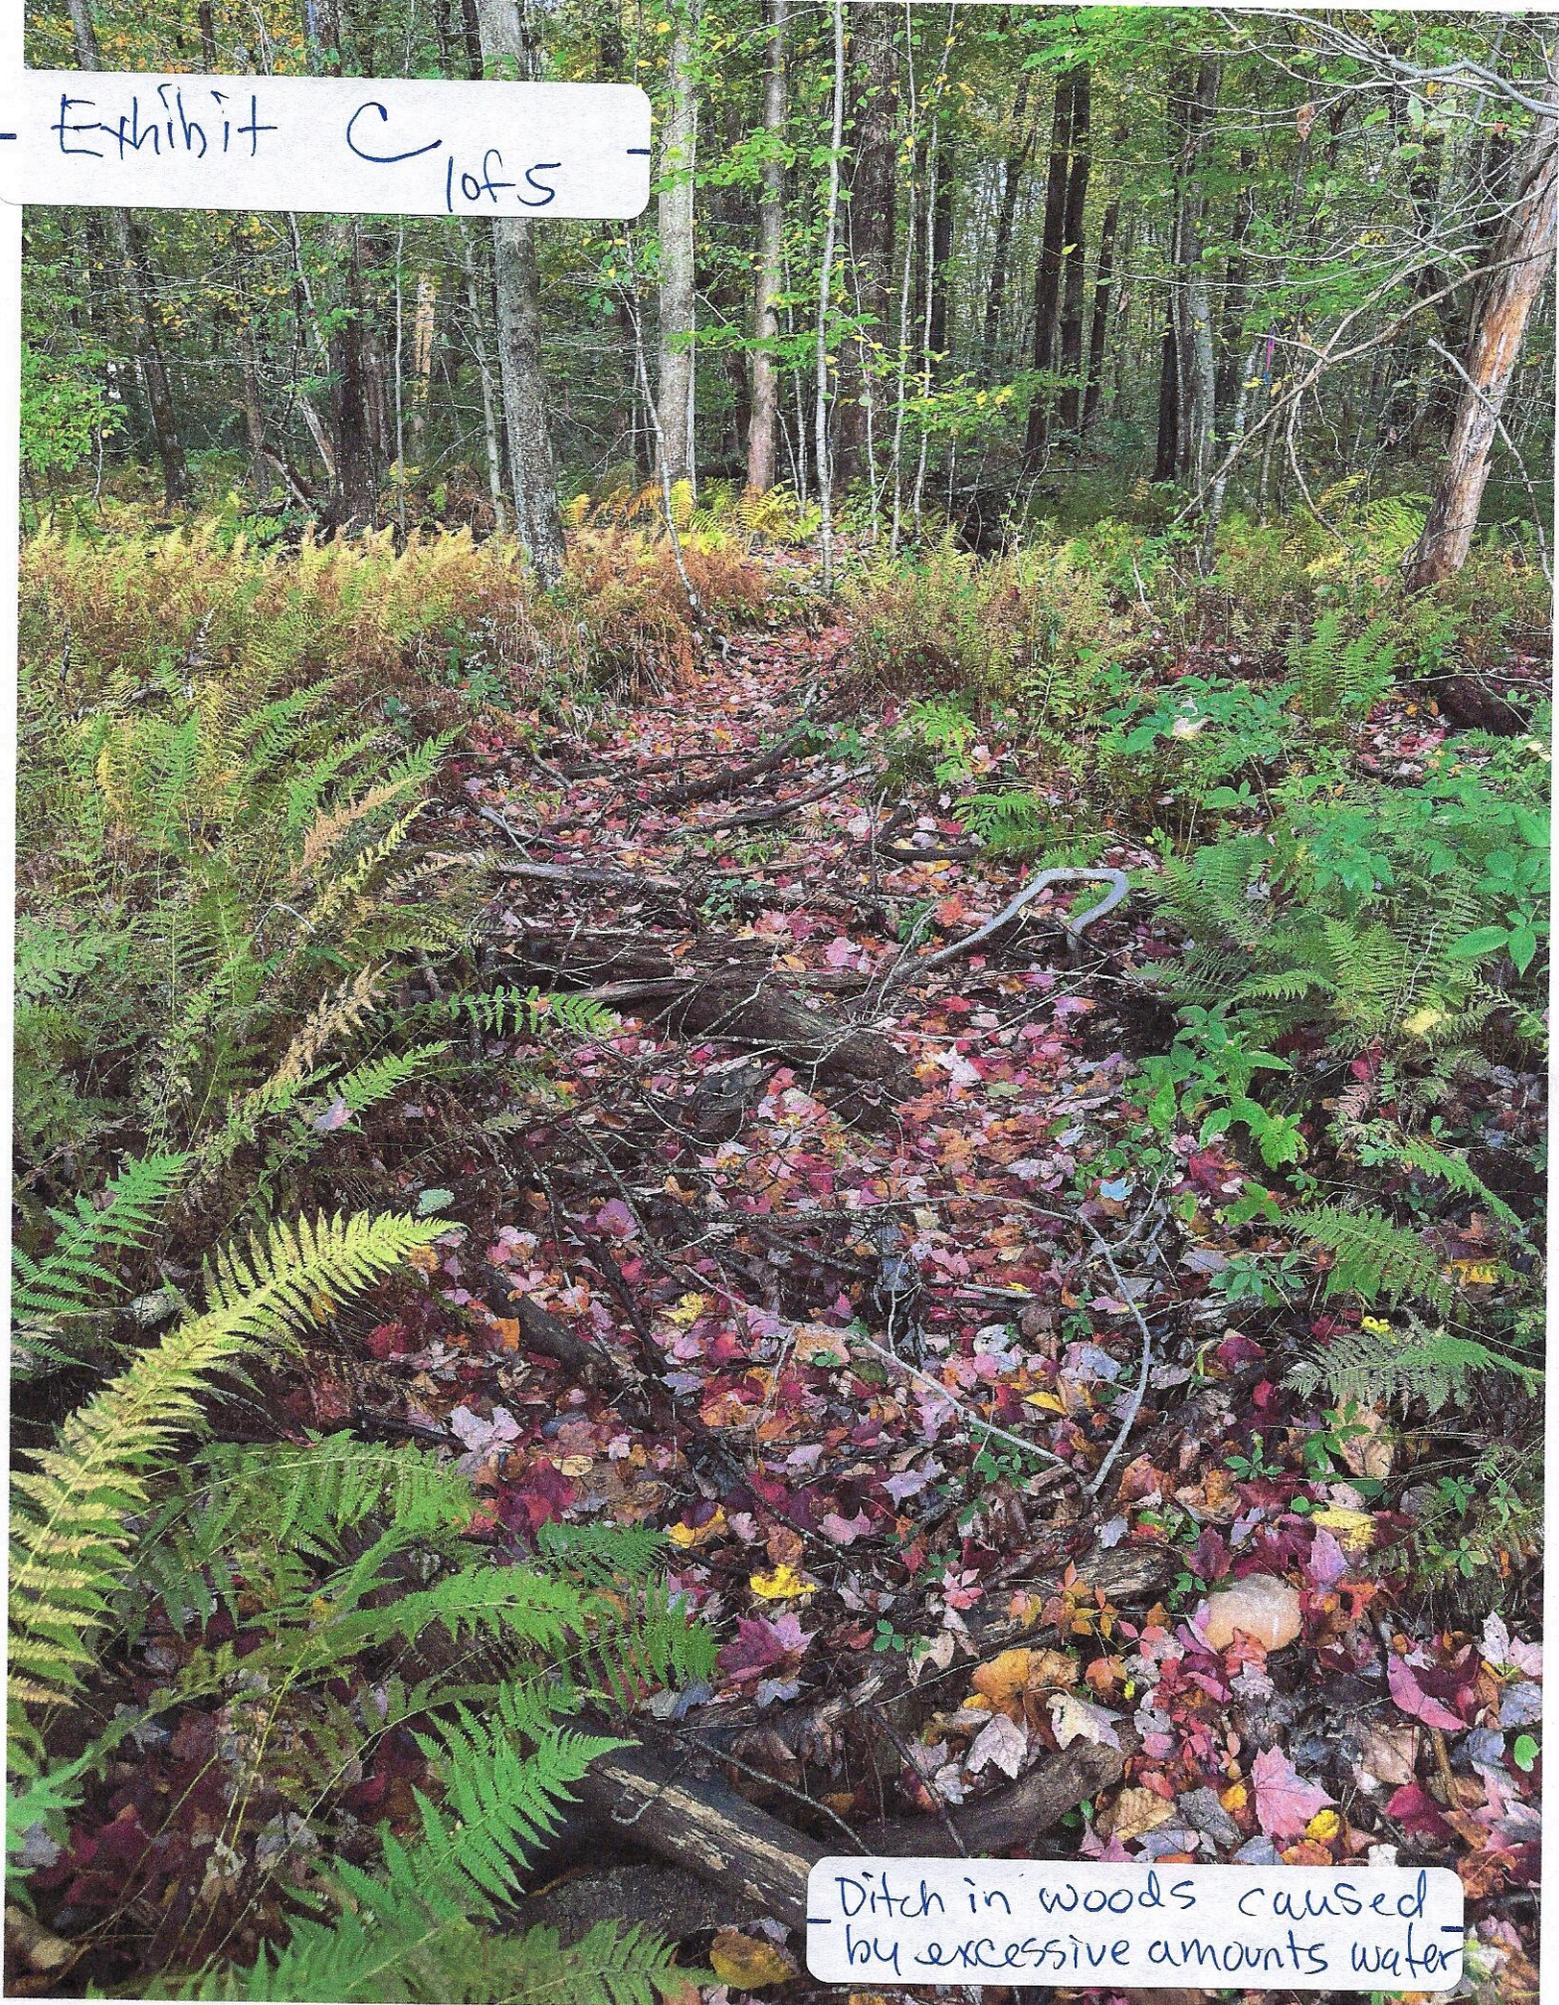
- Exhibit C
1 of 5

- Ditch in woods caused
by excessive amounts water

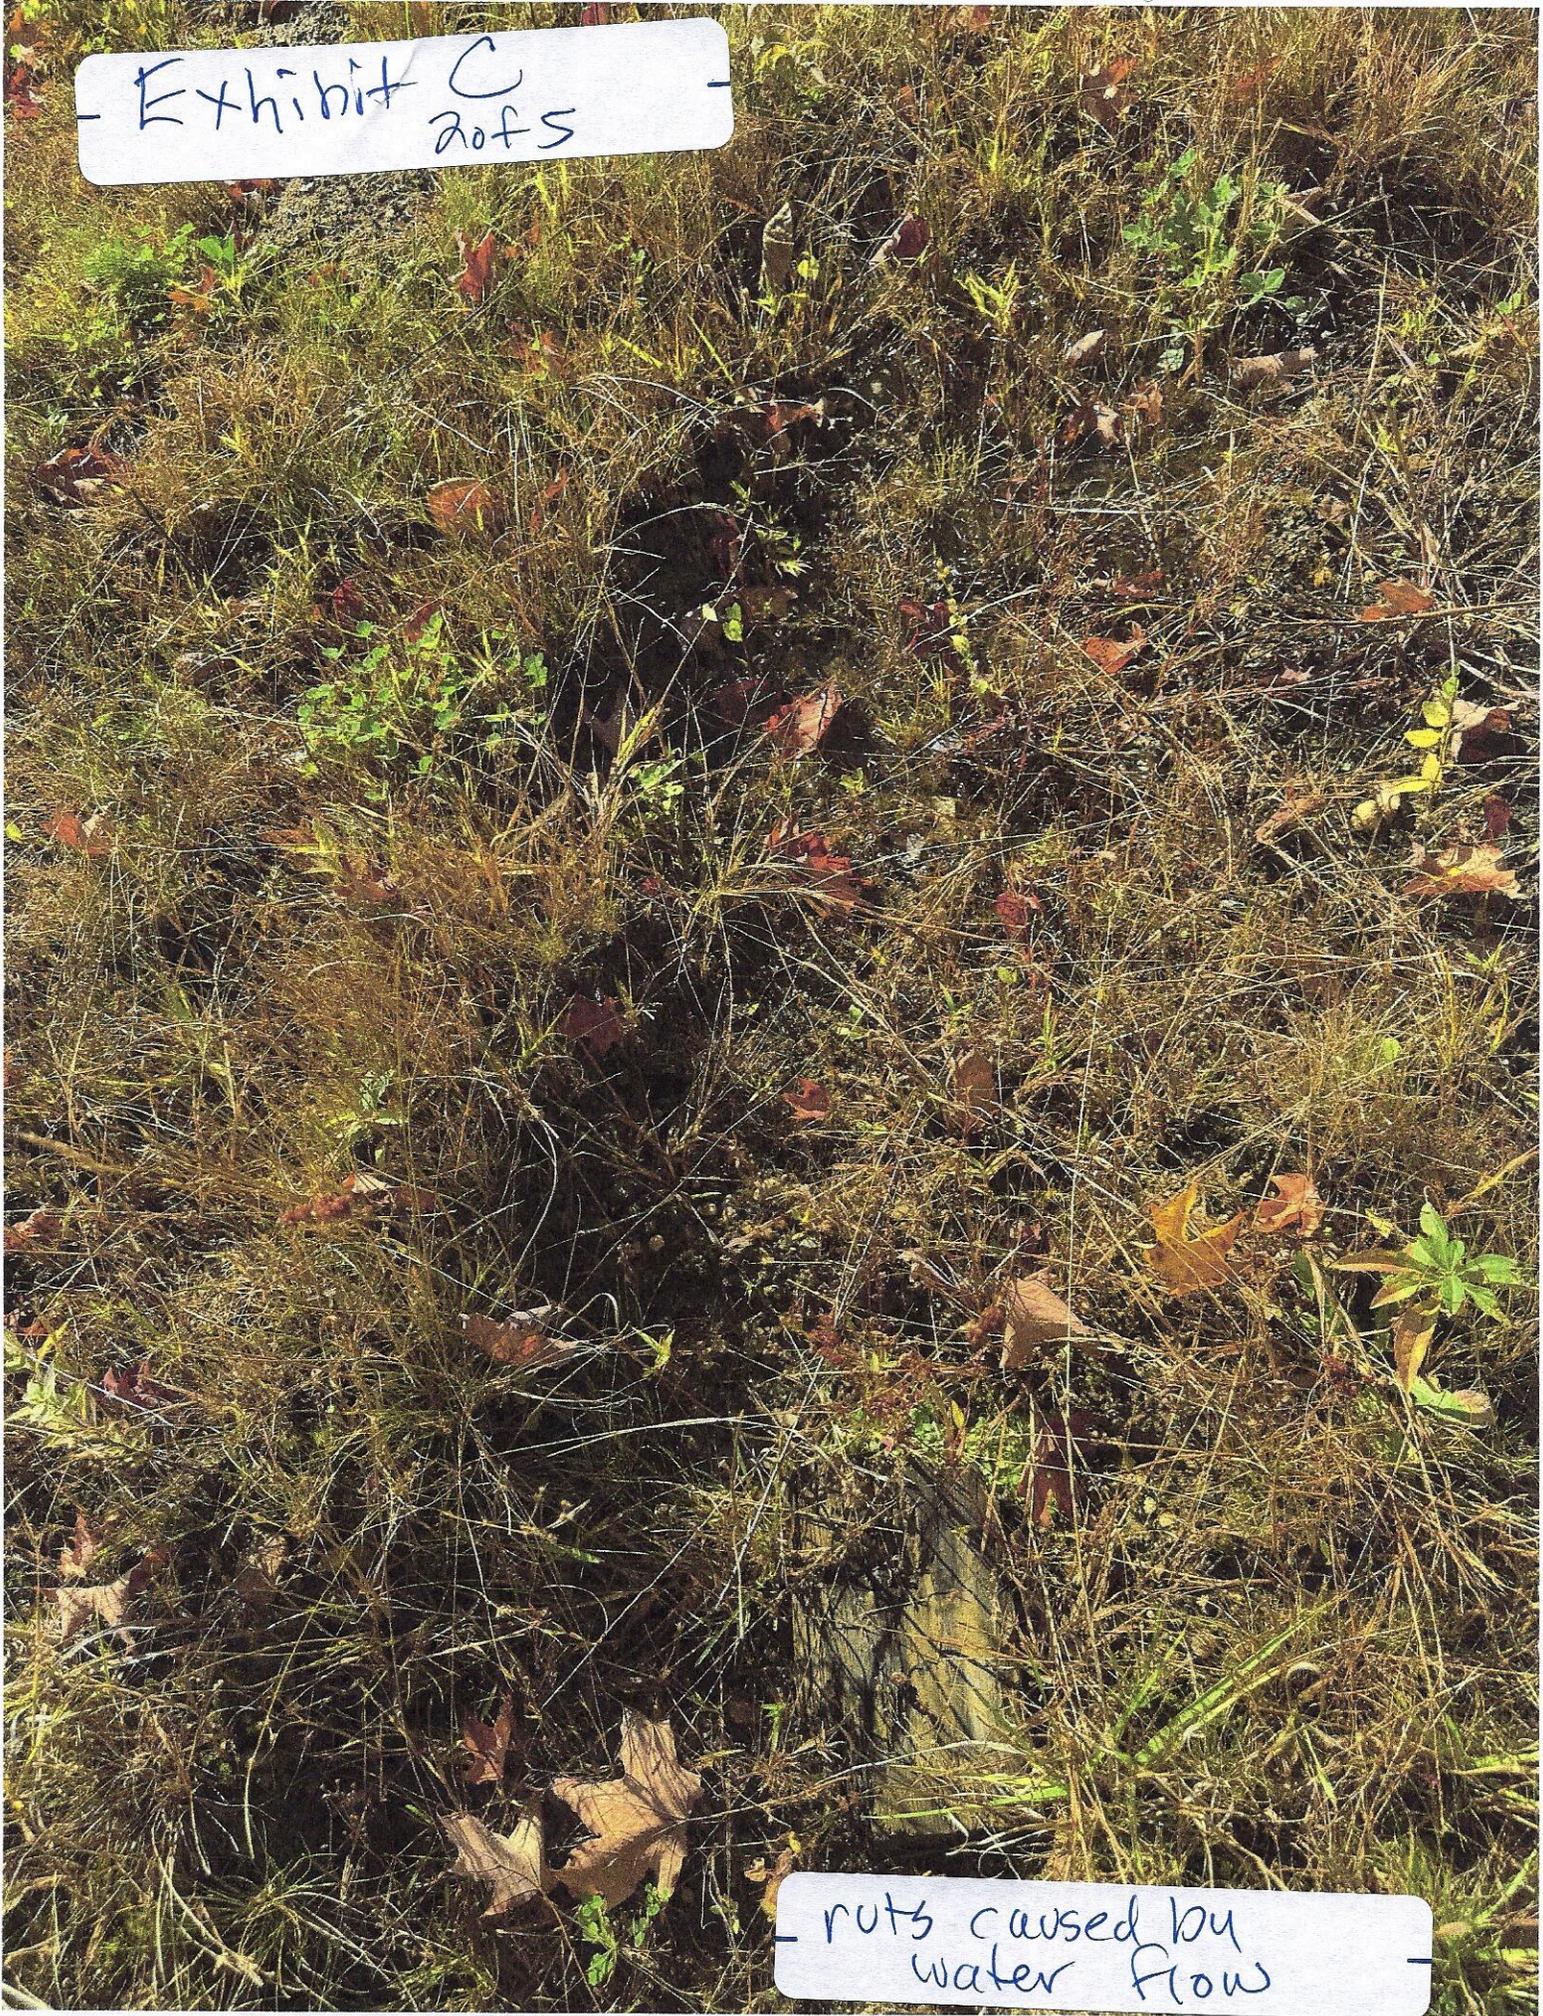
Exhibit C
2015

rut caused by
water flow

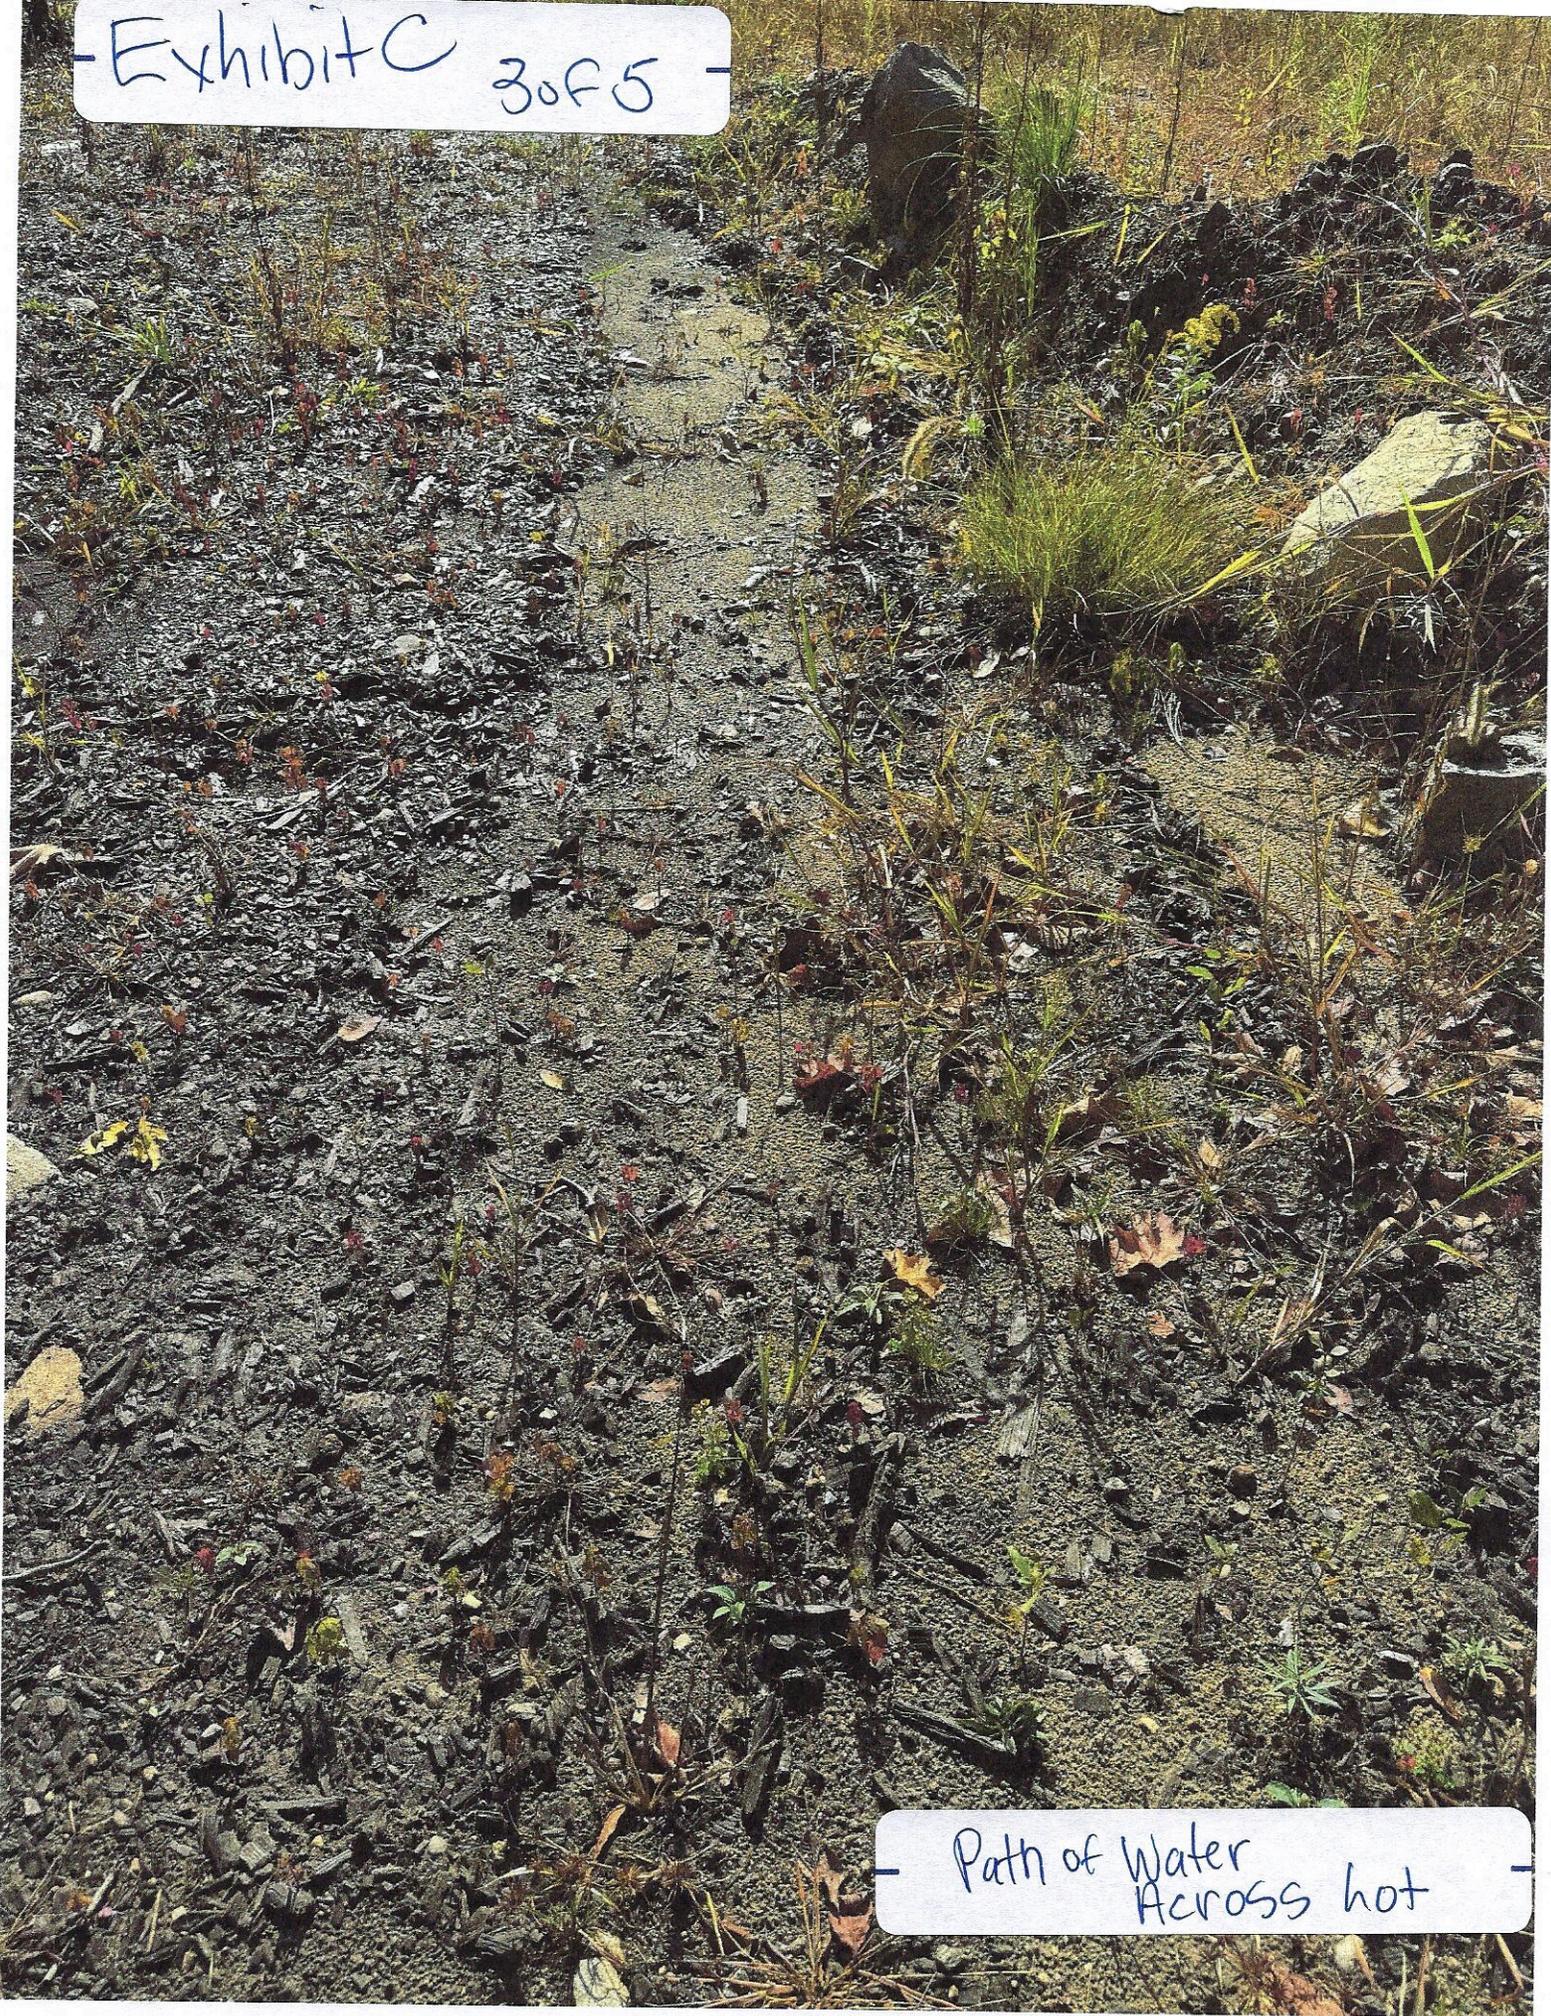
- Exhibit C 3 of 5 -

- Path of Water Across hot -

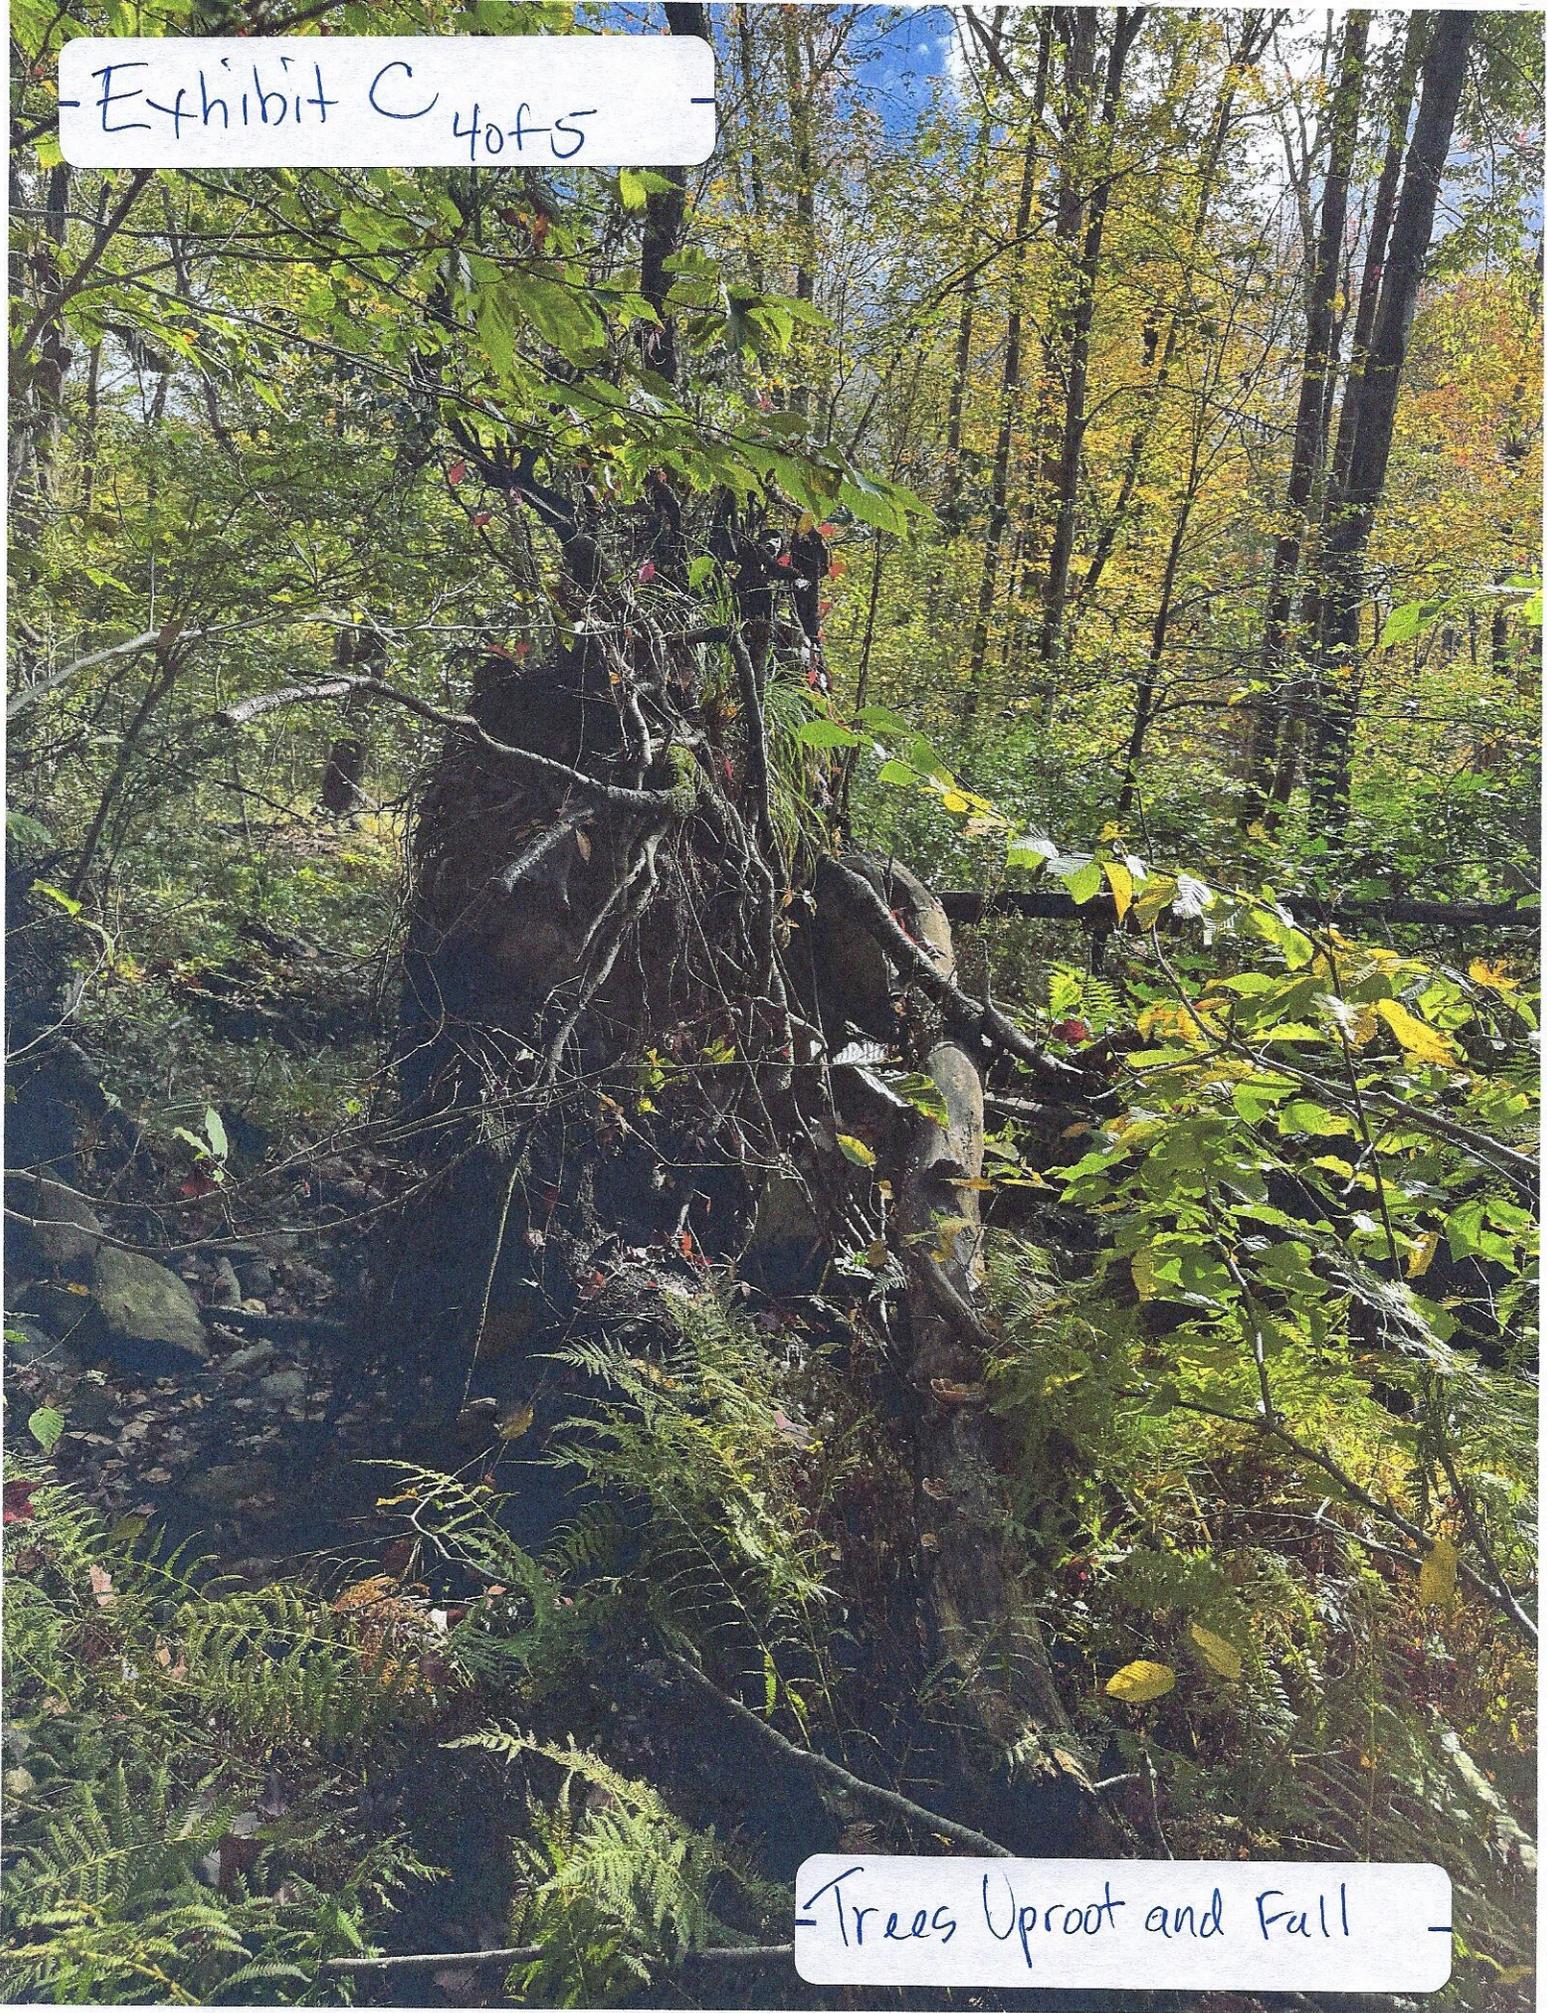
-Exhibit C 4 of 5-

-Trees Uproot and Fall-

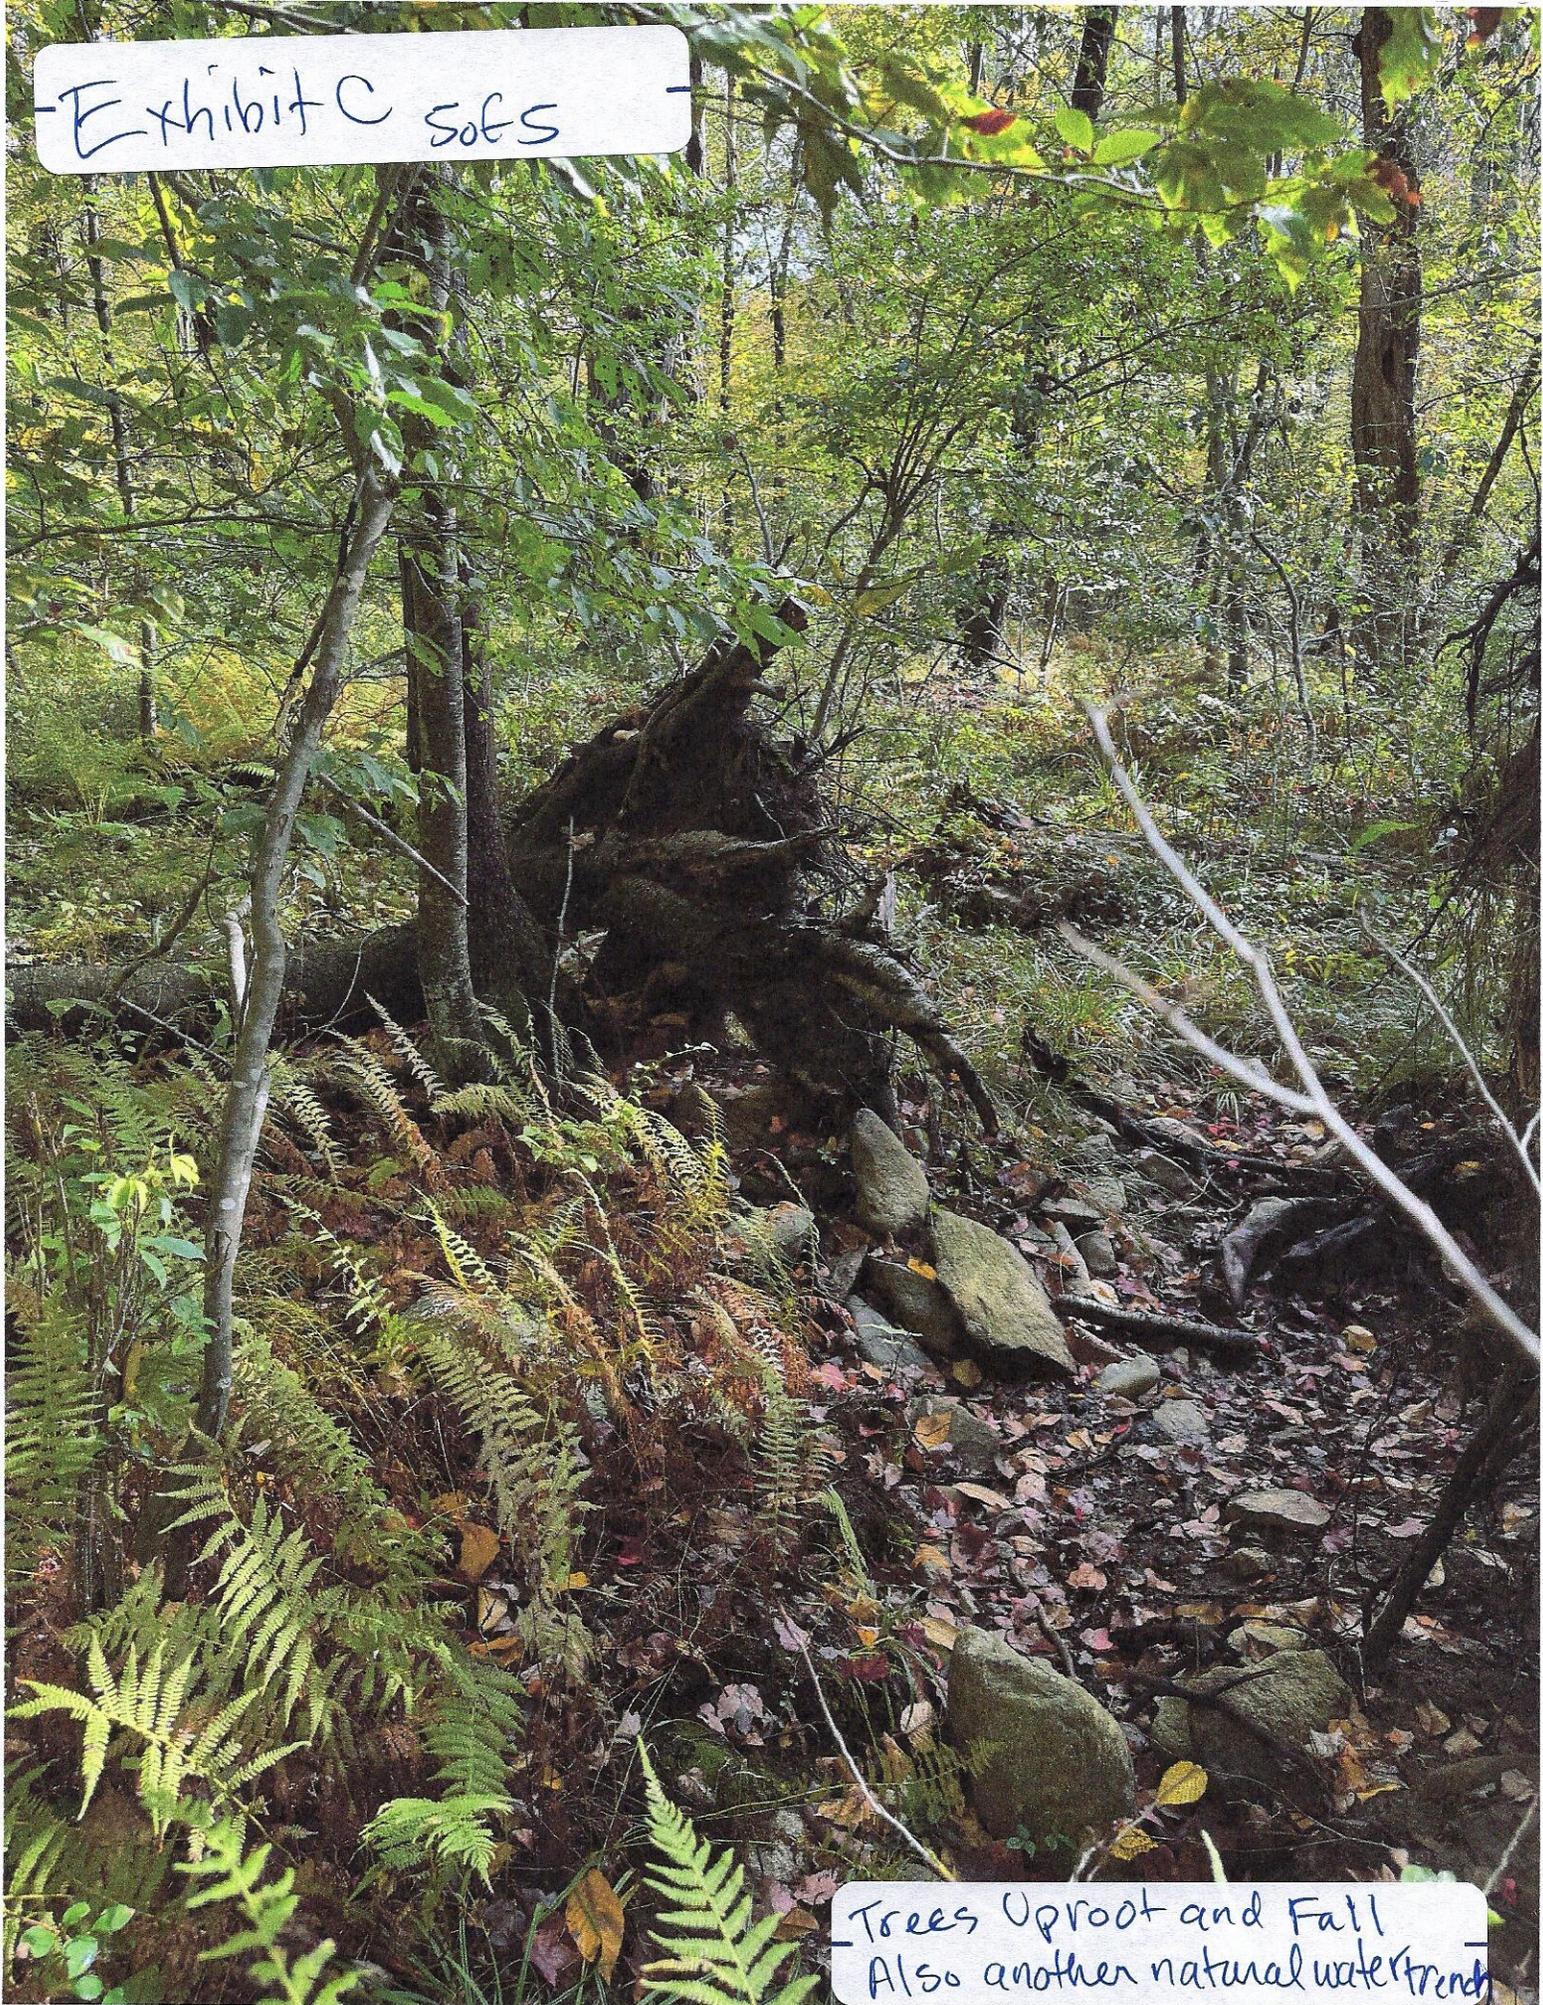
Exhibit C S&S

Trees Uproot and Fall
Also another natural water trench
