WP-25-28

Wetlands Permitting

Proposed activity in the upland review area for tree cutting, site grading, driveway, shed, footing drain discharge, erosion controls, etc. Modification of Wetlands Permit #20-47.

RE: *MONITORING OF VERNAL POOL CREATION & WETLAND SWALE*
60 Zeya Drive, Coventry, CT
REMA Job #: 20-2311-COV20

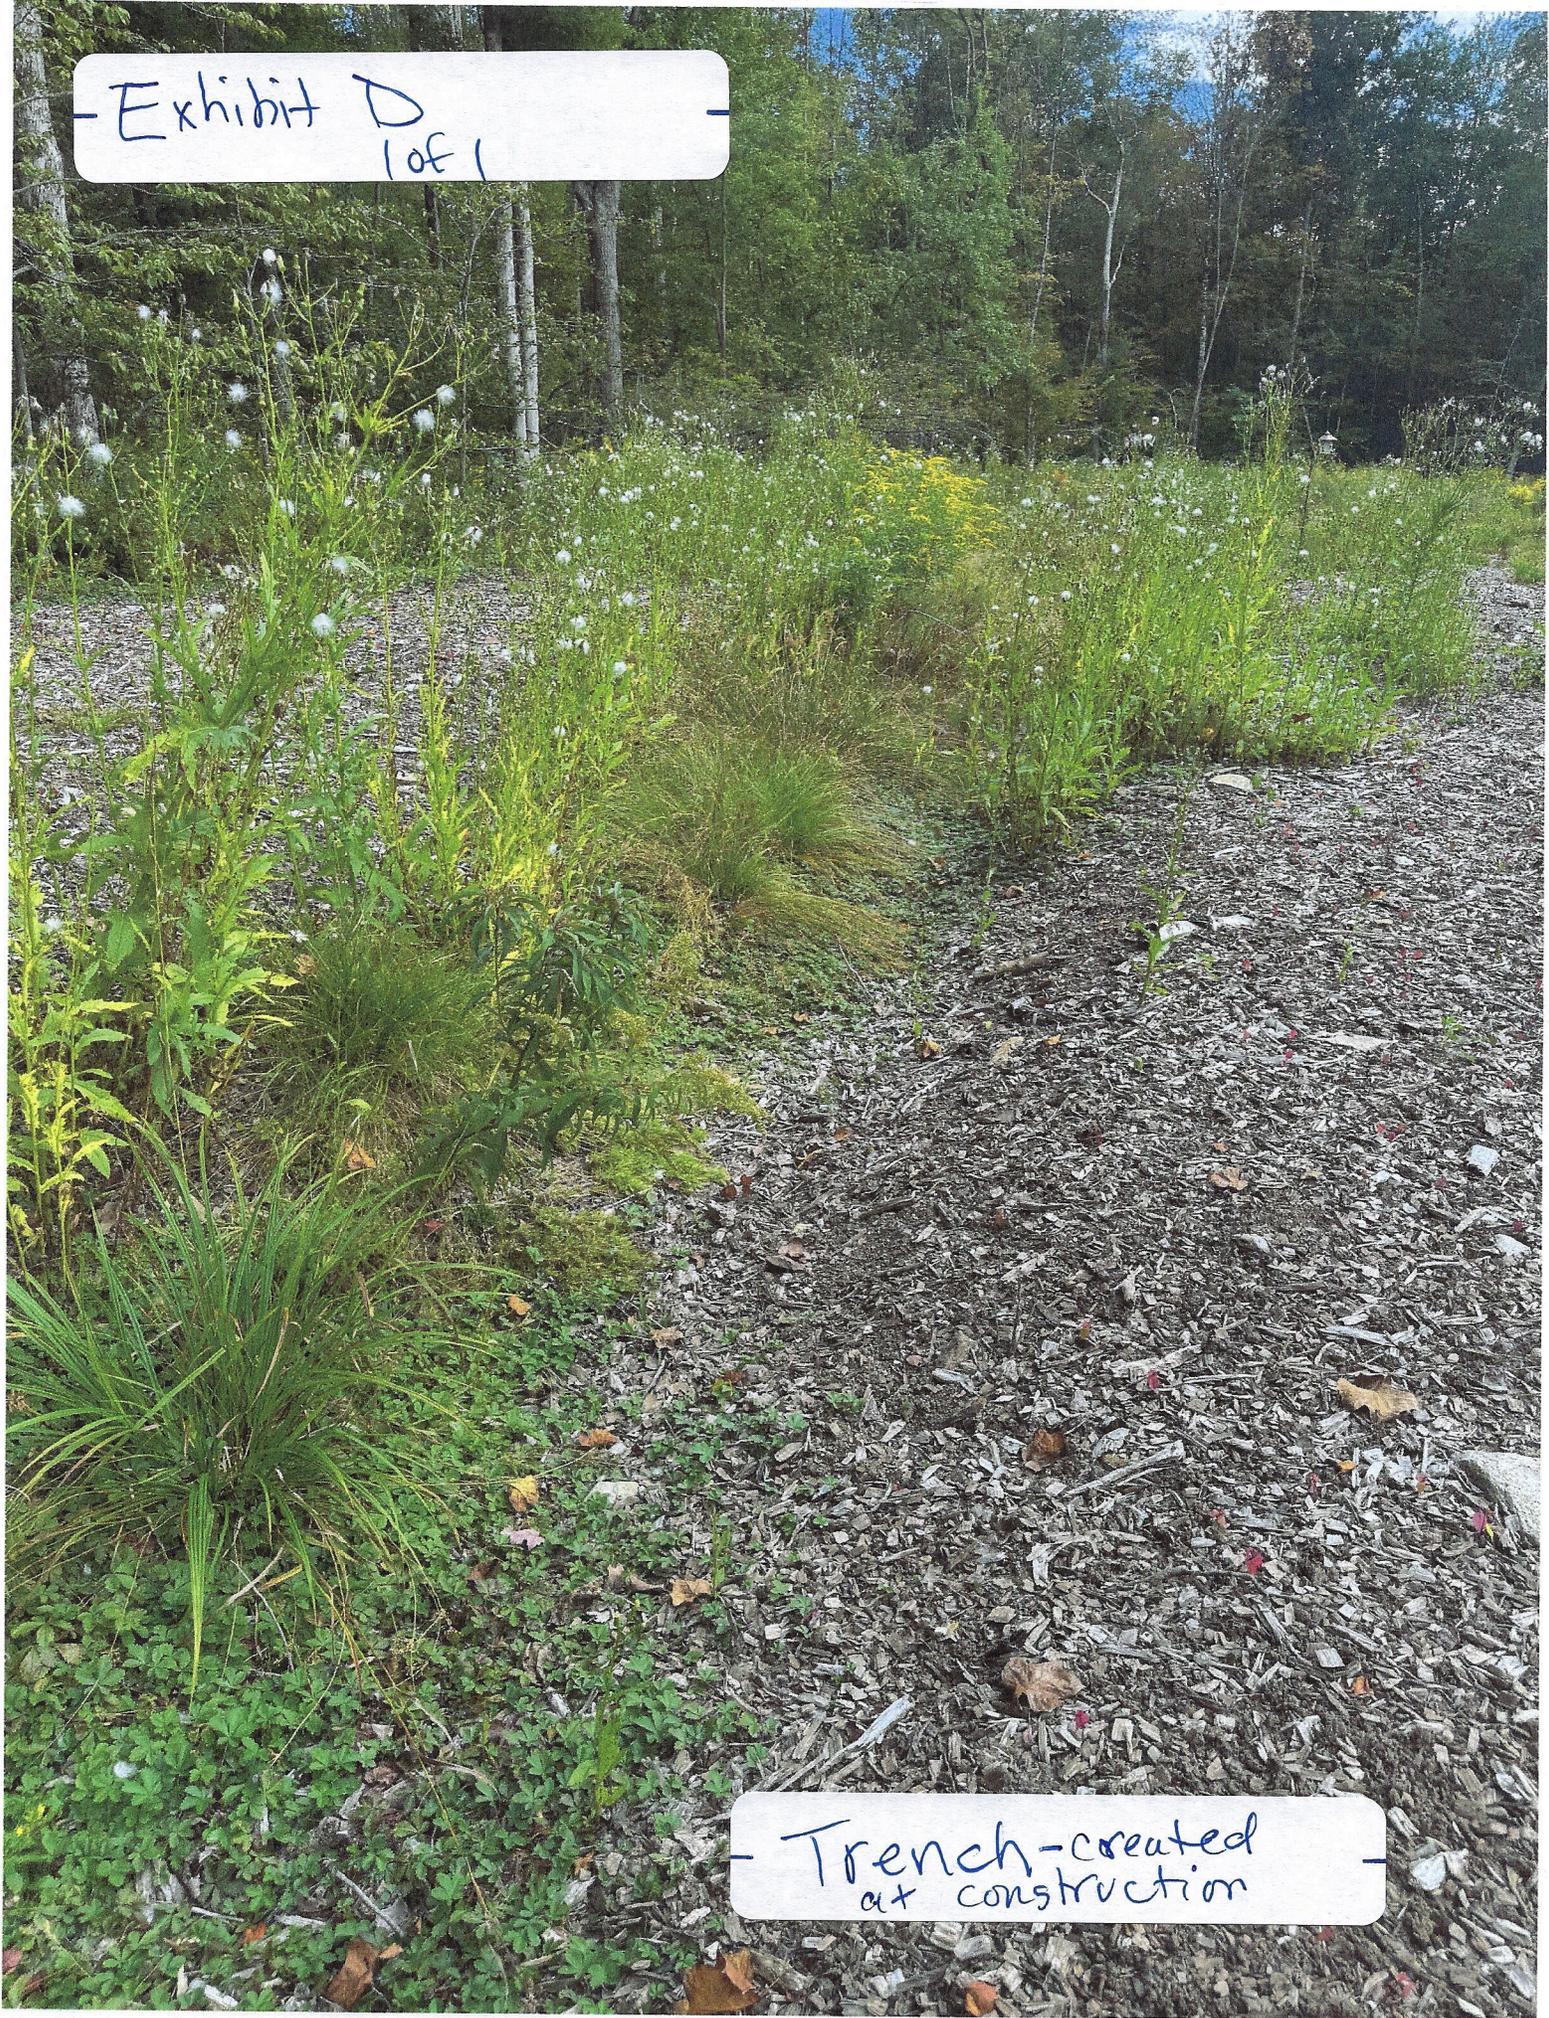
- Exhibit D
1 of 1

A trench was created in the cleared area of 64 Zeya Drive when we began construction. I don't know why it was not noted. It is a small trench used to slow down the flow of excess water. Some of it may be in the upland review area. It has not been touched since it was created and I wasn't planning on doing anything to it in the future. A photo of the trench is attached labeled Exhibit D.

- Trench-created
at construction

- An unpermitted activity, diversion trench was installed to reroute the surface flow of water away from existing house at 60 Zeya Drive. This activity needs to be located by your land surveyors as it relates to the wetlands and upland review area. Your agents shall provide an opinion as to its impact on the adjacent wetland. The applicant shall provide commentary as to whether this trench will remain in place. Consideration should be made to how the area surrounding the trench will be maintained as well as how the trench will be maintained in the future.

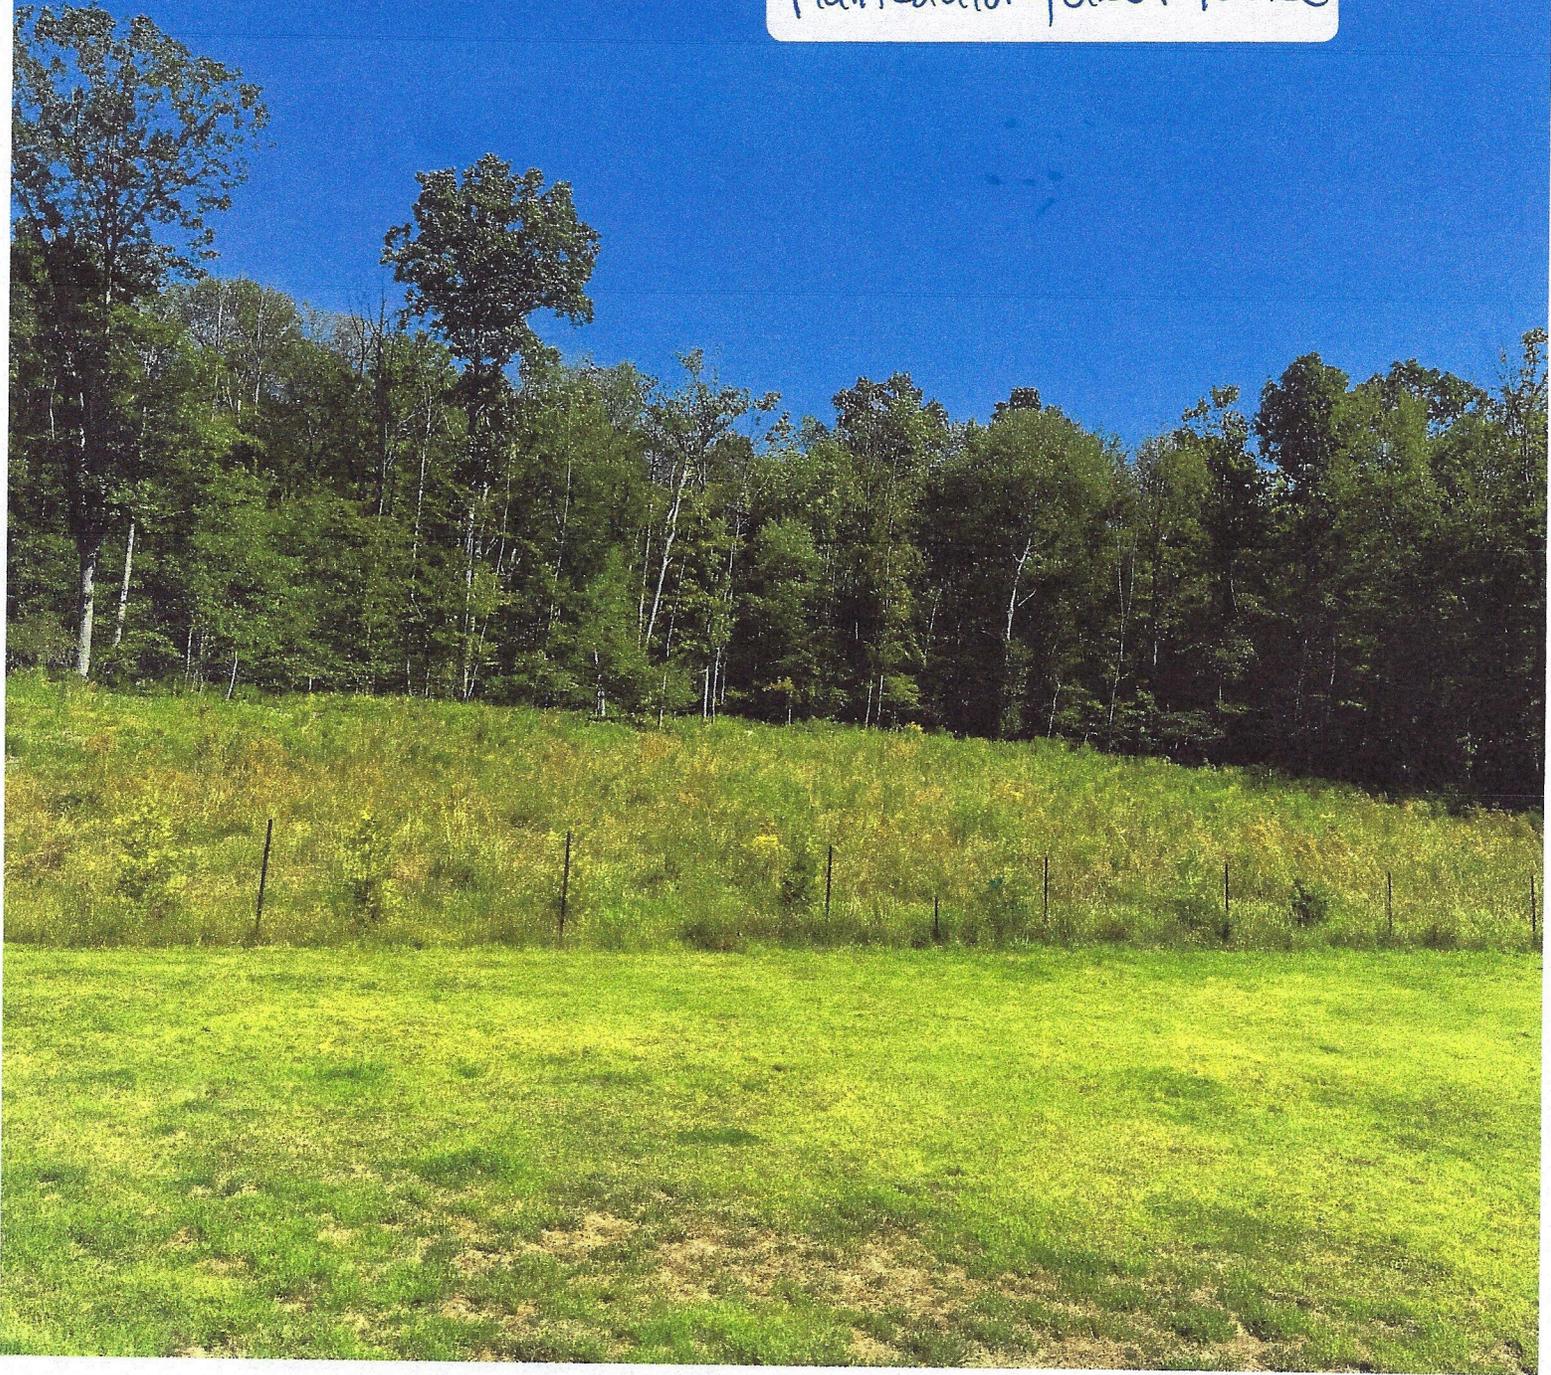
Exhibit E - 1 of 1

Meadow - trees
Planted along deer fence
