Coventry Lake – Hydrilla Management Program

2017 Final Report

February 2018

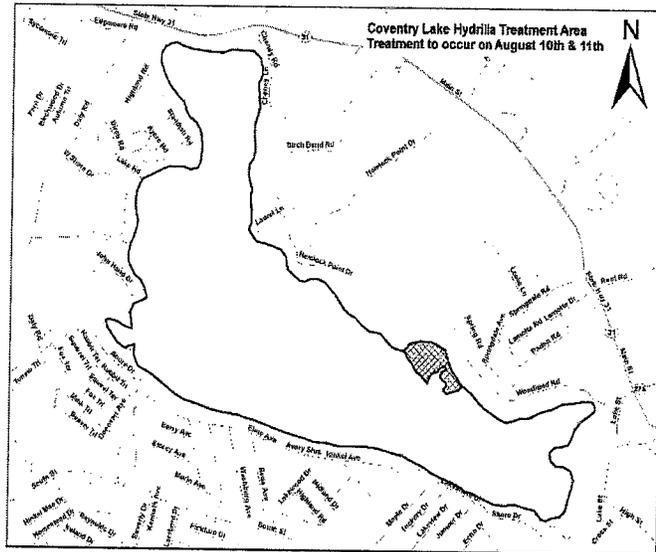
Map 1 - 2016 Initial Treatment Areas

- Initial treatment on August 10th & 11th of 9-acre cove. (**Map 1**)
- Two 1.5 parts per million (ppm) Aquathol-K doses each day (3 ppm total).
- Treatments were conducted about 16 hours apart to increase the duration exposure of plants to herbicide.
- Initial post-treatment survey results showed prolonged Hydrilla growth after treatment, but eventual decay by October 16, 2016.

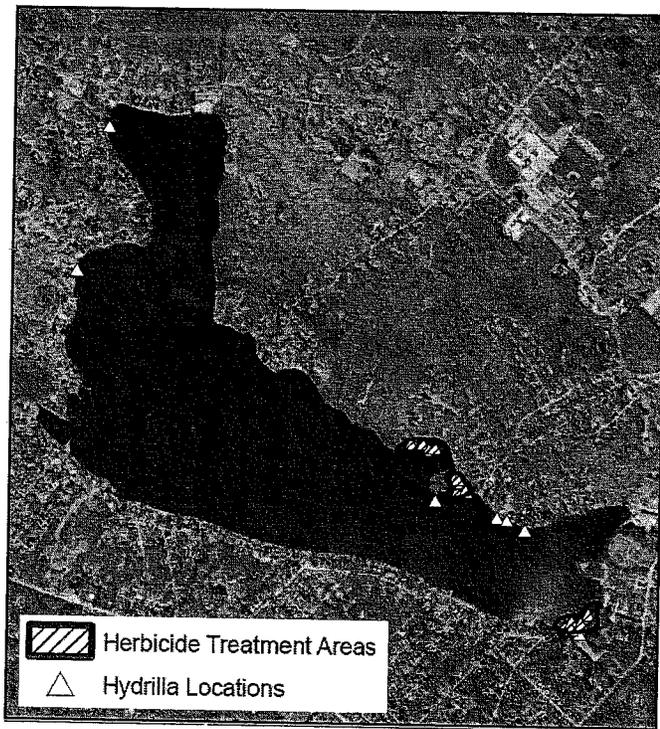
Map 2 - 2017 Management Areas

- Treatment was performed on September 28th in areas of the island cove plus around the boat ramp. (**Map 2**)
- Treatment occurred later than planned due to funding and contractual delays.
- Treatment included a combination of liquid and granular formulations of the endothall (Aquathol-K & Aquathol Super K) herbicide to achieve a total dose of 5 ppm.
- Liquid herbicide was applied in the morning and the granular herbicide was applied in the afternoon, approximately 6 hours apart.
- Post treatment survey on October 18, 2017 showed plants were unaffected.
- November follow-up found plants still present in northeastern bed.

- All small patches covered successfully. The larger untreated bed off shore of the island cove was only half covered (using 8 full barriers) - area indicated in **Map 2**. Hydrilla plants in this bed documented as 3'-5' tall and 8'-12' deep.

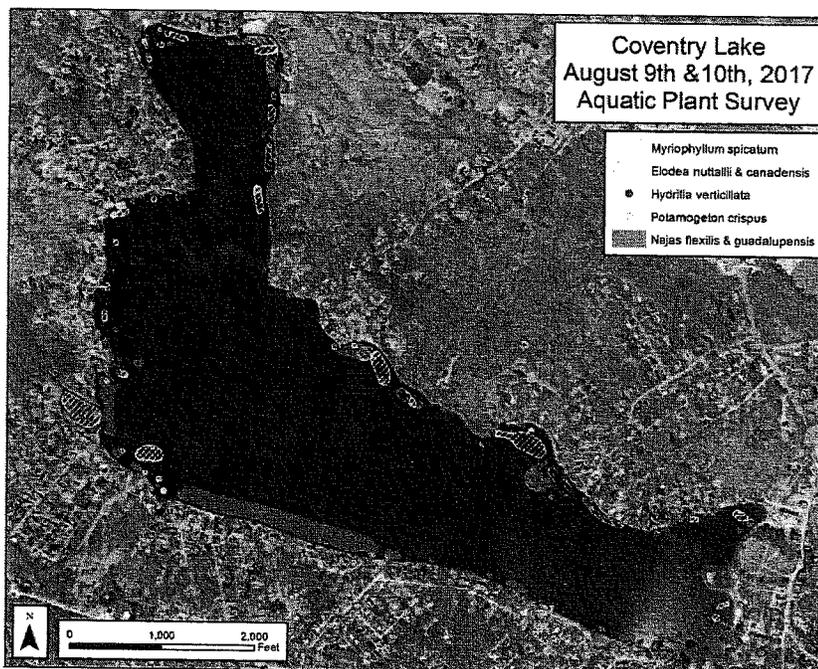
Map 3: August 9-10th, 2017 Dominant Species and Hydrilla Points

- The most dominant aquatic plant species lake-wide were: *Zosterella dubia*, *Ceratophyllum demersum*, *Nitella sp.*, *Najas flexilis & guadalupensis*, *Myriophyllum spicatum* (invasive), and *Elodea nuttallii & canadensis*. Dominant species displayed in **Map 3**.

- 20 new waypoints with Hydrilla (waypoints were made at each bed so some points are grouped together where there are clusters of beds). Also remove many floating Hydrilla fragments.

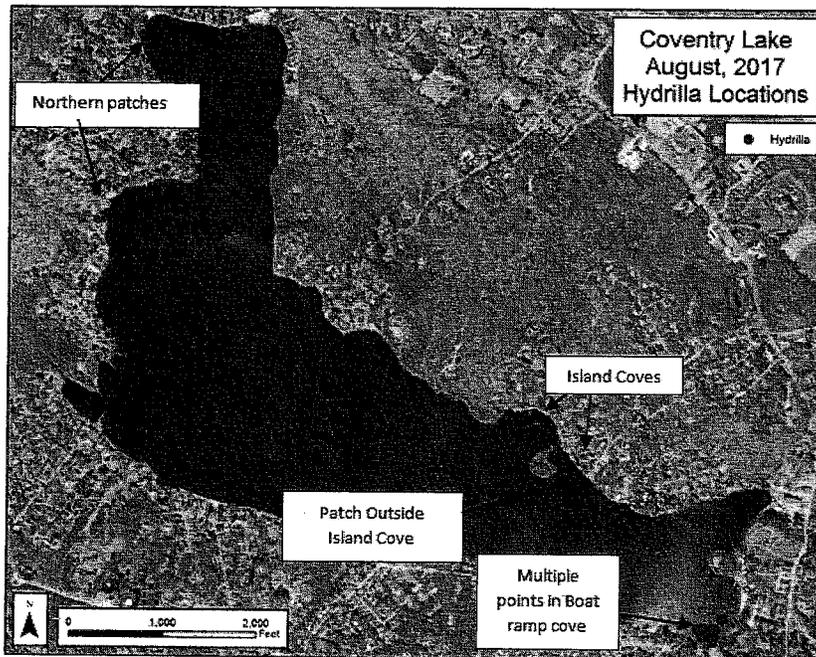
Map 4: August 9-10th and 16th, 2017 Hydrilla Locations (pre-treatment survey results)

- Two new small (3'x3') Hydrilla patches found in northern part of lake (**Map 4**).
- Many scattered small Hydrilla plants on both sides of the island cove area in <2' of water. Snorkel surveyor removed multiple plants, but this finding provides further evidence that Hydrilla fragments are spreading and starting new patches lake-wide.

- One new larger patch was found by the snorkel surveyor in 8'-12' of water, just outside the island. Bed size was estimated to be about 10'x12'.

- Underwater survey of boat ramp area and partial shoreline survey from Island cove shore towards the outlet/dam cove.
- Transect survey was conducted in fan-like pattern from the State boat ramp dock. [Notes on page 10] Survey boat followed diver to pick up waypoints; waypoints and diving notes were used to create the August 2017 Hydrilla map (**Map 4**).

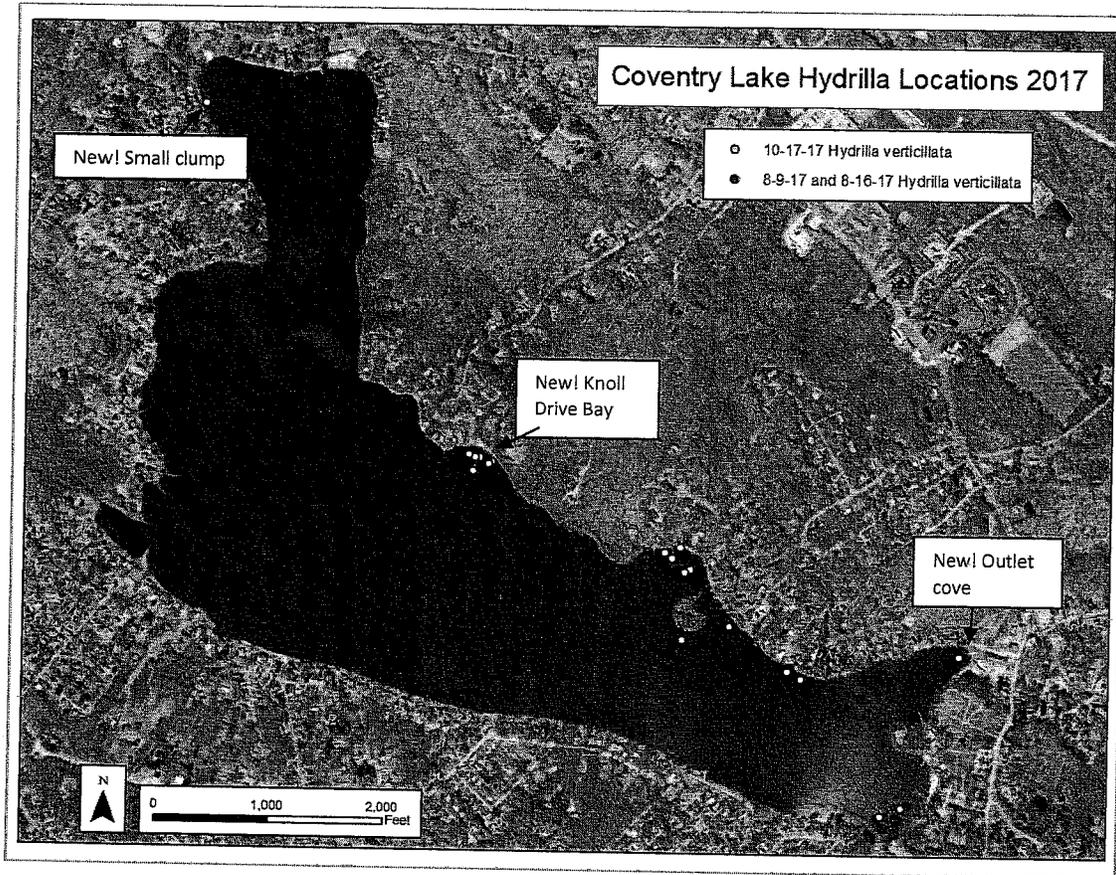
Map 5 – Latest Map of Hydrilla Locations in Coventry Lake

- Two **new** Hydrilla locations in the lake (**Map 5**):
 1. Outlet/dam cove - One bed estimated from surface to be 12'x12'. Hydrilla fragments found in outlet grate, Hydrilla may be moving downstream of the lake.

2. Central northern shore near Knoll Drive -
 - Large Hydrilla bed estimated ~15'x50' with 100% cover in central part of bed and less dense along edges.

- Possible that this large patch grew entirely in the 2017 season.
 - Two additional 6' diameter patches and three 3' diameter patches were also found in the Knoll Drive location.

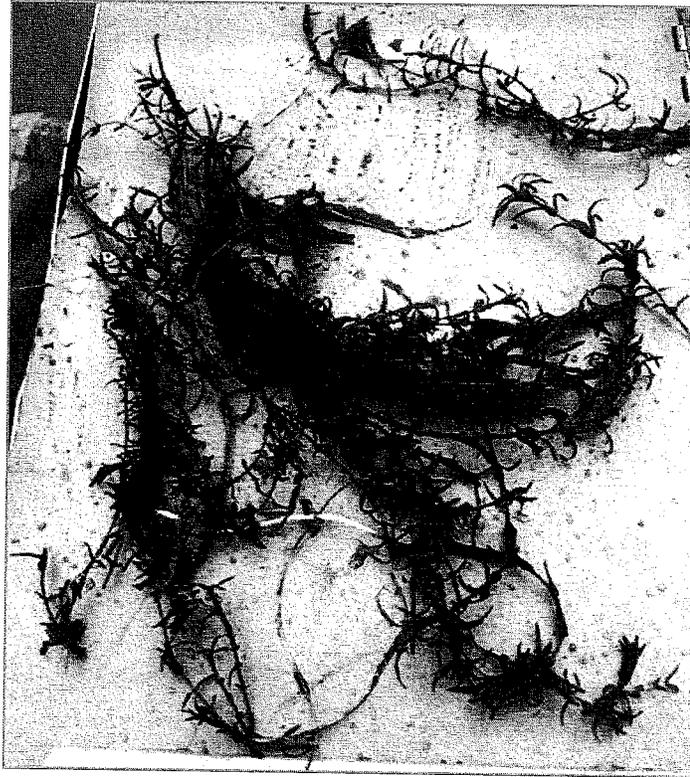
Photo 1: November 20, 2017 - Treated Hydrilla Partially Decaying

- No Hydrilla was visible from the surface near the outlet cove (untreated) nor boat ramp area (treated 2017).
 - Several ~10' pole hand rakes revealed no Hydrilla, but throw-rake tosses were not conducted to avoid potential fragmentation.
- One of the original patches (northern eastern most) in the island cove area (treated in 2016 and 2017) still had Hydrilla present.
 - Hydrilla plants appeared to be partially decaying - Photo 1 – Page 11.
 - Due to choppy water and low temperatures, no other beds were inspected on this date.
