# **Coventry Lake Hydrilla Management Program 2021 Treatment Report**

**Prepared for the Town of Coventry, CT**

**January 2022**

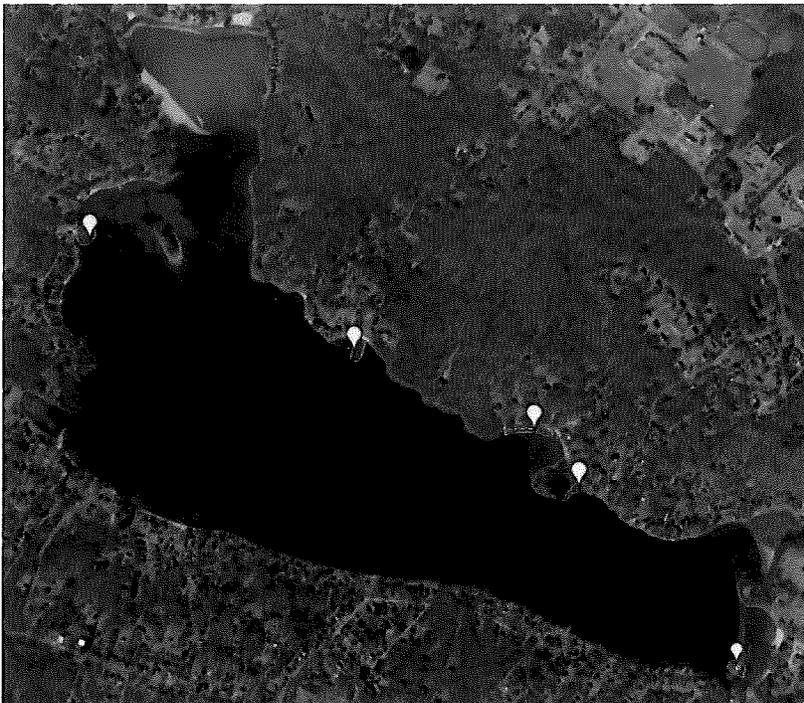
*Map 5. 2021 underwater survey locations of September 21<sup>st</sup>, 2021.*

Hydrilla present only in the area of the red "island" location in mostly 10-12ft of water. Approximate 9/21/21 underwater survey areas are outlined.

In addition to the surveys conducted from a boat, underwater inspections were done on September 21<sup>st</sup>, two months after the initial herbicide treatment. Six sites that had Hydrilla documented in previous years were inspected via underwater survey techniques (**Map 5**). Sites were swum in an underwater transect pattern, searching for visible Hydrilla growth. A considerable number of small Hydrilla plants were found in the area that had been previously covered with benthic barriers, just offshore of the peninsula. This area had been previously referred to as the "Island Patch" in past reports (**Map 5**, red location). The Hydrilla plants found on September 21<sup>st</sup> were approximately 3-5 inches tall and scattered in 10 to 12 feet of water. Observed Hydrilla plant density at this area was approximately 1 small plant every 2-3ft. The plants were brittle and visibly discolored, exhibiting the whiteish and purplish discoloring that is characteristic of fluridone herbicide chlorosis (**Images 1-2**).
