Coventry Lake Hydrilla Management Program 2022 Treatment Report

**Prepared for the Connecticut Department of Energy and
Environmental Protection & the Town of Coventry, CT**

November 2022

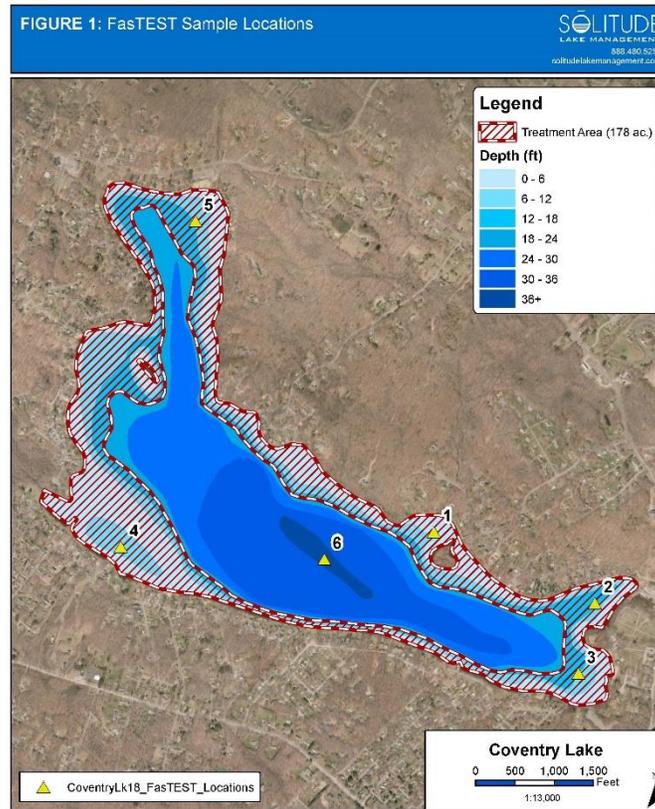
Map 1. Coventry Lake 2022 Treatment Area.

To monitor fluridone concentrations, water samples were collected from the surface and 1-foot off the bottom from six different locations in the lake, as shown in **Map 1**. Samples were collected multiple times over the course of the project. Results are displayed in **Table 1**.

The 2022 management approach was the same as the prior four years. A 4-ppb dose of Sonar One (Fluridone) was applied to the 178-acre littoral zone on July 21st. The first booster treatment was administered on August 22nd, using a lake-wide dose of 2-ppb applied to the littoral zone. A second booster treatment was administered on September 20th, using the same 2-ppb lake-wide dose.

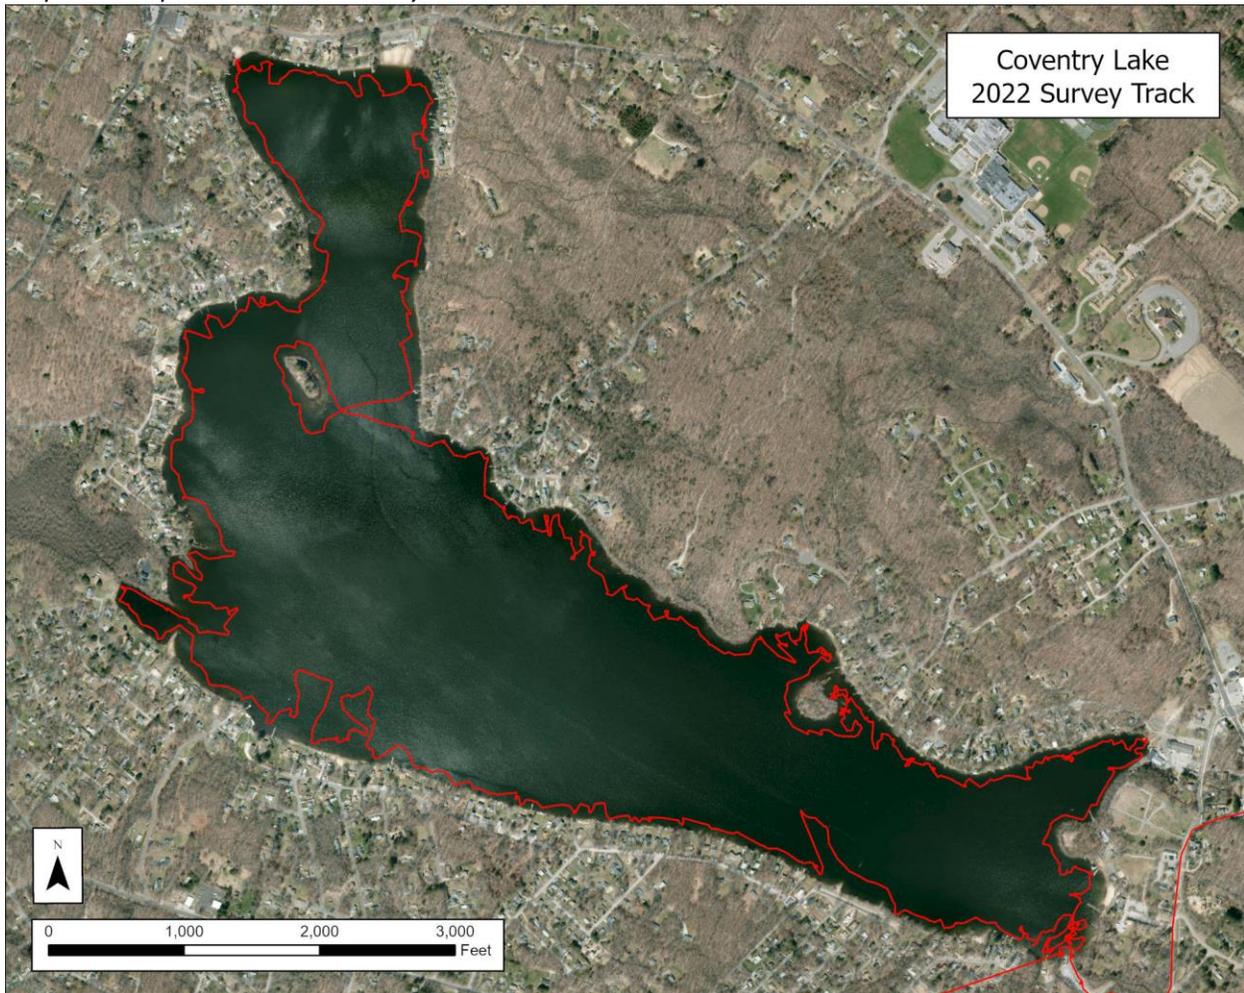
Map 2. 2022 post-treatment survey track.

NEAR conducted a pre-treatment aquatic plant survey on July 13th. Waypoints were created every ~150 feet throughout the lake's littoral zone and waypoints where Hydrilla had been found in previous years were revisited (**Map 2**). The survey utilized a combination of visual assessments, hand-raking in shallow water, grappling rake tosses, and depth-soundings to view plants growing in deep water.

NEAR conducted a post-treatment survey on October 6th. Again, the survey covered the entire littoral zone of the lake, with the aim of assessing the impact of the herbicide treatment on both the invasive and native plant populations.

Hydrilla was not found anywhere in the lake in 2022. All locations where Hydrilla had been found in prior years were thoroughly searched, but no plants were present. Hydrilla plants produce turions (winter buds) that can remain dormant in the sediment at the lake bottom for several years, so while plants were not found this year, it is very possible that plants could sprout from turions in the future. Therefore, it is vital that thorough aquatic plant surveys are conducted every year to search for new Hydrilla plants.

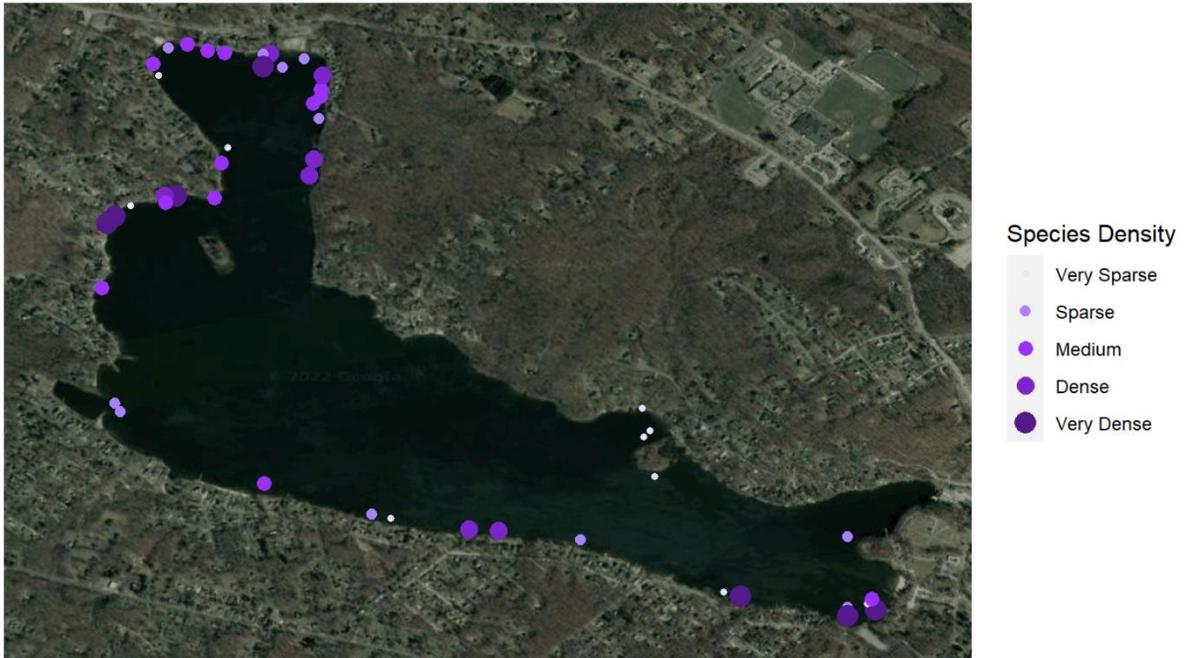
Map 3. Pre-treatment survey locations and densities of *Potamogeton perfoliatus*.

Potamogeton perfoliatus :: July 13, 2022

A total of 23 aquatic plant species were found in the lake during the pre-treatment survey, along with Filamentous Algae and *Lyngbya* sp. (Cyanomat) (**Table 2**). Of these, the dominant species (those found at greater than 20% frequency) were *Potamogeton perfoliatus* (Clasping-leaf pondweed), *Nitella* sp. (Stonewort), and *Potamogeton amplifolius* (Large-leaf pondweed) (**Map 3, Map 4, Map 5**).

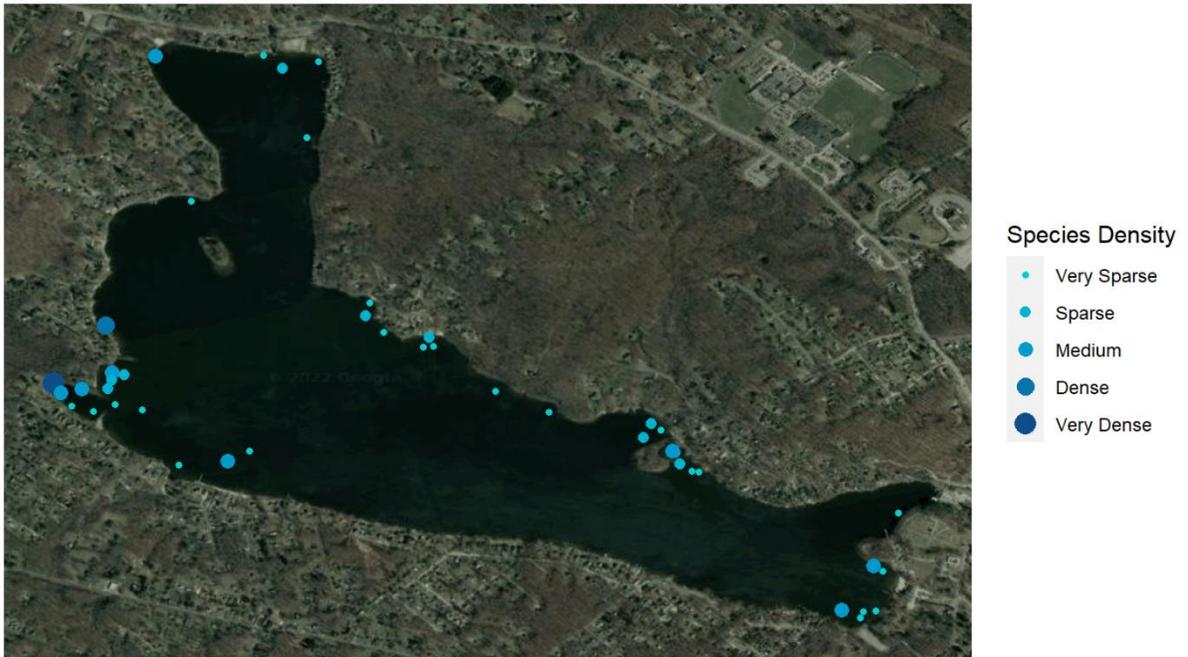
Map 4. Pre-treatment survey locations and densities of *Nitella* sp.

Nitella sp. :: July 13, 2022

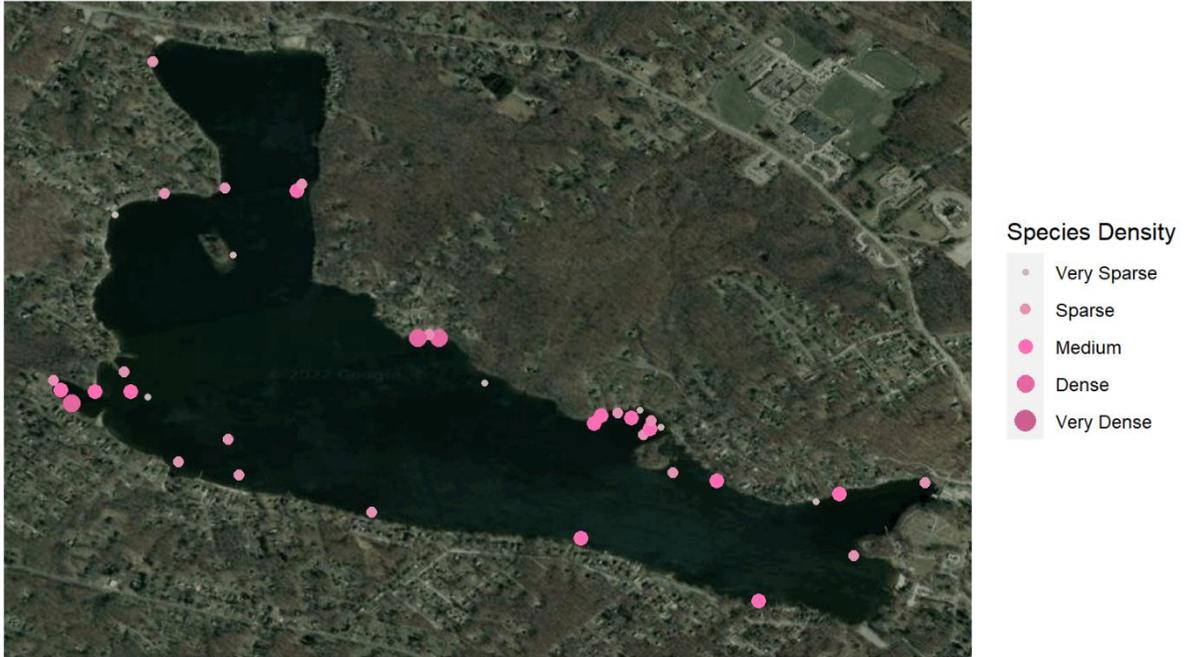
Map 5. Pre-treatment survey locations and densities of *Potamogeton amplifolius*.

Potamogeton amplifolius :: July 13, 2022

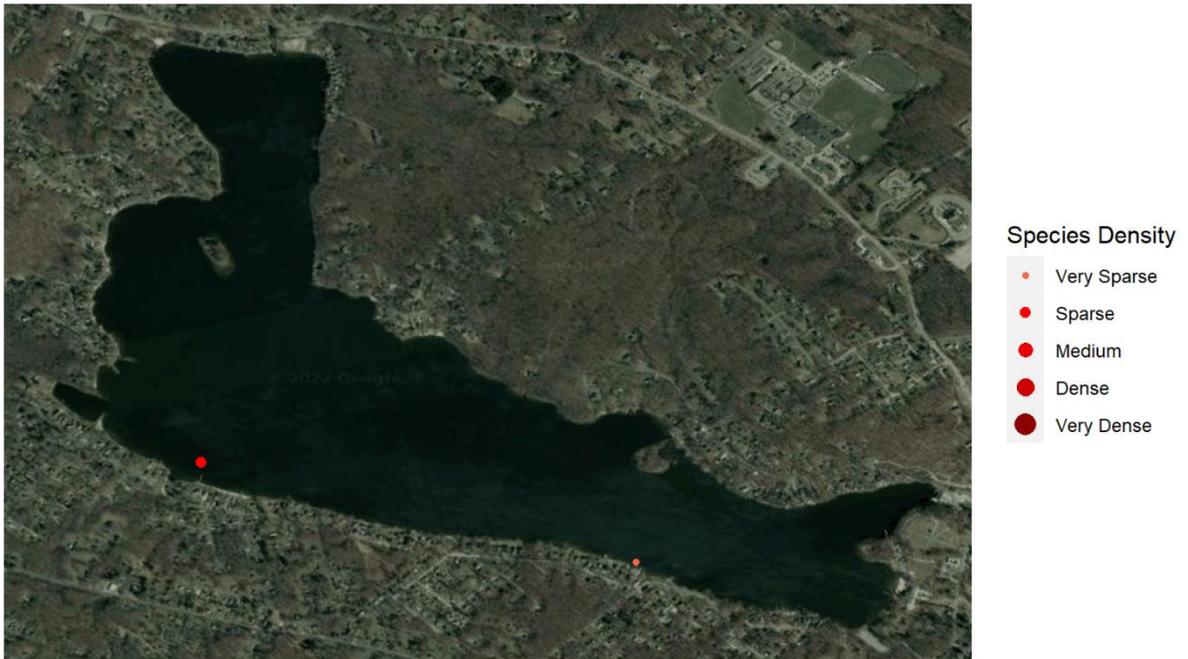
Map 6. Pre-treatment locations and densities of *Potamogeton crispus*.

Potamogeton crispus :: July 13, 2022

Two small patches of the invasive species *Potamogeton crispus* (Curly-leaf pondweed) were found on the lake's southern shoreline (**Map 6**). A few floating Curly-leaf pondweed fragments were also found along this shoreline.

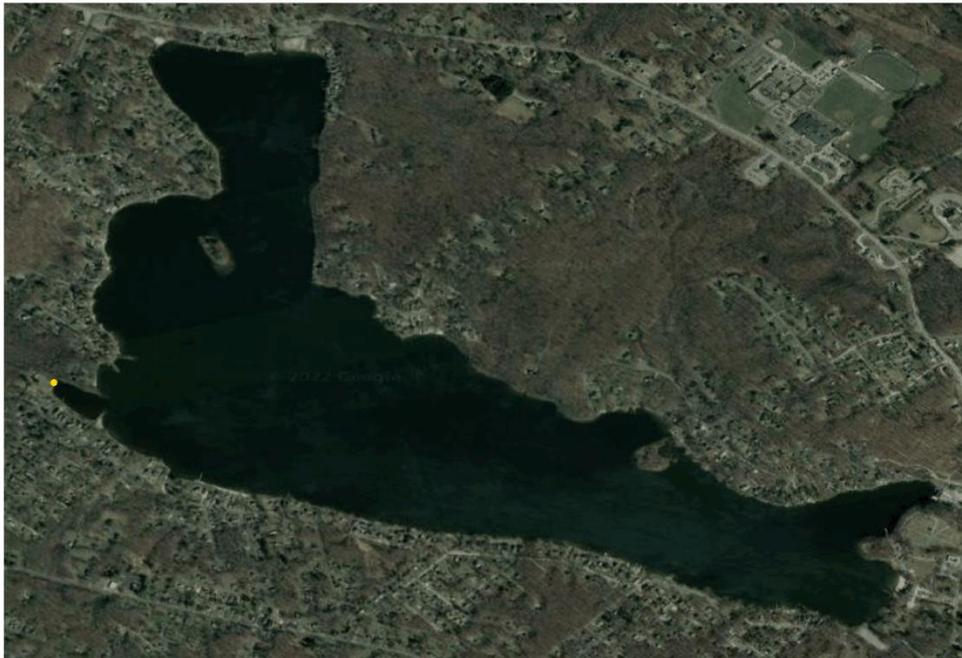
Map 7. Pre-treatment locations and densities of *Glossostigma cleistanthum*.

Glossostigma cleistanthum :: July 13, 2022

One patch of the invasive species *Glossostigma cleistanthum* (Mudmat) was found in the cove at the southwest corner of the lake (**Map 7**).

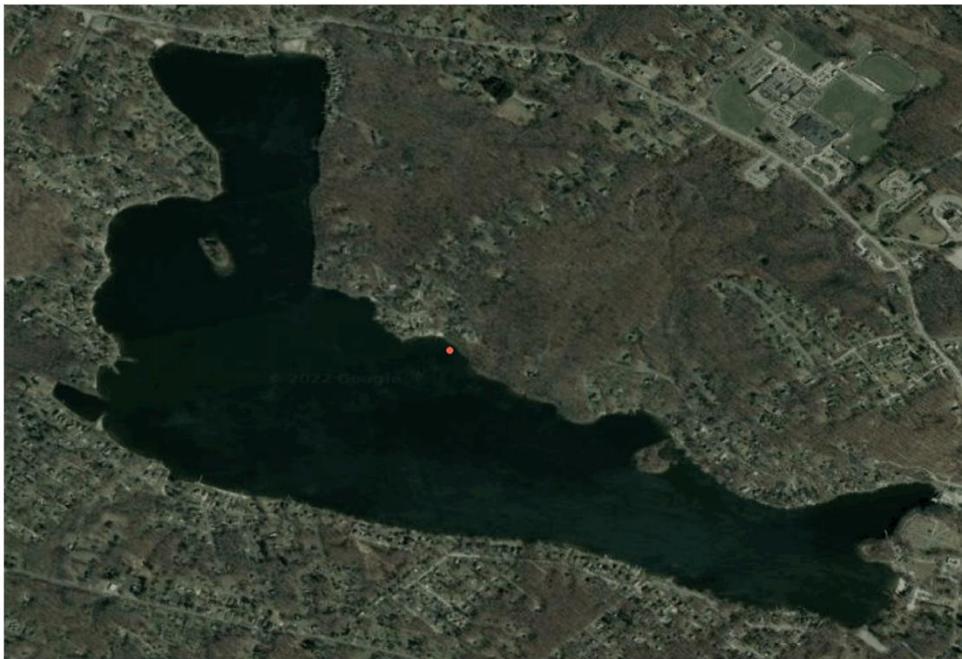
Map 8. Pre-treatment locations and densities of *Trapa natans*.

Trapa natans :: July 13, 2022

One invasive *Trapa natans* (Water chestnut) plant was found on the lake's northern shoreline (**Map 8**). The plant was immediately pulled and removed from the lake.

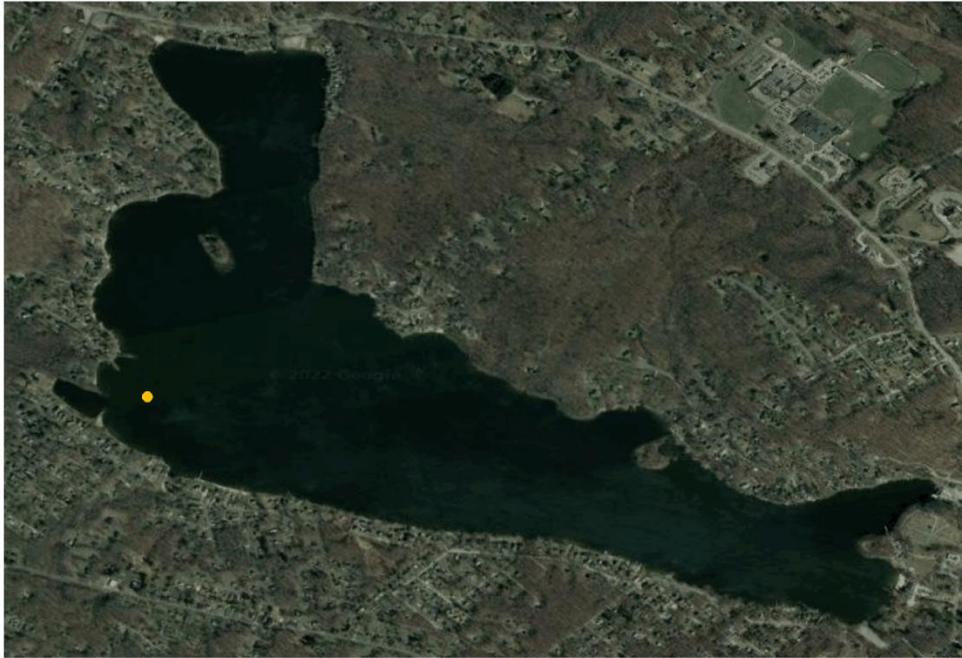
Map 9. Pre-treatment survey locations and densities of *Potamogeton vaseyi*.

Potamogeton vaseyi :: July 13, 2022

The state-listed Threatened species *Potamogeton vaseyi* (Vasey's pondweed) was also found in one location, in approximately 6 feet of water near the southwest corner of the lake (**Map 9**).

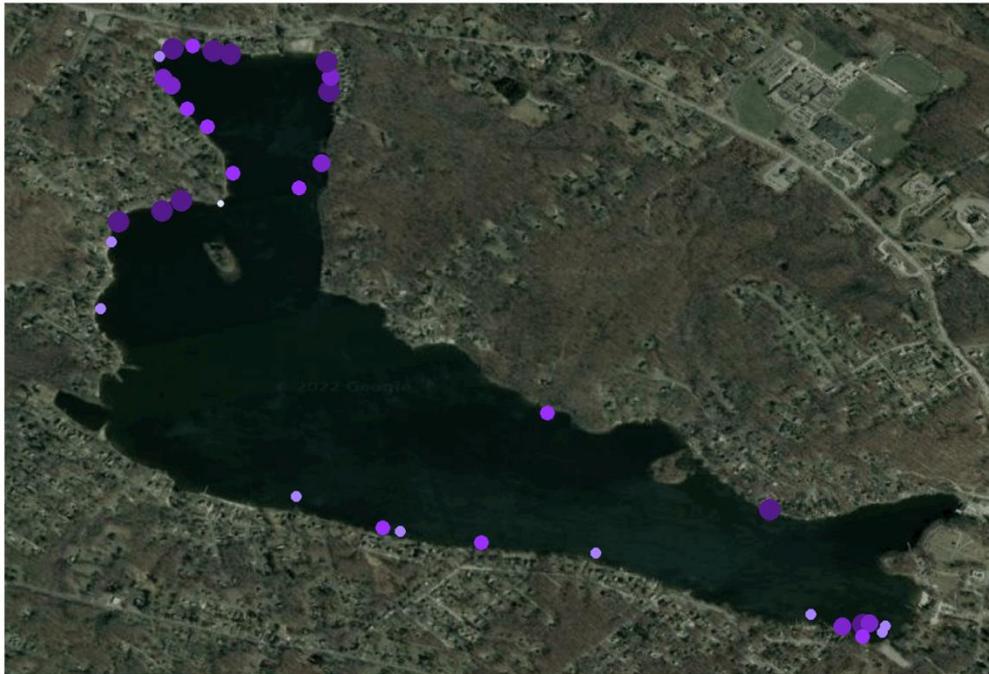
Map 10. Post-treatment survey locations and densities of *Potamogeton perfoliatus*.

Potamogeton perfoliatus :: October 3, 2022

During the post-treatment survey, *Potamogeton perfoliatus* was the only dominant species (**Map 10**). Two patches of Mudmat were found in shallow water, one patch on the northern shoreline and one patch on the western shoreline (**Map 11**).

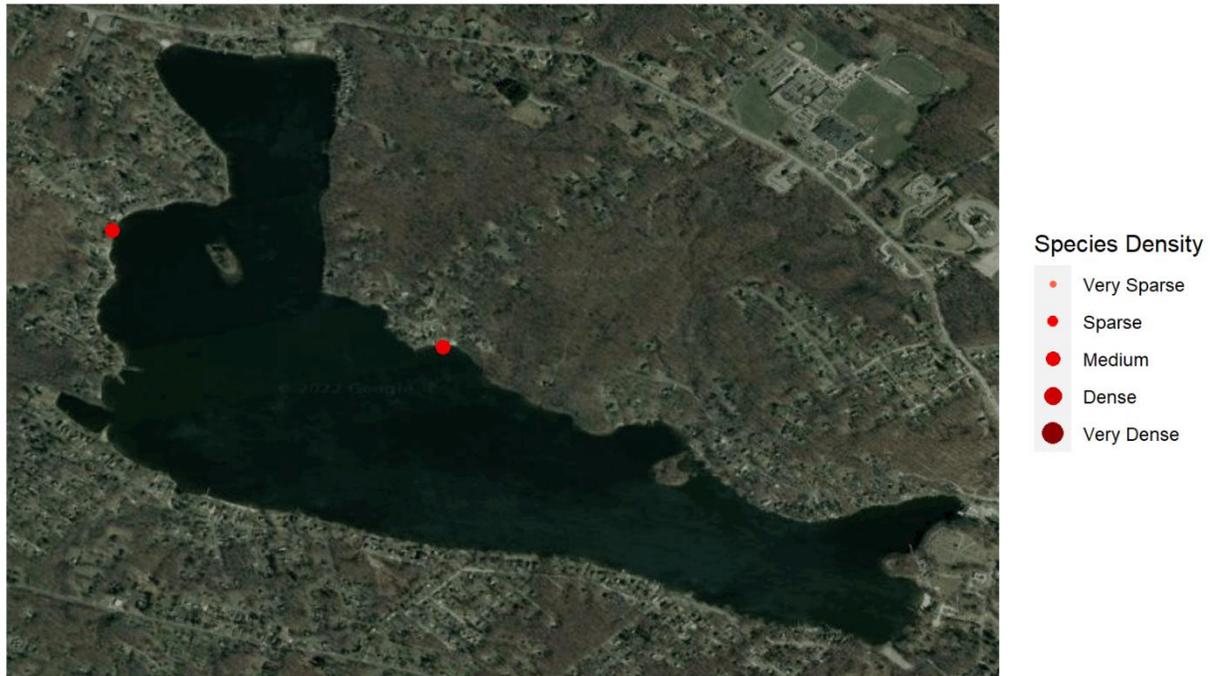
Map 11. Post-treatment survey locations and densities of *Glossostigma cleistanthum*.

Glossostigma cleistanthum :: October 3, 2022
